Commercial Inspection Report

**200 S. Main Street
Bellevue, Idaho**

Inspection Date: 02/10/2007

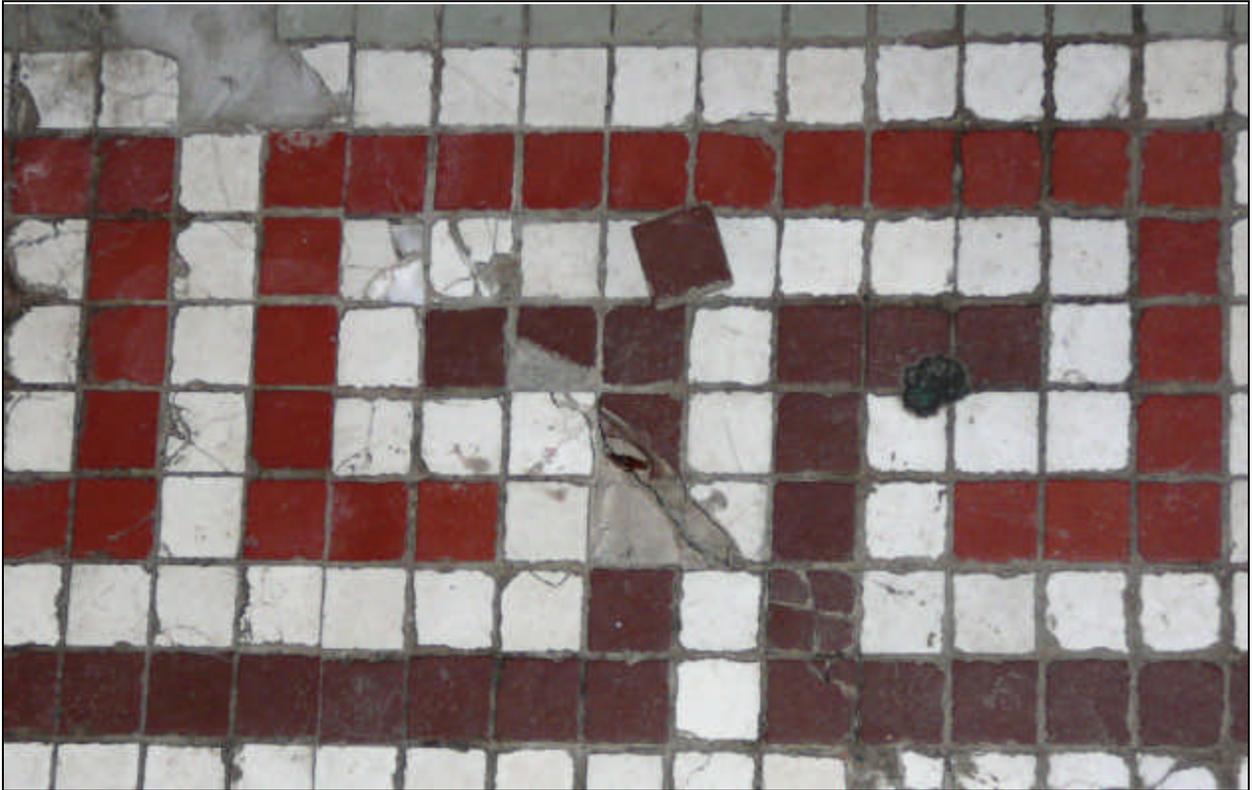
- The interior of the "Bank Bar" portion at the right front of the property has mosaic tiled floors applied directly over concrete. For the most part, these mosaic tile floor surfaces are in great condition. However, the following photo shows a few small

tile pieces separating from the concrete just inside the main entry door.

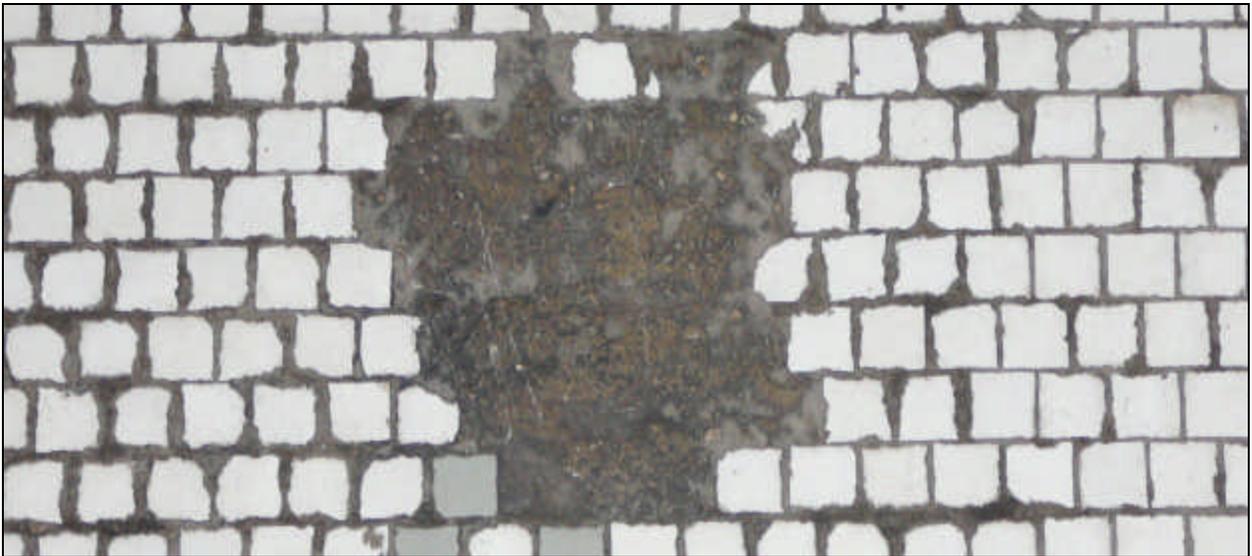
Another small area with missing mosaic tiles has been filled in with mortar. This area is just east of the center of the meat counter.

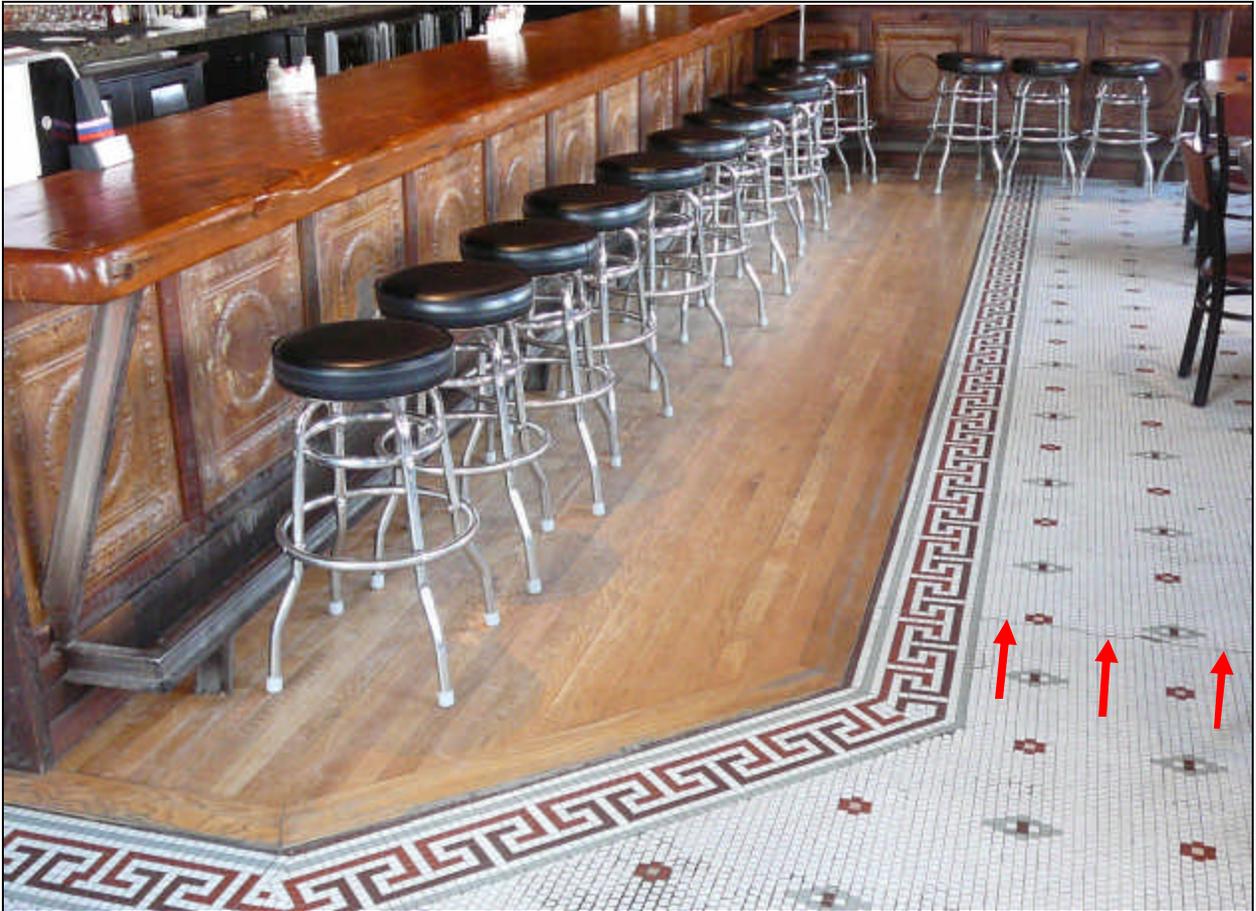
6. The following photo shows the overall layout of the “Bank Bar” interior, as viewed from the front. Of particular note in this photo is the condition of the hardwood flooring finish under the bar stool areas. I suggest that this area of the hardwood floors be refinished at this time (to avoid further abrasion damage to the wood, itself). I also suggest planning to apply carnauba wax to the hardwood flooring surfaces on a regular basis in this area. One such wax can be purchased in large tins through Ace Hardware Stores. It is Trewax® in the clear version. The wax is very hard. It should be applied each time with #0000 steel wool pads to scrape away any soils left on the floor from previous applications. The wax will require a power buffing machine for this large an area. (In contrast, the finish of the hardwood flooring of work area behind the bar is still in great condition.)

Also, note the crack lines in the mosaic tile flooring. These are simply following the control joints of the underlying concrete. They are to be expected. (One such crack line is pointed to by the small red arrows in the photo, above.)

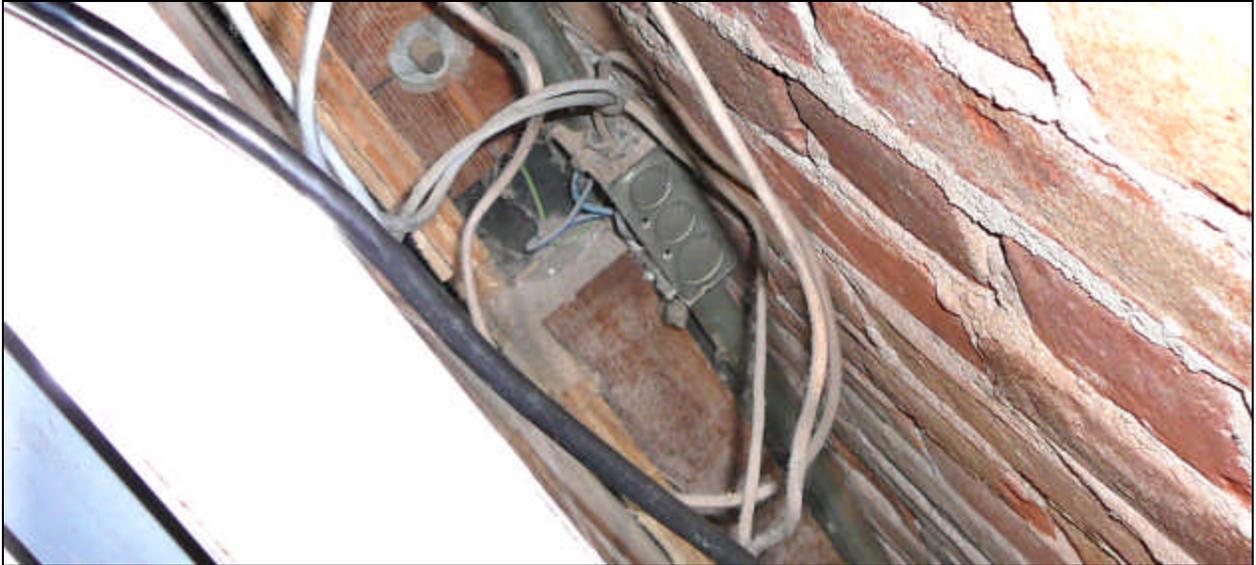
7. The electrical junction box between the meat counter and the brick wall (at the east end of the bar area) is missing its cover plate.

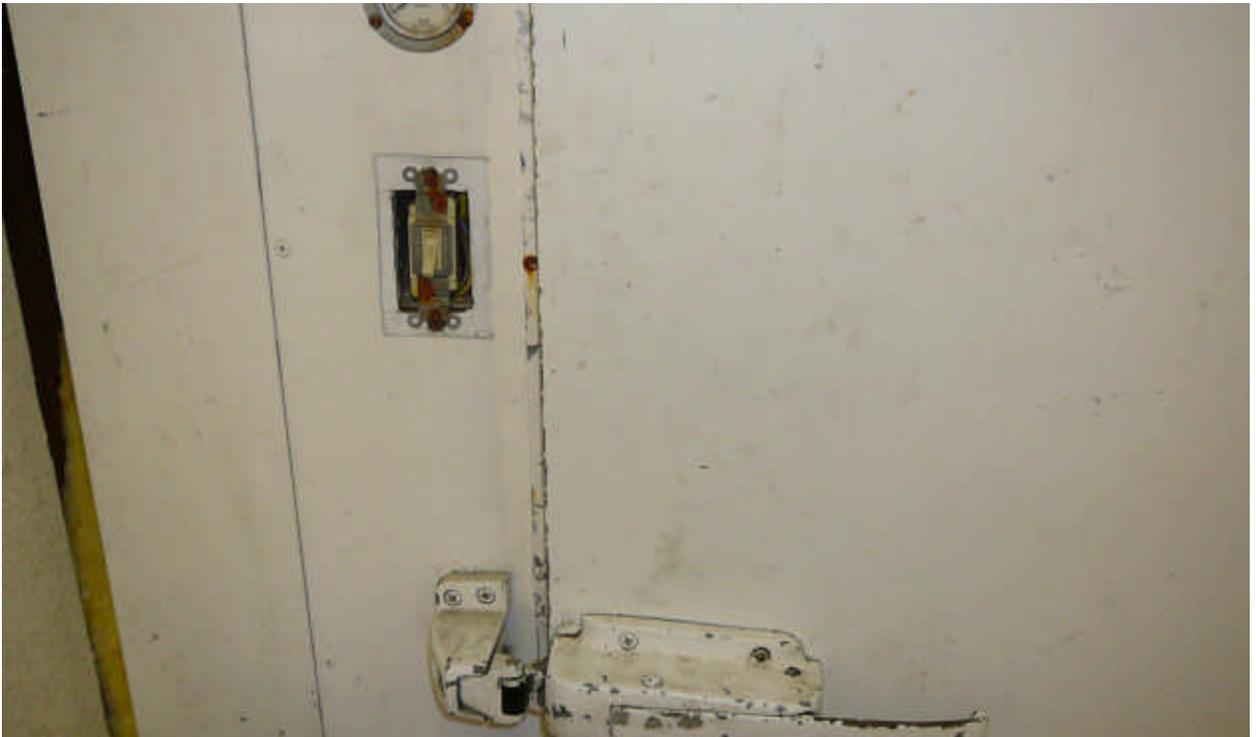
8. The wall switch for the pass-thru freezer between the backs of the kitchens is missing its cover plate.

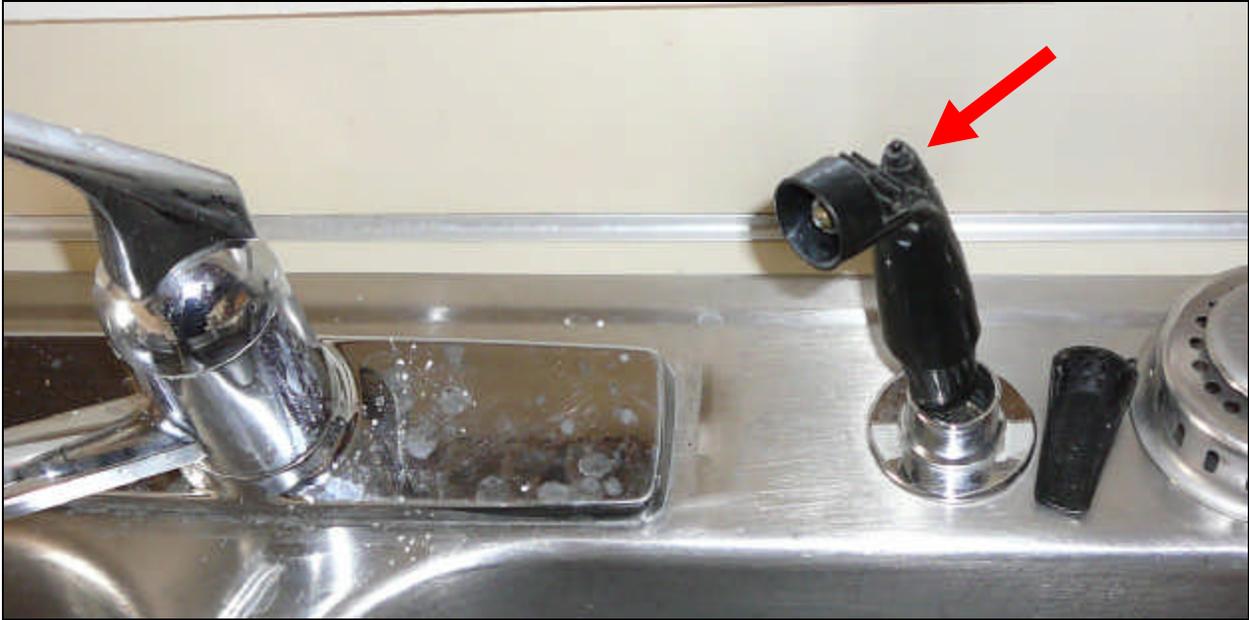
9. The spray head at the kitchen sink for the upper rear apartment is broken. A qualified plumber should address and/or correct this issue, as necessary.

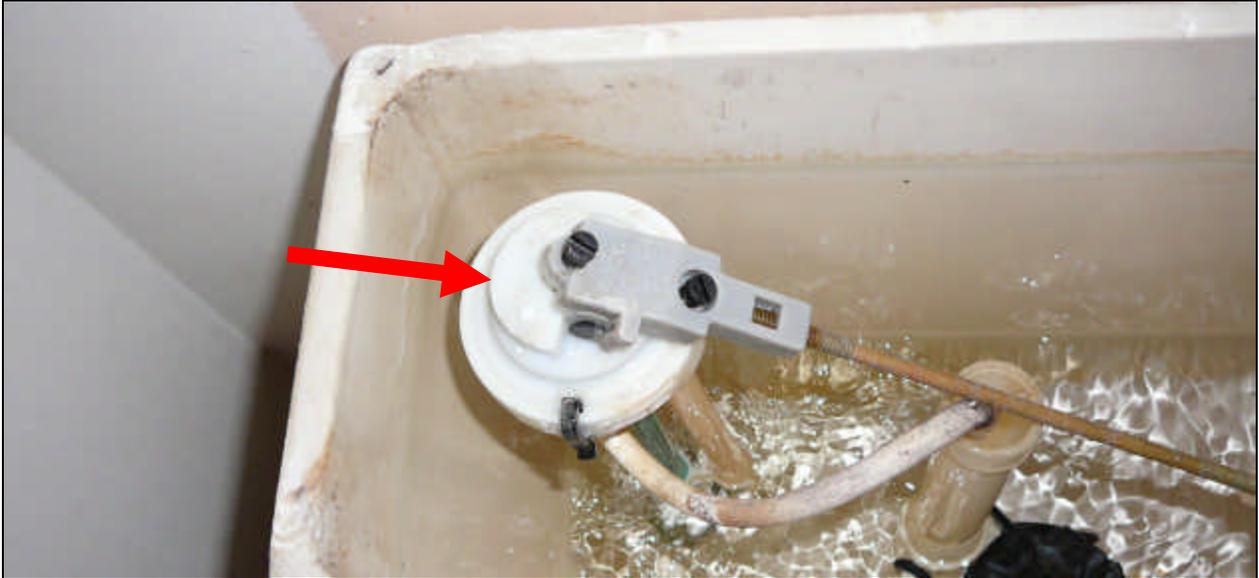
11. The float valve for the toilet of the upper rear apartment lets water out of its top that tries to spray past the tank lid. I noticed water on the floor around the base of the toilet after flushing it. (There may also be leak past the toilet's floor flange.) A qualified plumber should address and/or correct this issue, as necessary.

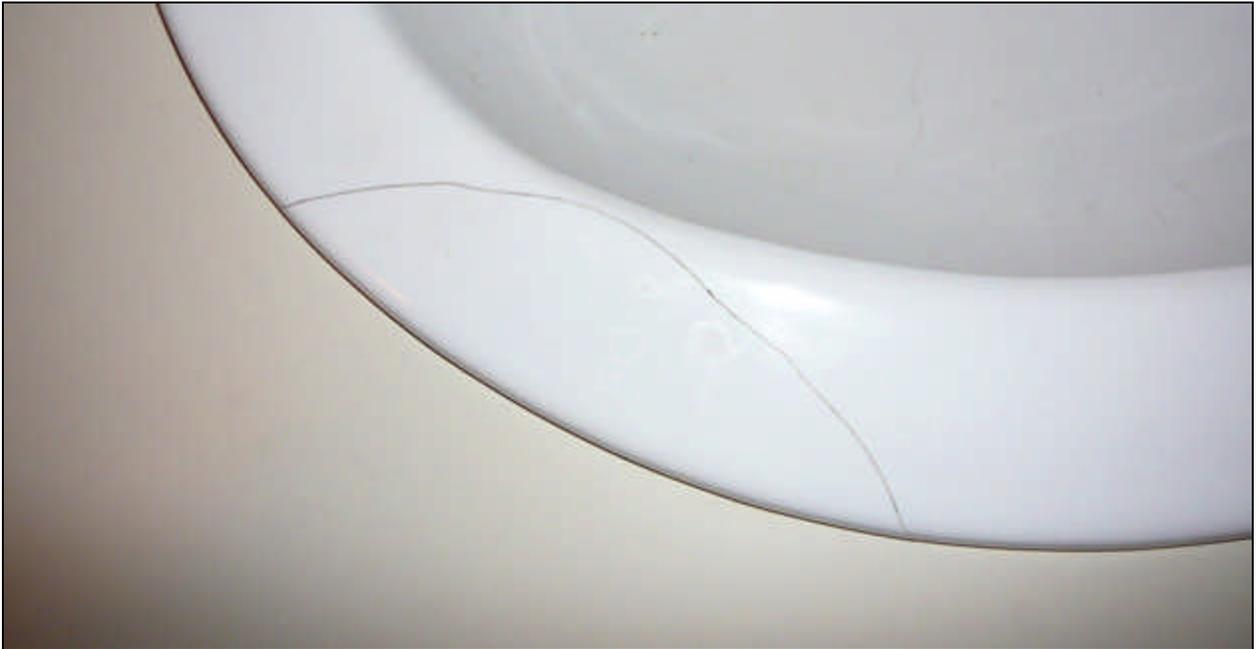
12. The rim of the vanity basin in the bathroom of the upper rear apartment is cracked. A qualified plumber should address and/or correct this issue, as necessary.

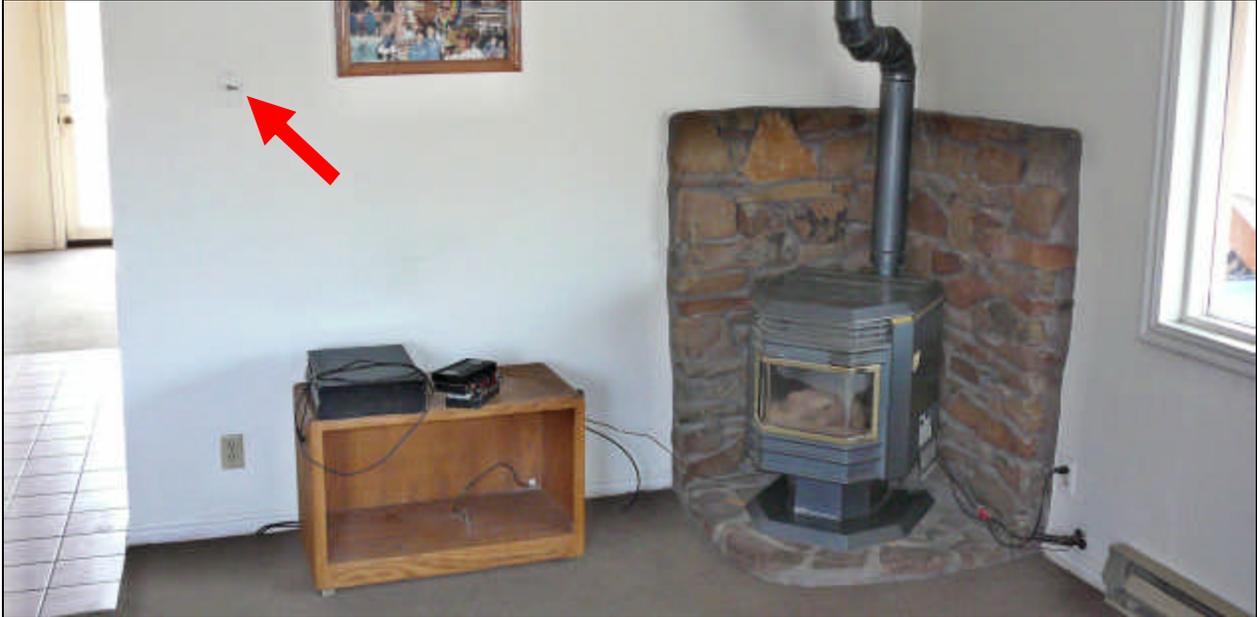
13. The free-standing natural gas space heater in the upper rear apartment seems to work fine. However, its wall thermostat has been removed. (I had to temporarily touch the thermostat wires together to make the heater work.) A qualified electrician should address and/or correct this issue, as necessary.

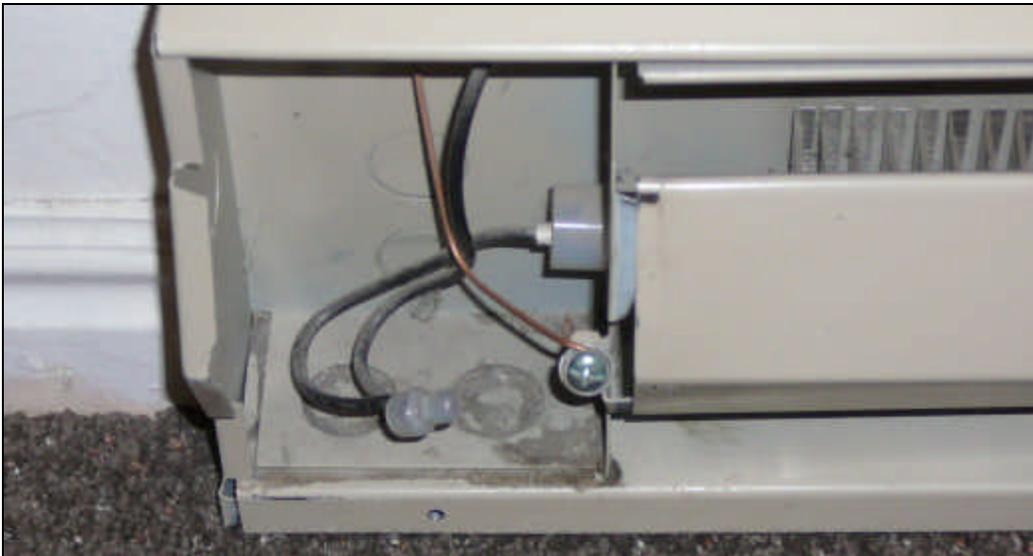
14. The junction box cover for the electric baseboard heater at the rear of the living room for the upper rear apartment is missing, exposing live wires. A qualified electrician should address and/or correct this issue, as necessary.

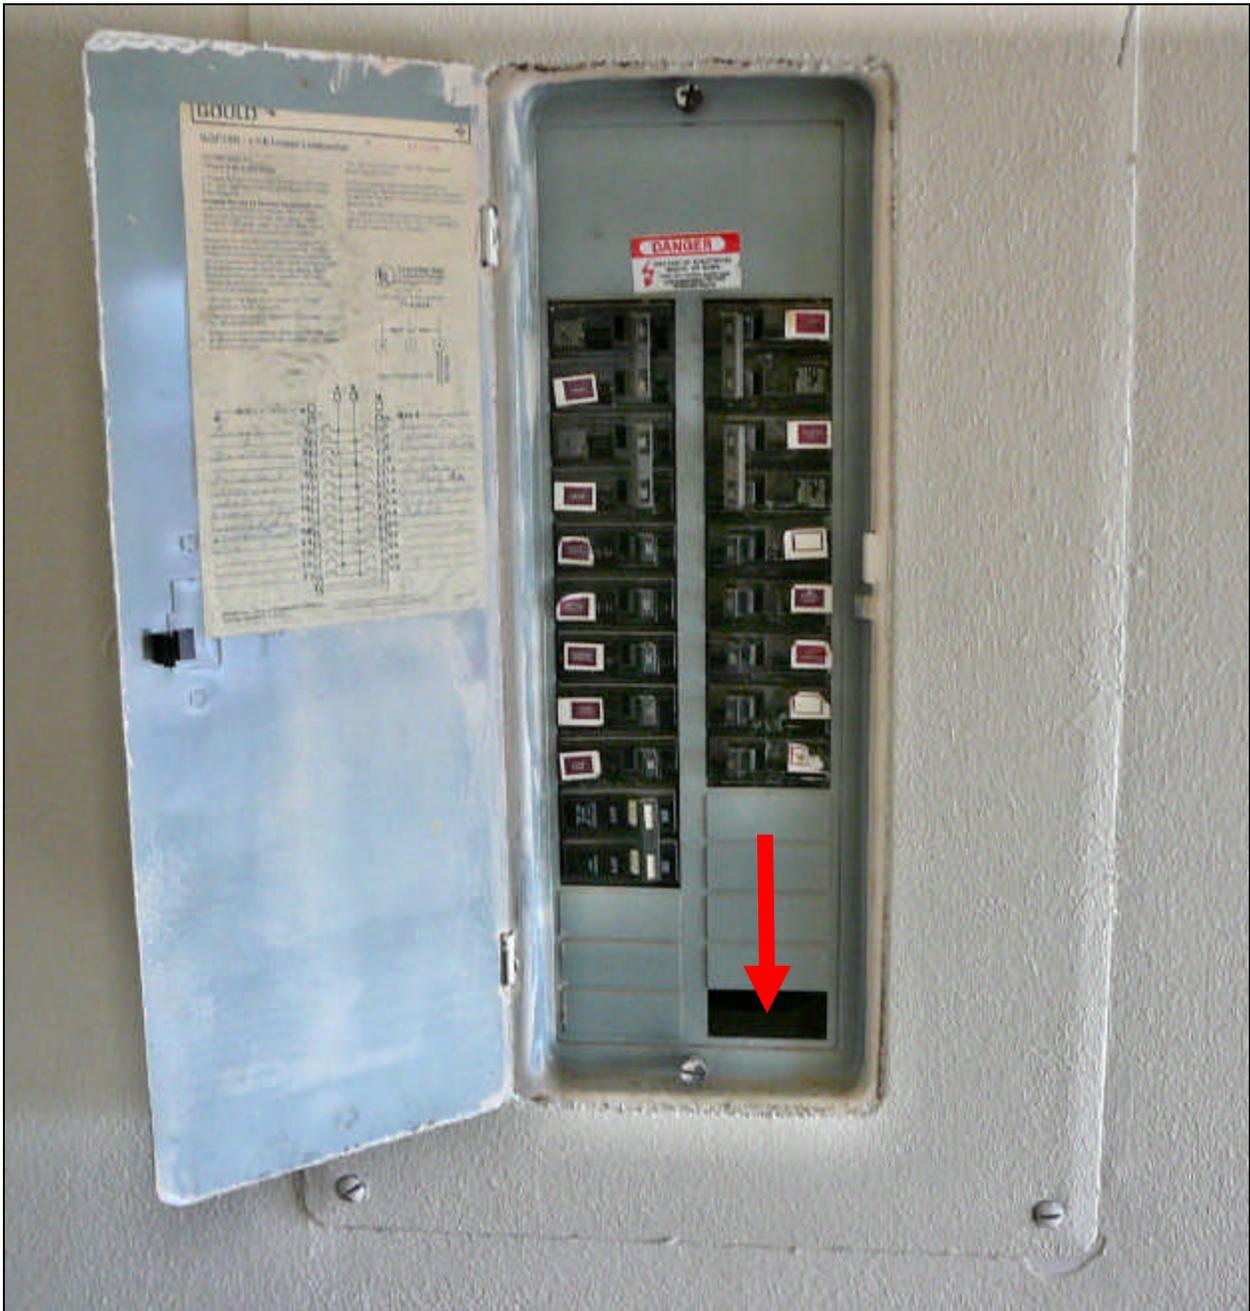
15. One of the circuit breaker positions in the distribution panel across from the kitchen in the upper rear apartment is open. A black plastic pop-in cover plate made for that purpose should be inserted to block ready access to live buss surfaces behind the intermediate panel. A qualified electrician should address and/or correct this issue, as necessary.

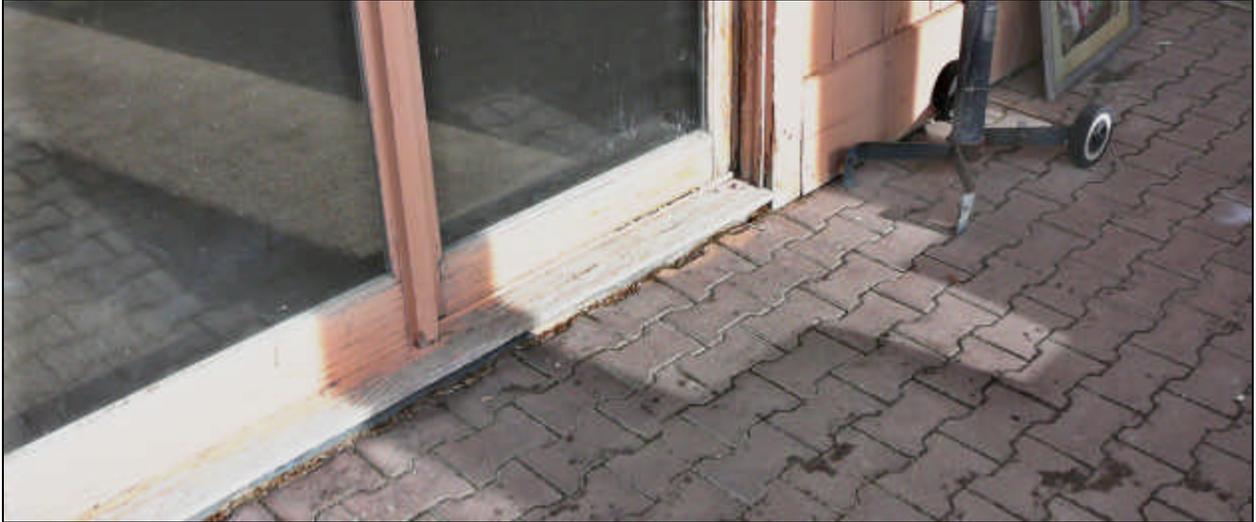
16. The wood at the exterior side of the atrium door frames from the upper rear apartment to the balcony area is exposed where paint is peeling and missing. I suggest removing all unsound paint, repriming all resulting bare wood surfaces, and repainting to reasonably match adjacent trim.

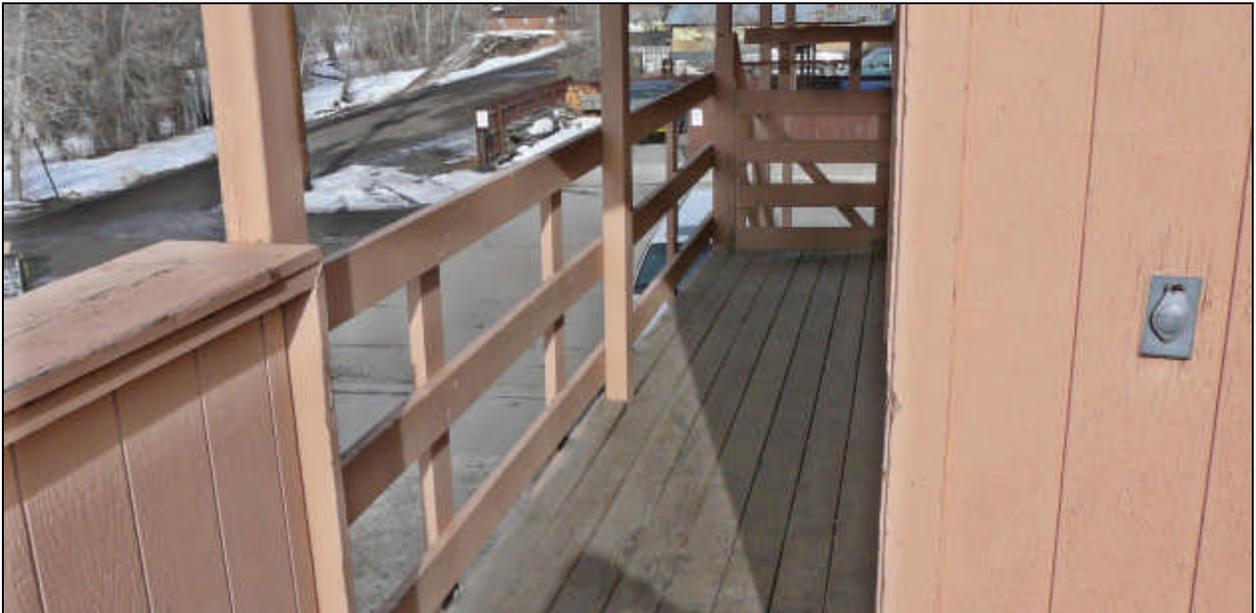
17. The spaces between guard railing members along the perimeter of the balcony to the west of the upper rear apartment are too great to provide adequate protection for infants or small children. If toddlers are to be present, I strongly suggest remaking these guard railings to meet today's codes.

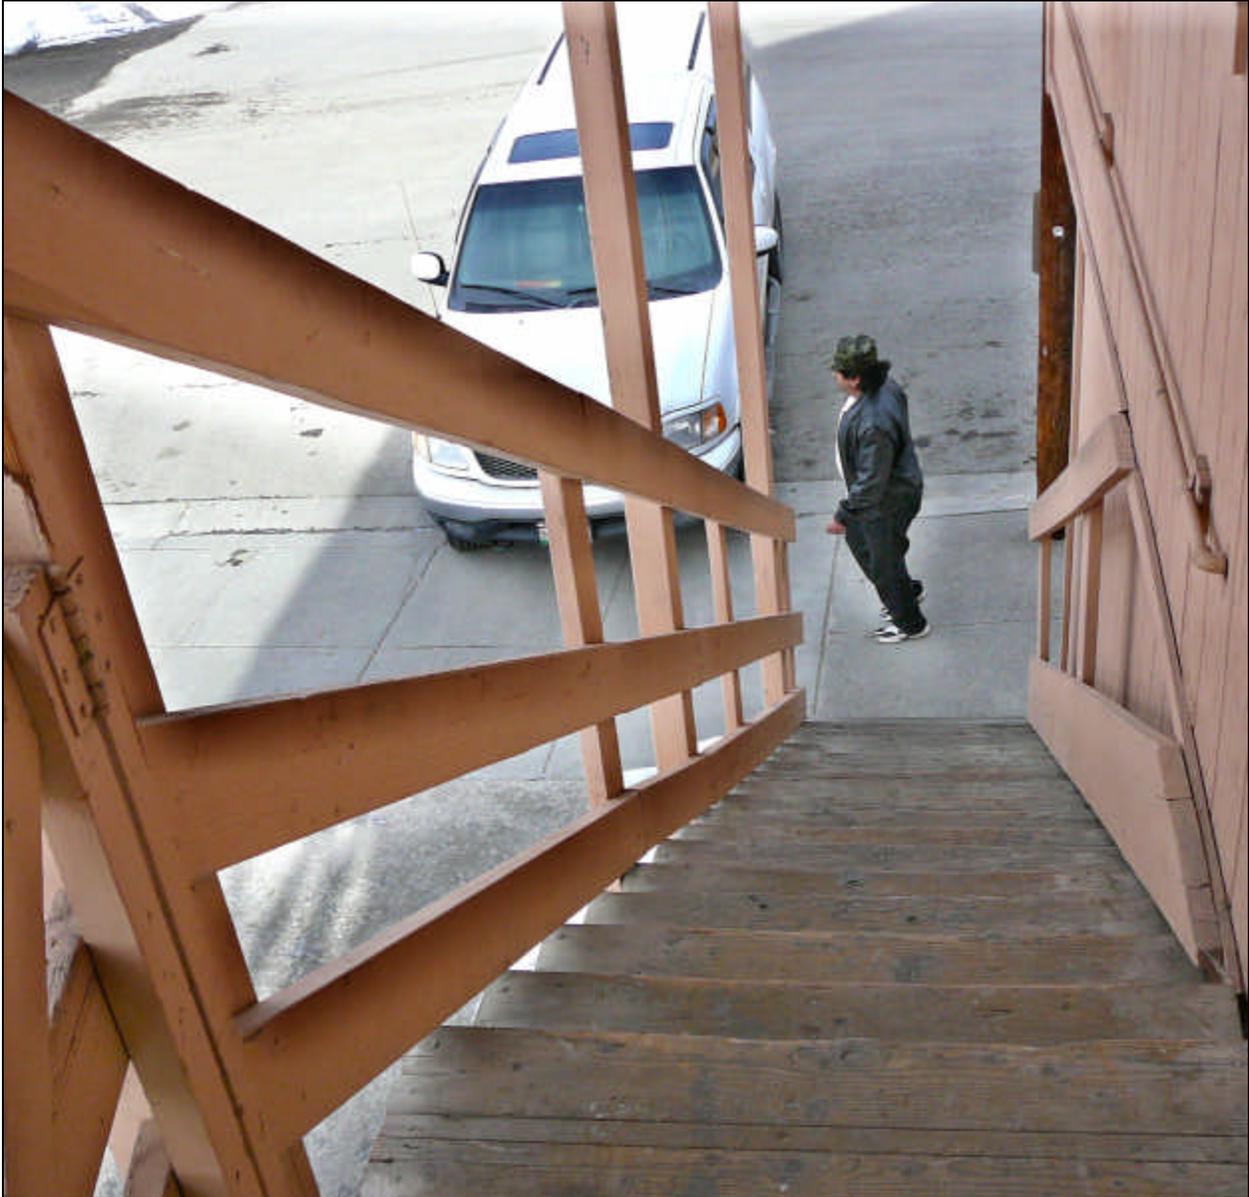
18. The balcony stairway from the upper rear apartment area down to the rear exterior of the building does not provide adequate closure to protect infants or small children. If toddlers are to be present at any time, I strongly suggest upgrading these guard railings to meet today's codes.

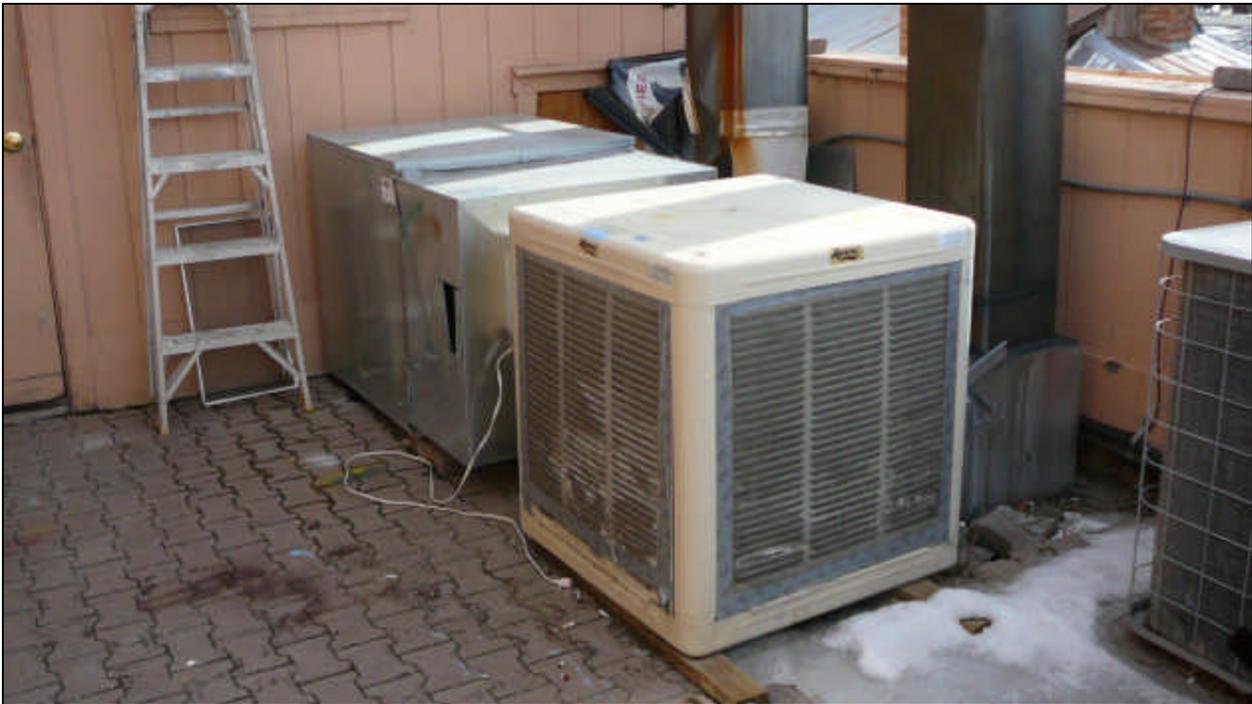
20. The evaporative cooler shown in the following photo appears to be associated with the south kitchen. It was not in operable order at the time of this inspection.

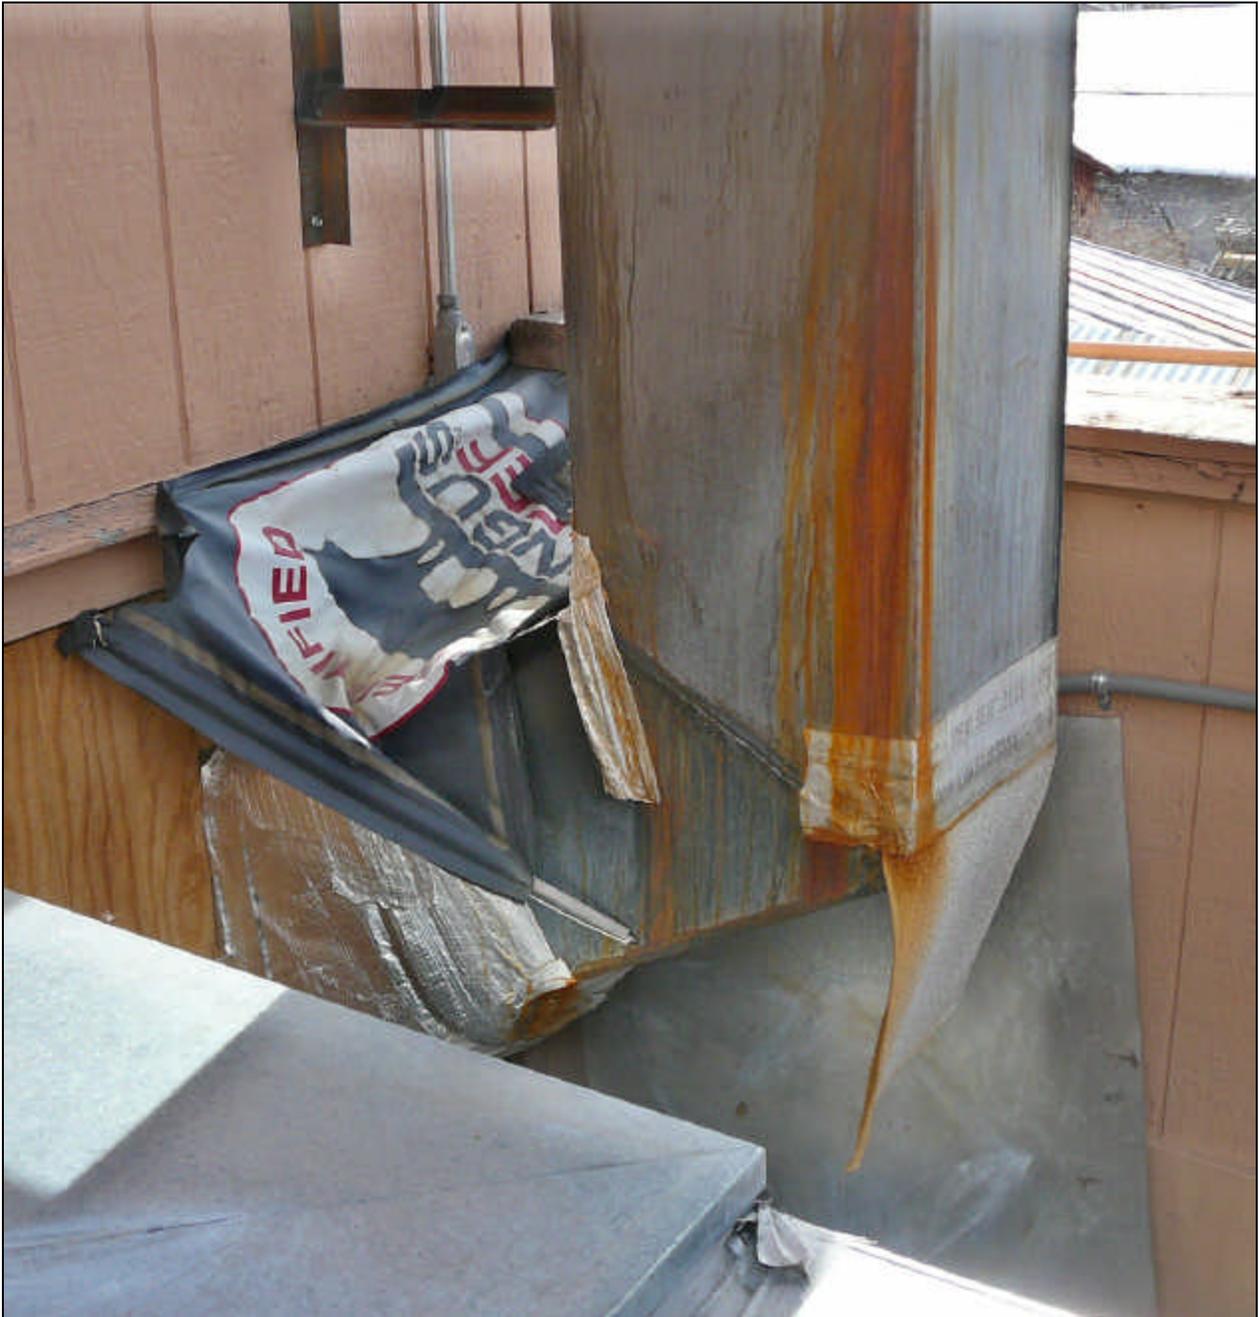
21. The rectangular steel exhaust ducts (from the kitchen, below) may have had some problems with leaks. As can be seen, makeshift tarps have been placed over some of their joints. A qualified HVAC contractor should address and/or correct this issue, as necessary.

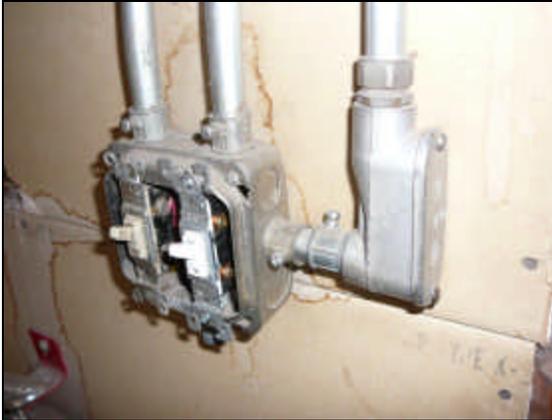
22. The switch boxes on the wall just inside the stairwell from the balcony area to the HVAC room needs wall plates.

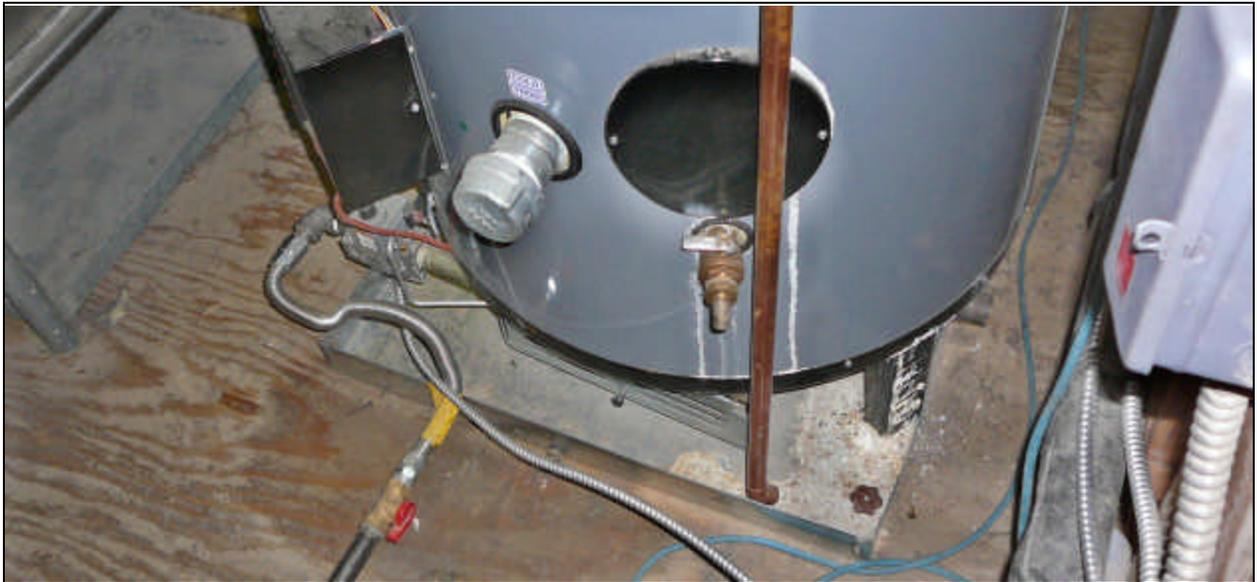
24. The water heater has had some past leaks. However, they appear to have been repaired. The following photo shows some mineral deposits left from the leaks. I suggest monitoring this appliance for future leaks.

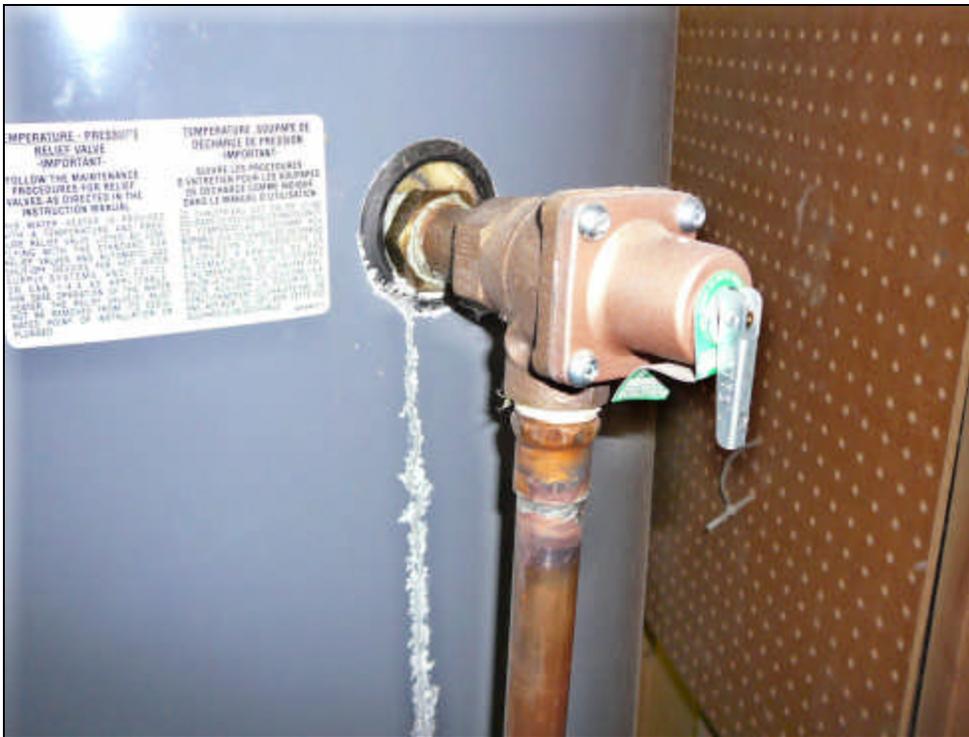
The following photo provides a close-up of the suspected past leak point.

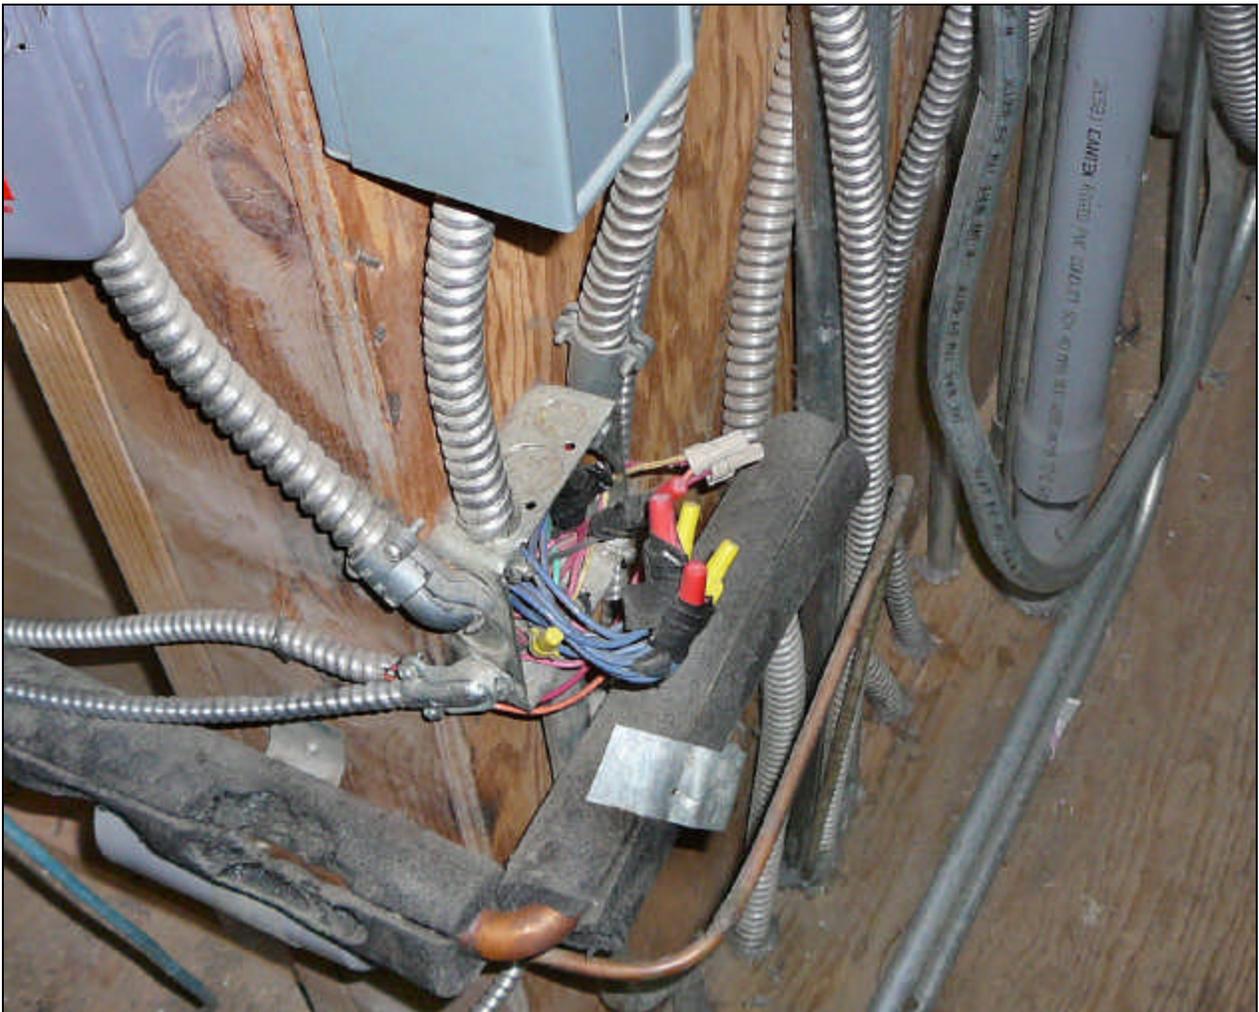
25. The TPRV (Temperature-Pressure Relief Valve) discharge line for the gas water heater dumps into a catch pan; but the catch pan has no drain to the exterior, itself. Unnecessary flooding could occur if the TPRV were to operate. A qualified plumber should address and/or correct this issue, as necessary.
26. The water heater makes percolation noises when its flames are on. This indicates the possibility of considerable mineral buildup at the inside bottom of the tank. The life of the appliance might be meaningfully extended if a qualified plumber were to remove as much of the sedimentary mineral buildup as possible.
27. A junction box is open, uncovered, on the wall in the HVAC room beneath the electrical distribution panels on one of the south walls. A qualified electrician should address and/or correct this issue, as necessary.

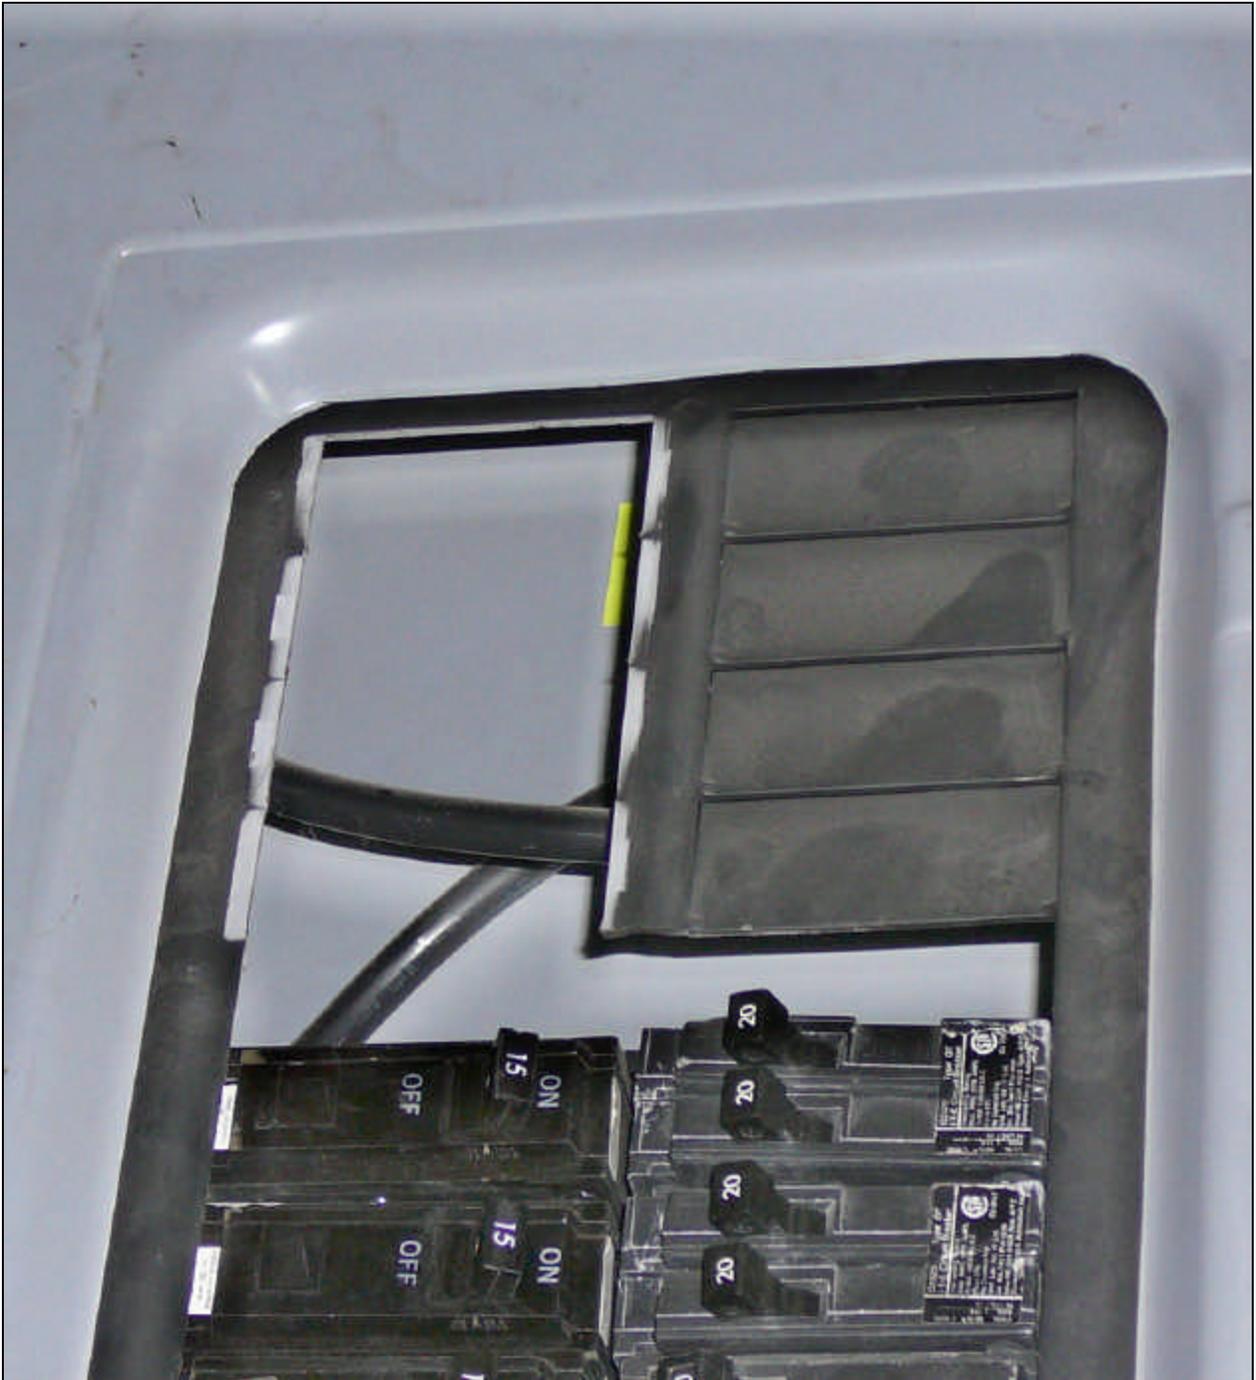
28. The intermediate panel front for the #1 Distribution panel in the HVAC room has breaker position knockouts that need closure. A qualified electrician should address and/or correct this issue, as necessary.
