Commercial Inspection Report

**200 S. Main Street
Bellevue, Idaho**

Inspection Date: 02/10/2007

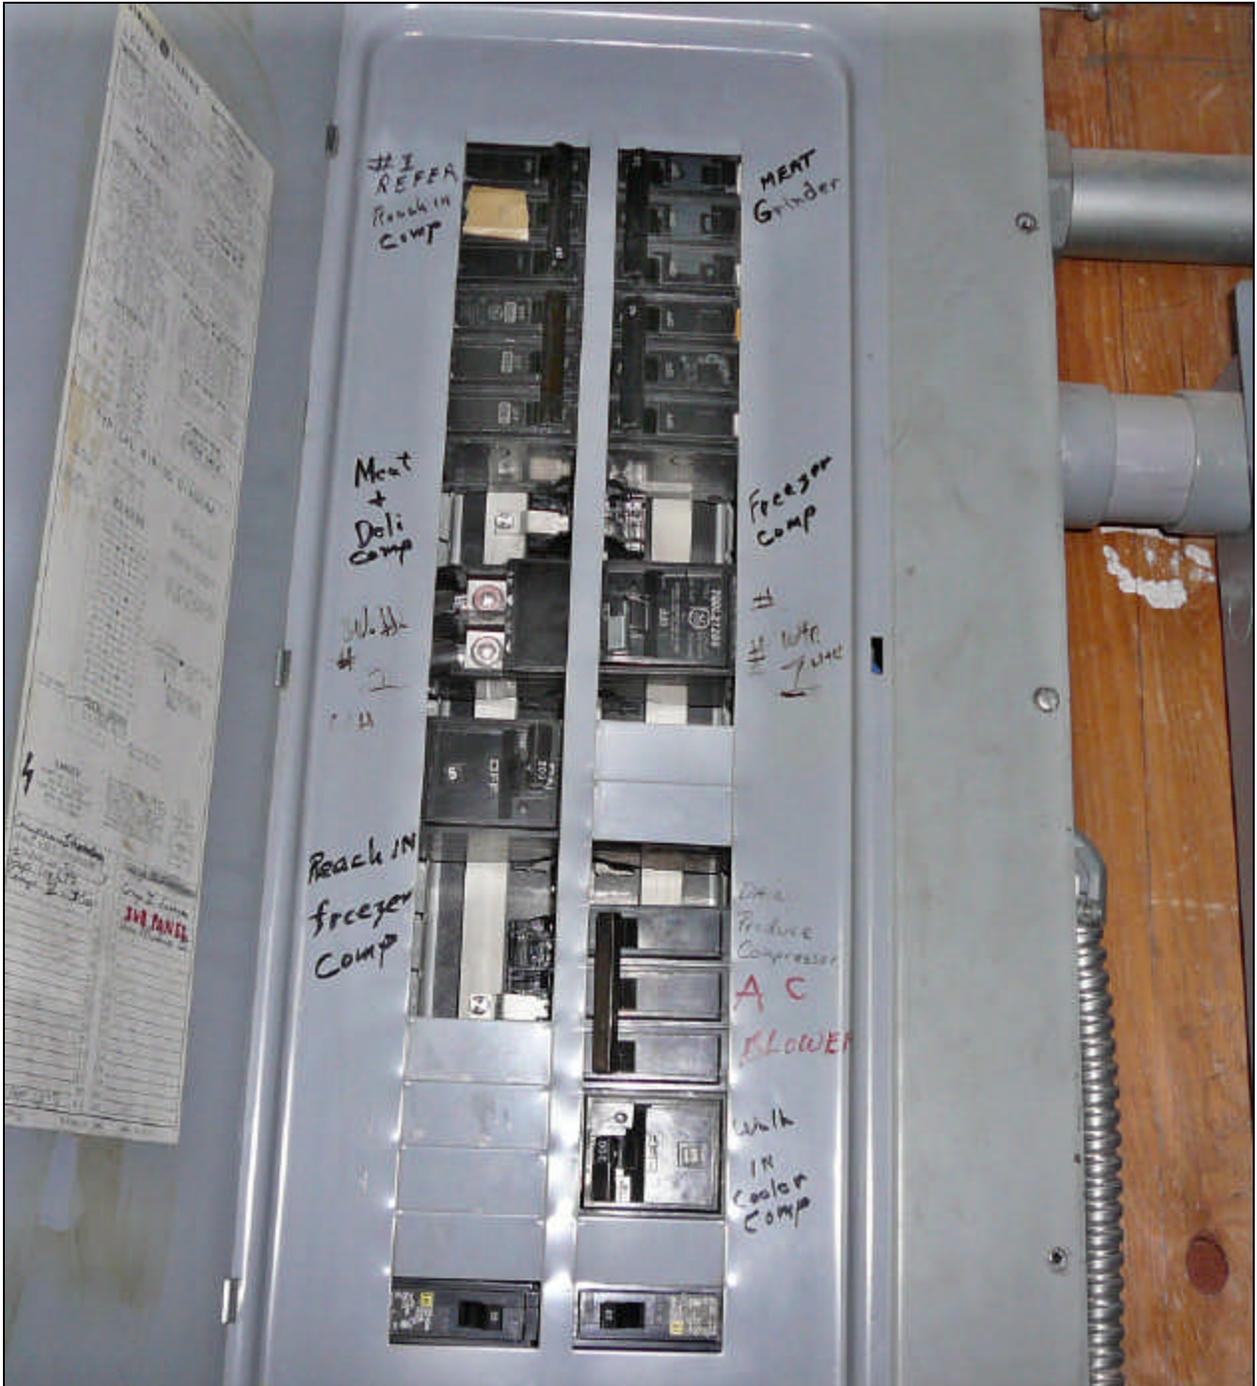
- 29. Electrical Pane #2 in the HVAC room has numerous circuit breaker positions that should be covered with pop-in fillers. A qualified electrician should address and/or correct this issue, as necessary.

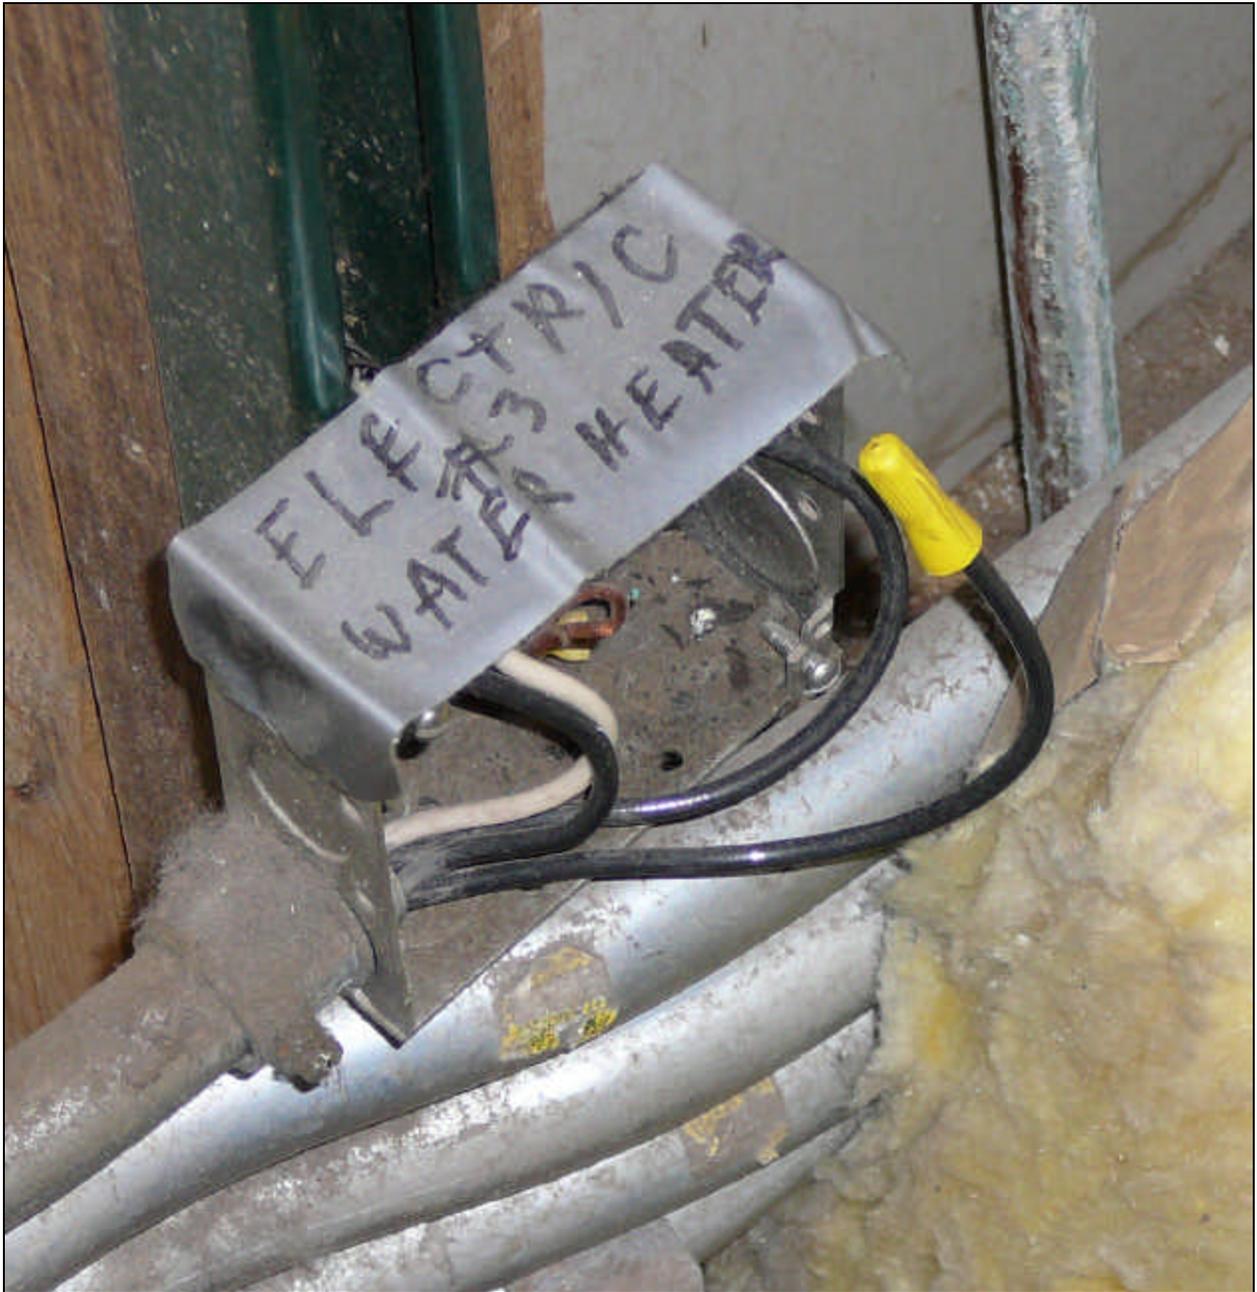
30. Panel #4 in the HVAC room is mounted on the west wall. However, its panel front has no screws in place. I suggest adding screws to keep the cover in place.
31. The following junction box is open and should be covered. It is low on the west wall of the HVAC room. A qualified electrician should address and/or correct this issue, as necessary.

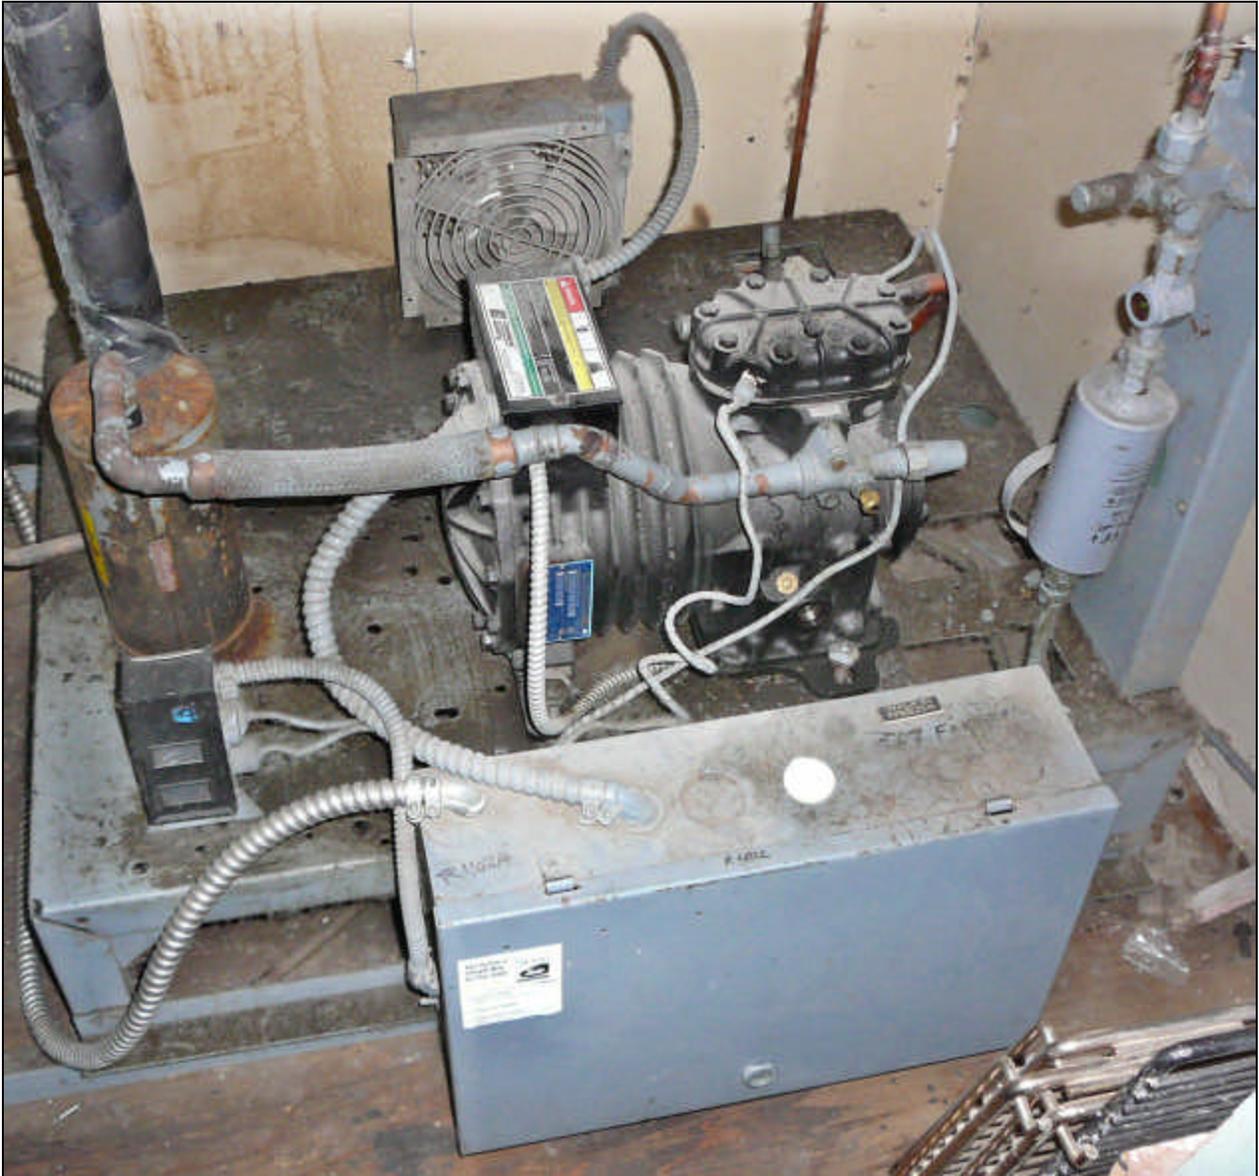
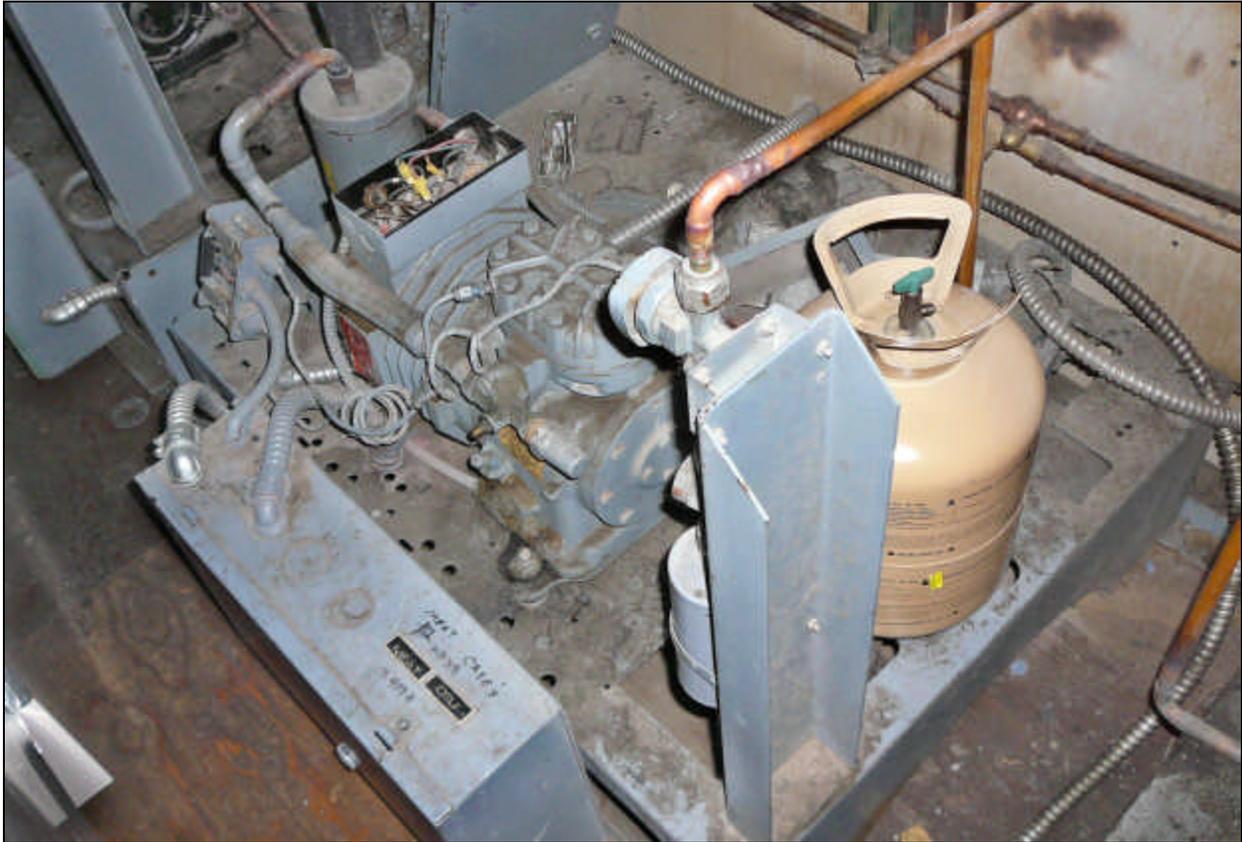
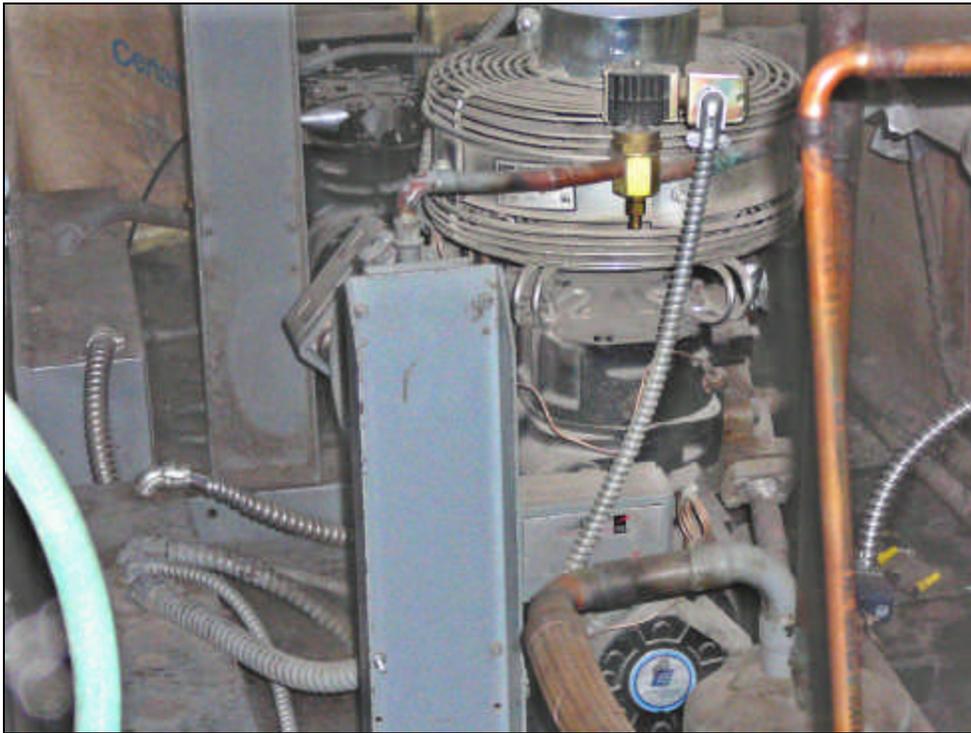
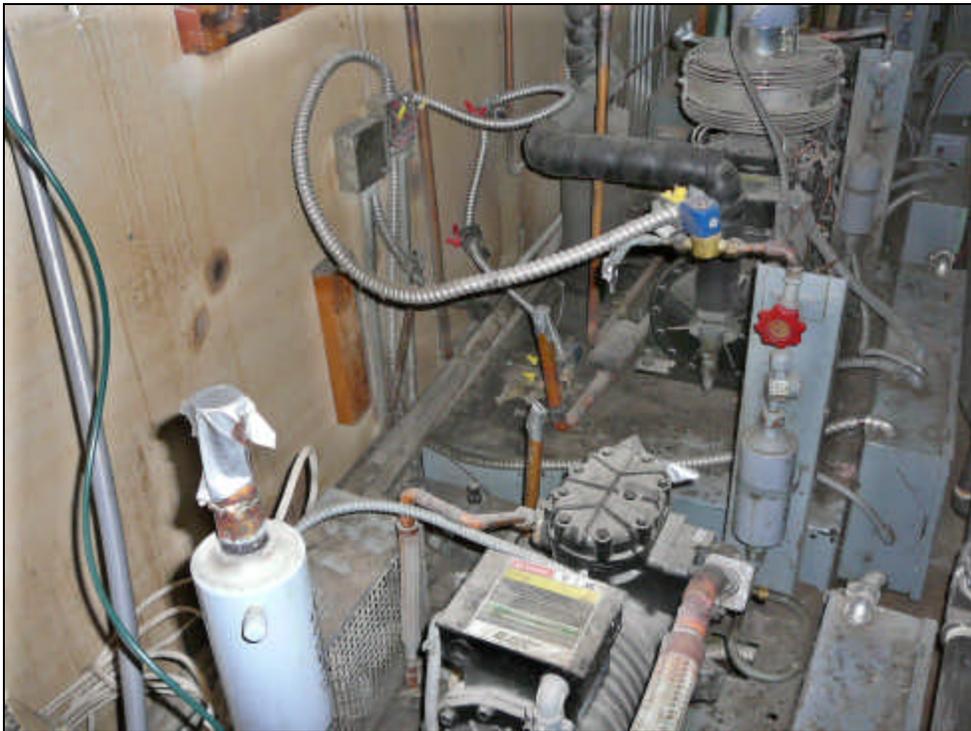
32. The following series of photos shows the five compressor units along the north wall of the HVAC room. The photos show the amount of dust that has been allowed to collect on these units. I suggest having them cleaned and serviced at least annually.

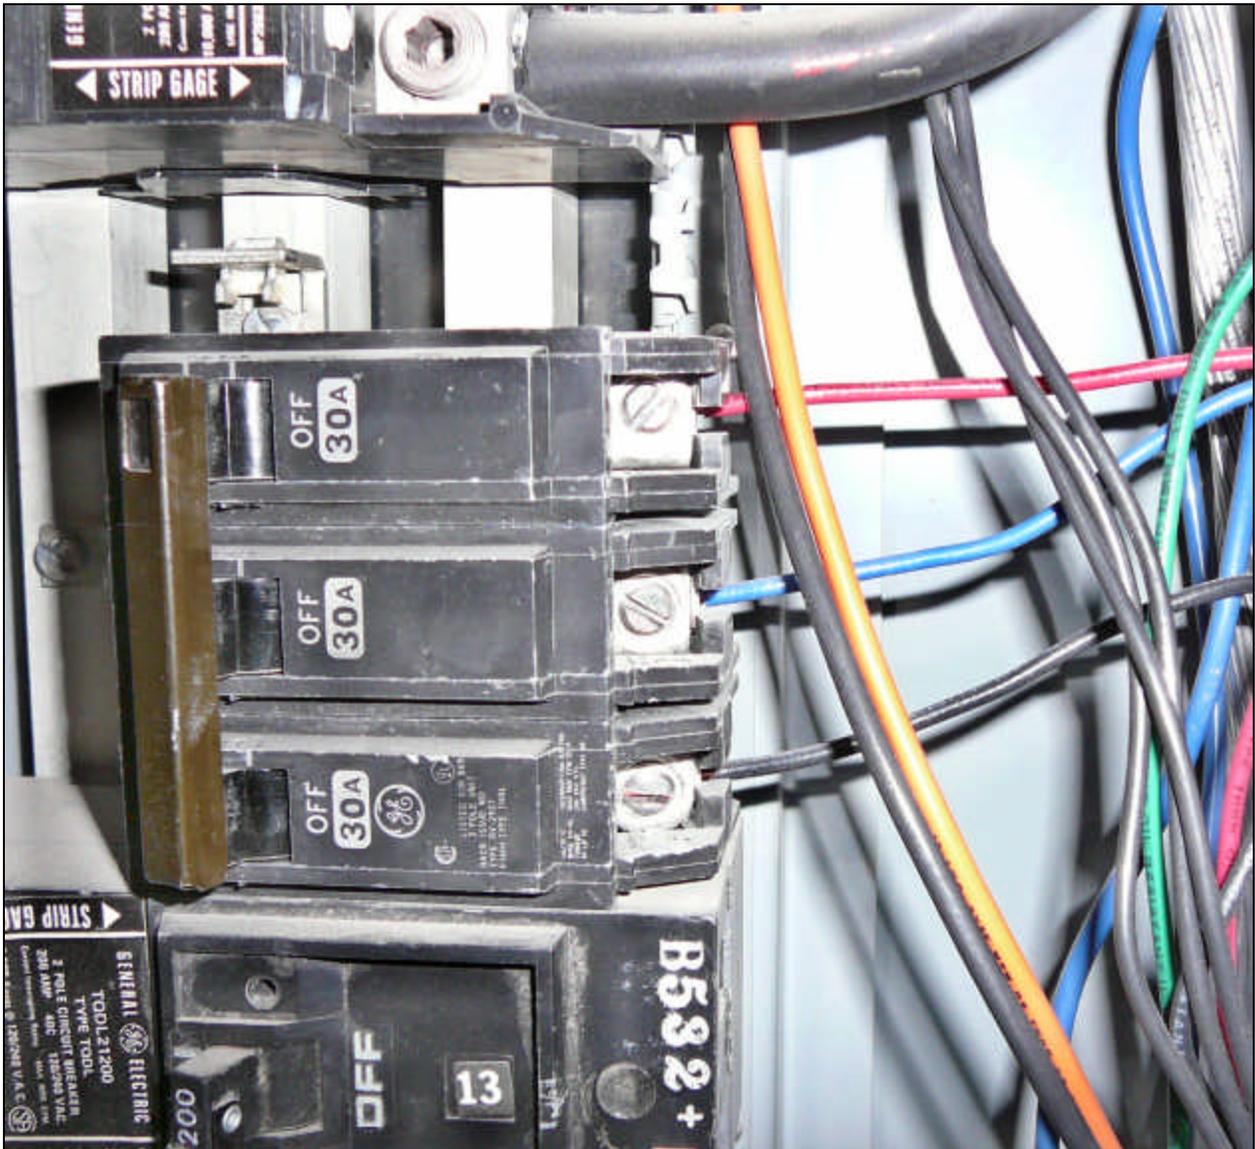
33. The three-phase circuit breaker at head level in the #2 electrical panel of the HVAC room serves an HVAC blower unit. However, the conductors are only 12-gauge. I suggest having a qualified electrician determine whether these wires are adequately sized for the breaker. (Normally, 30-amp circuit breakers should be feeding wires at least as large as 10-gauge.)

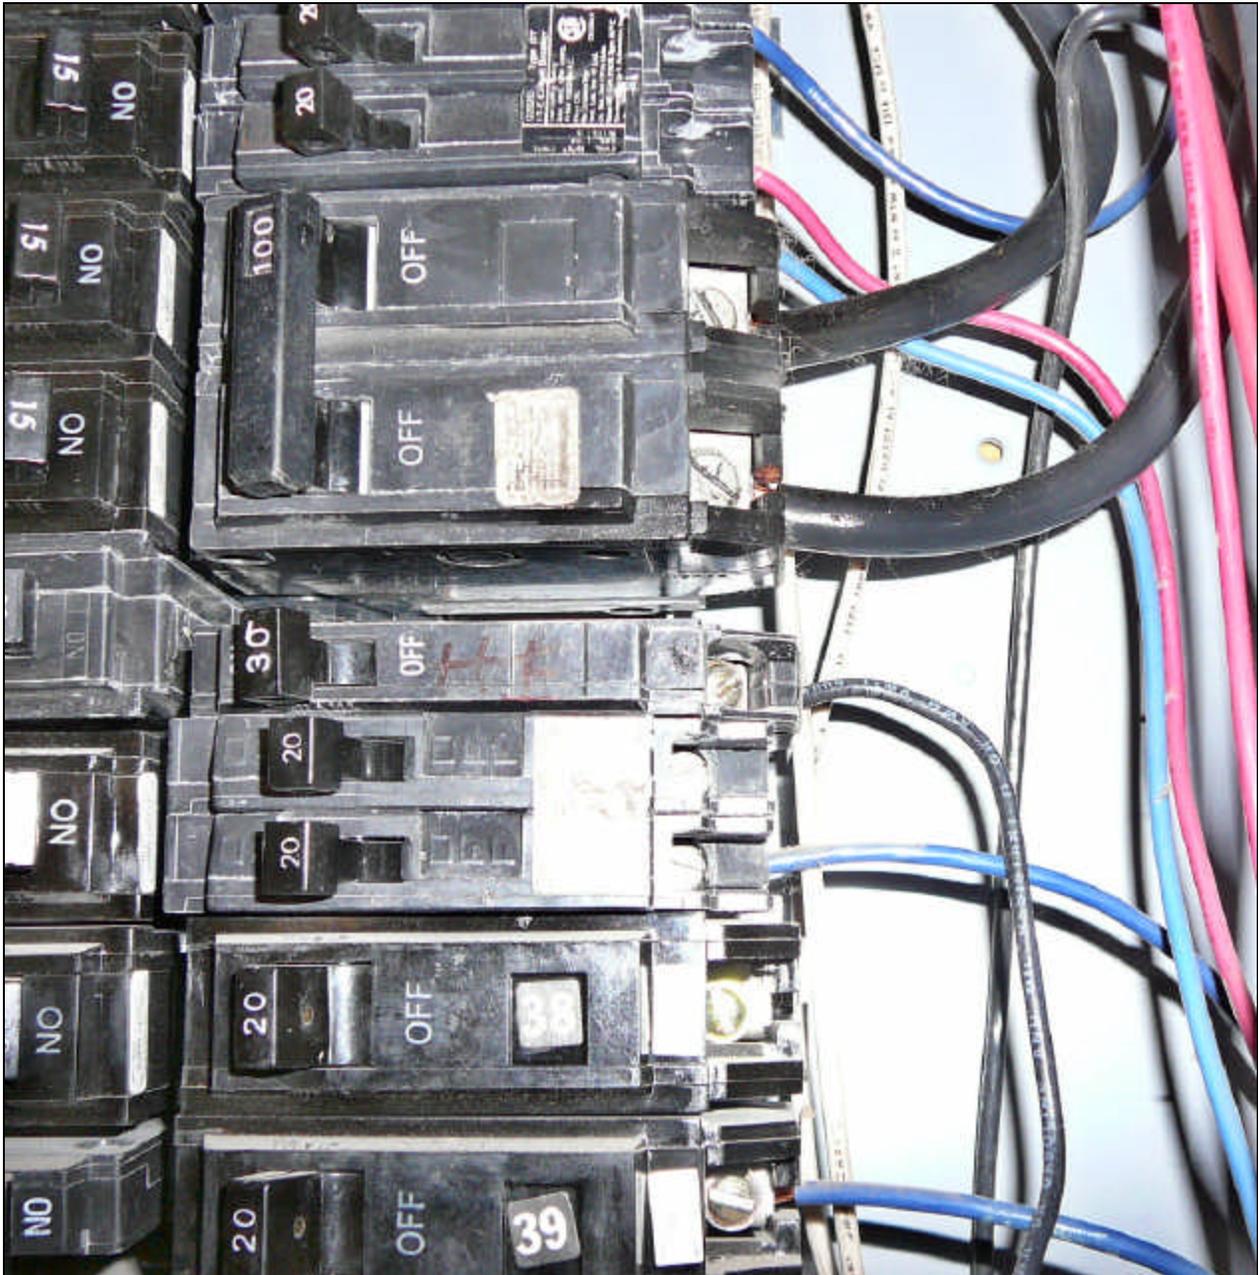
34. Even though the various electrical panels in the HVAC room are remote from the service entrance, they have their various neutral and ground conductors terminated to the same busses. It's my understanding the "subpanels" such as these should

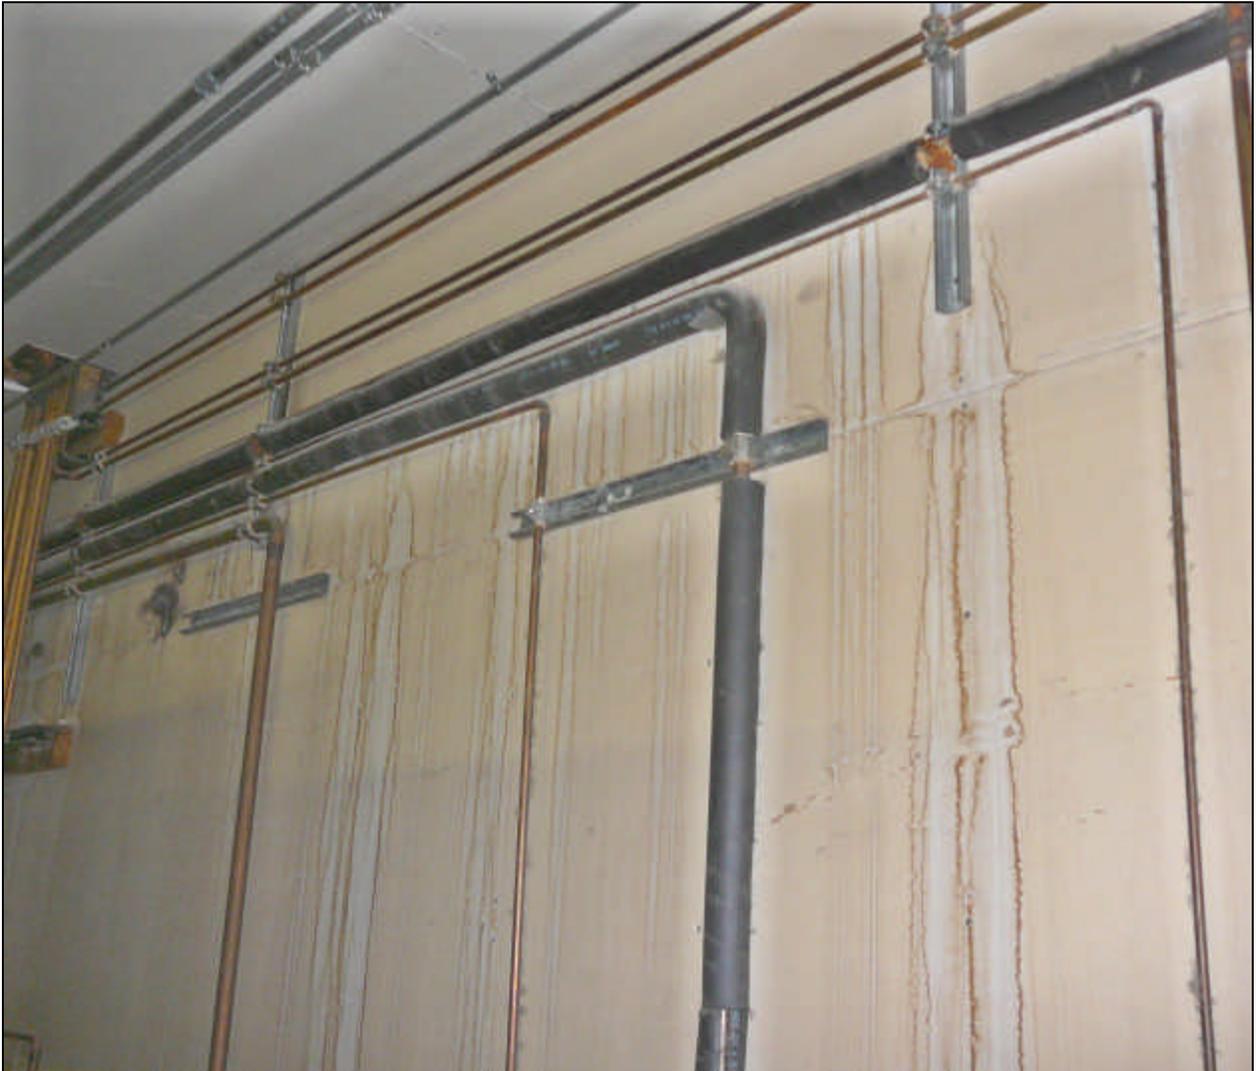
38. The water stains on the walls of the HVAC room are from condensate formed because of moisture in the air getting cold when contacting the refrigerant lines. Perhaps additional insulation around the refrigerant lines would not only reduce the condensation; but increase the efficiency of the units. I suggest asking a qualified refrigeration specialist about this.

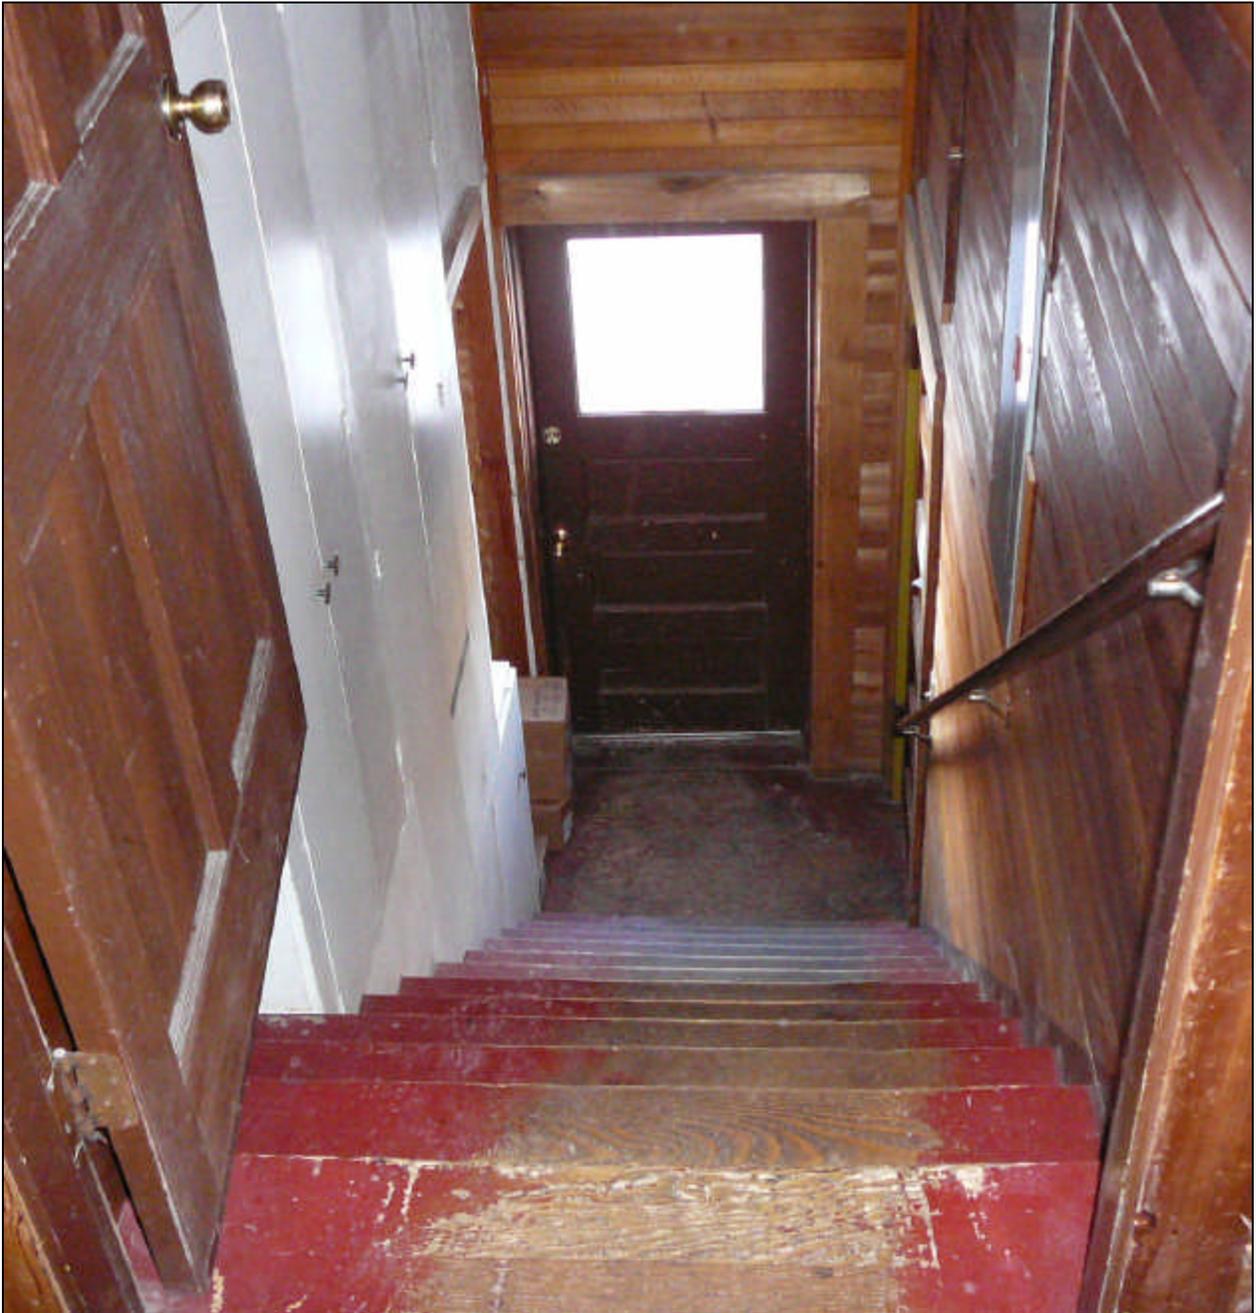
42. The doorway at the top of the first flight of stairs up from the north central entry to the building swings out over the stairs. This is somewhat more hazardous than a door that would swing out over a landing. (At least the handrailing is immediately accessible on the opposite wall of the stairs ☺.)

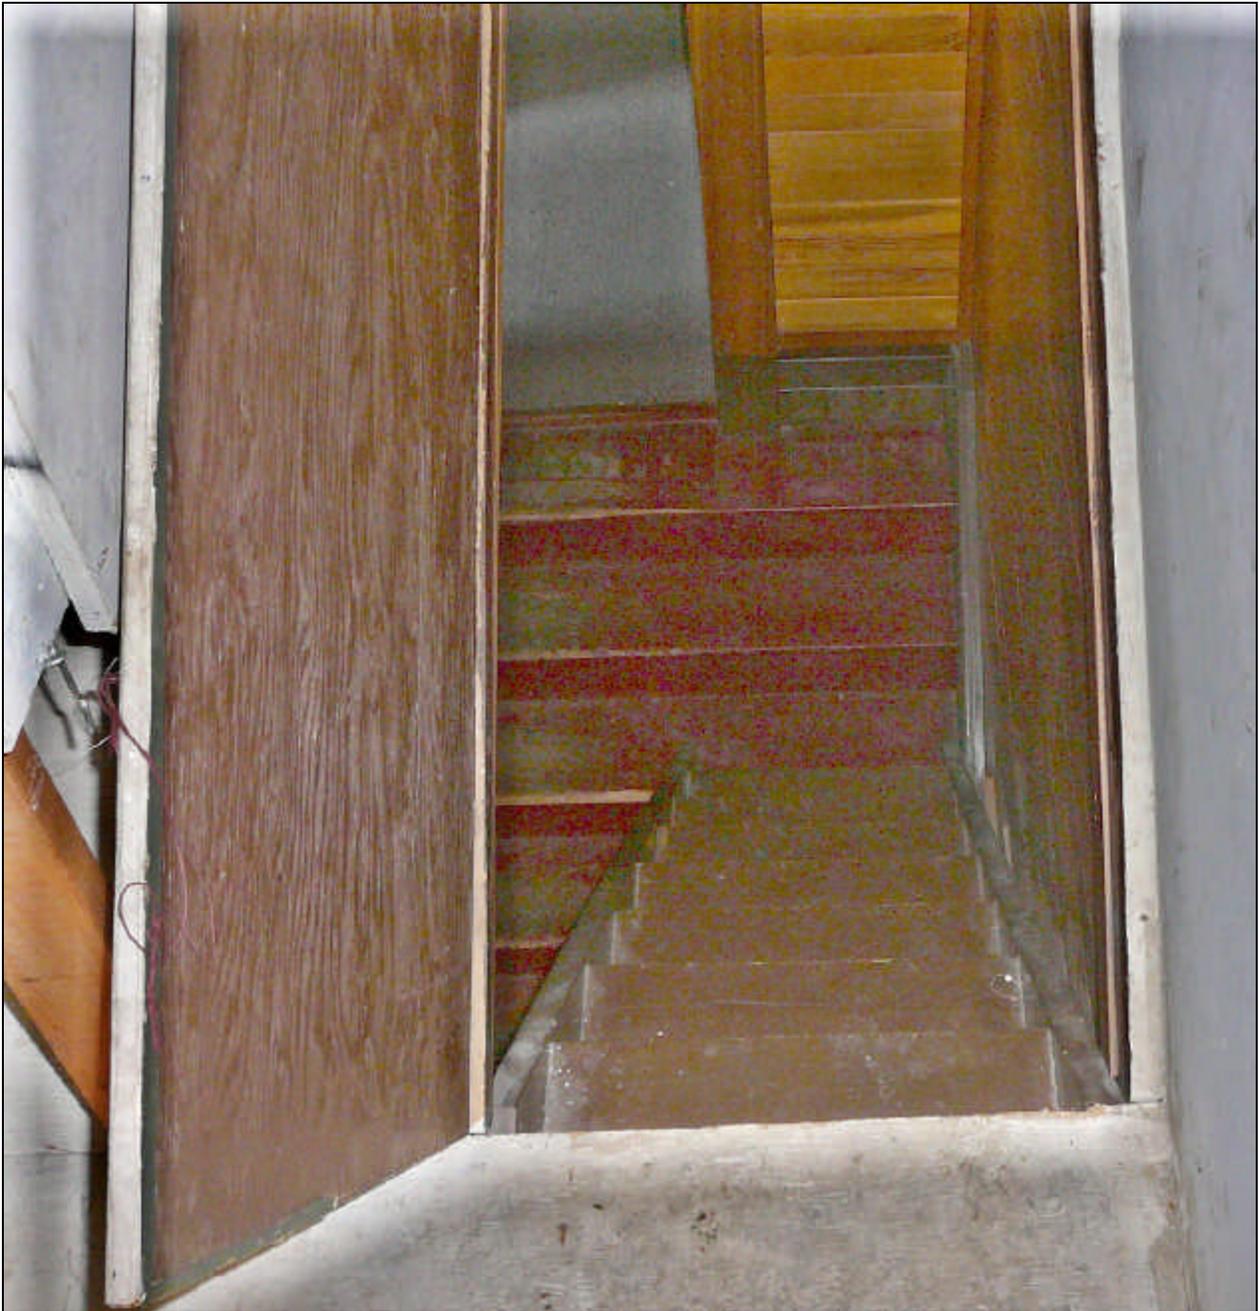
45. This photo shows the rather unsafe set of wooden stairs (built much like a ladder) that leads from the main interior stairway into the “dark room”. I suggest considering removing this stairway, or blocking access to it.

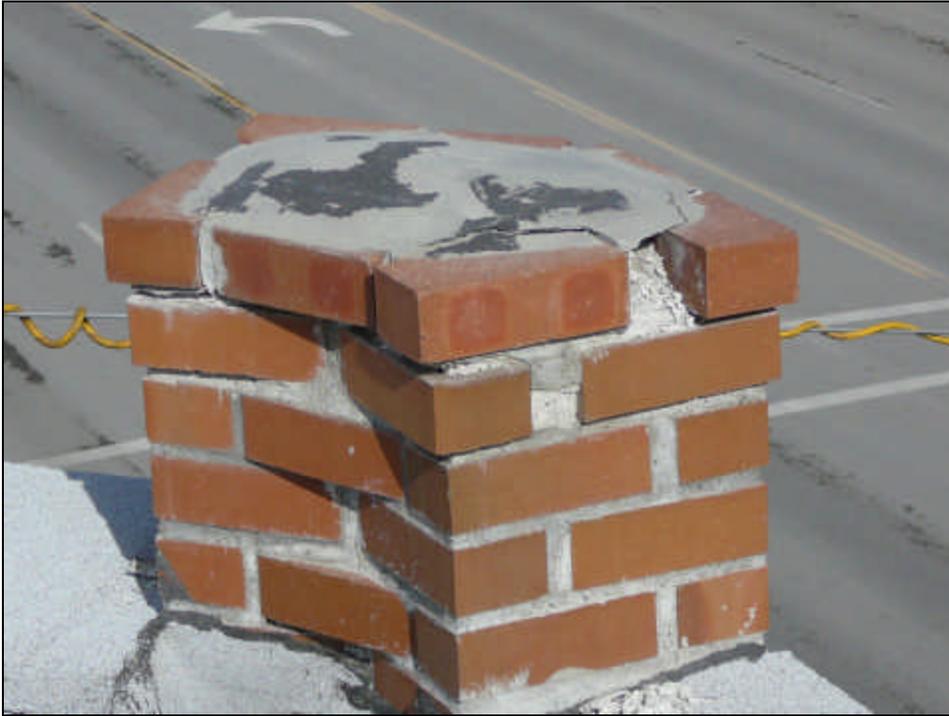
55. The brick towers rising above the parapet walls around the perimeter of the original north (right) section of the building's rooftop have decaying mortar crowns and brick mortar. I suggest remaking the mortar crowns and repointing the bricks, as necessary, at this time.

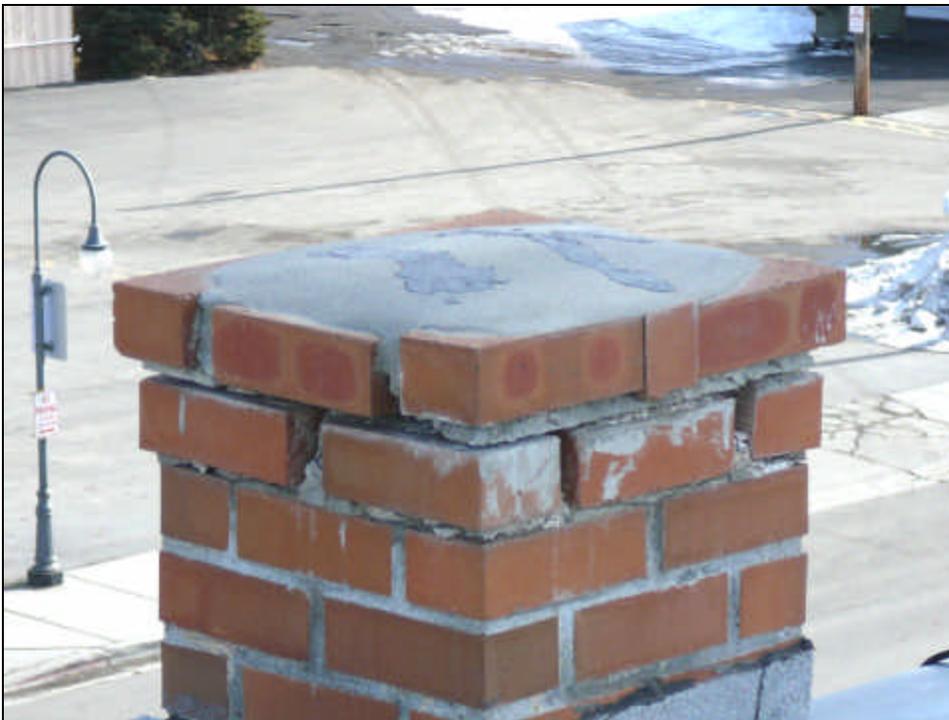
56. This is another brick tower at the rooftop perimeter that needs repair.

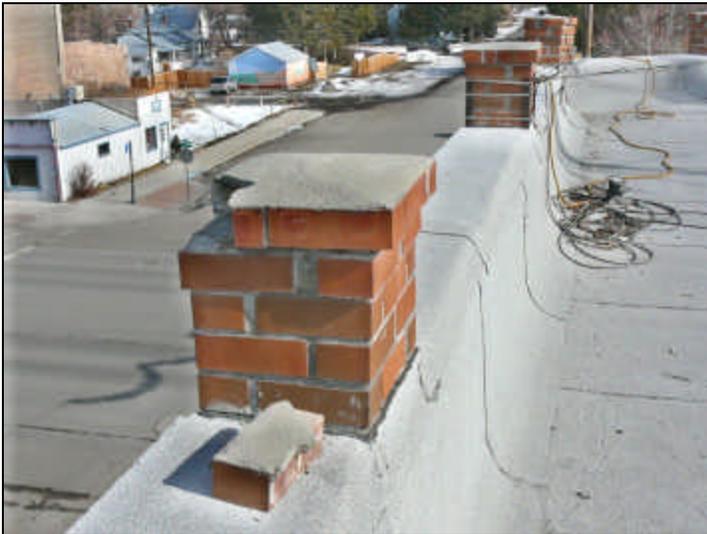
57. This is yet another brick tower at the rooftop that needs repair.

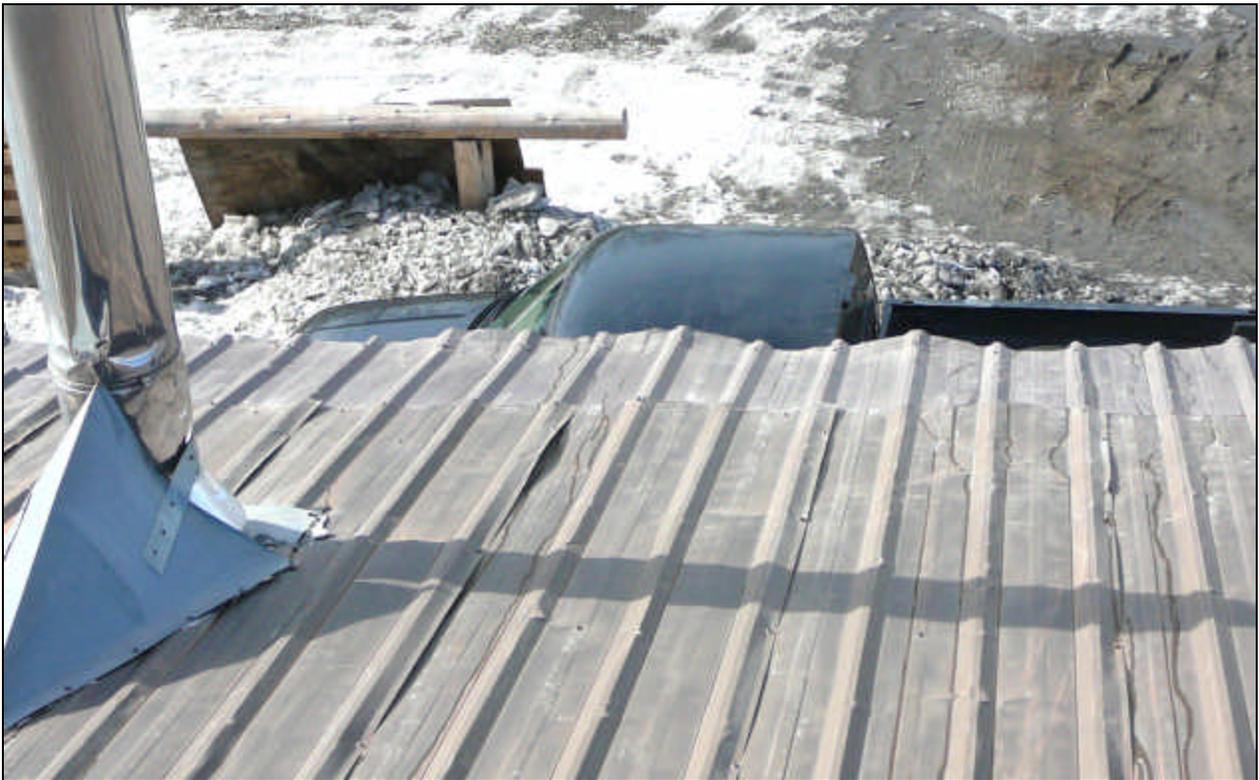
58. The stamped sheetmetal roof covering over the rear addition to the building is rather “beat up” by years of snow and ice, as seen in the following photo. (Note how the eave is very wavy due to distortions from ice loading.)

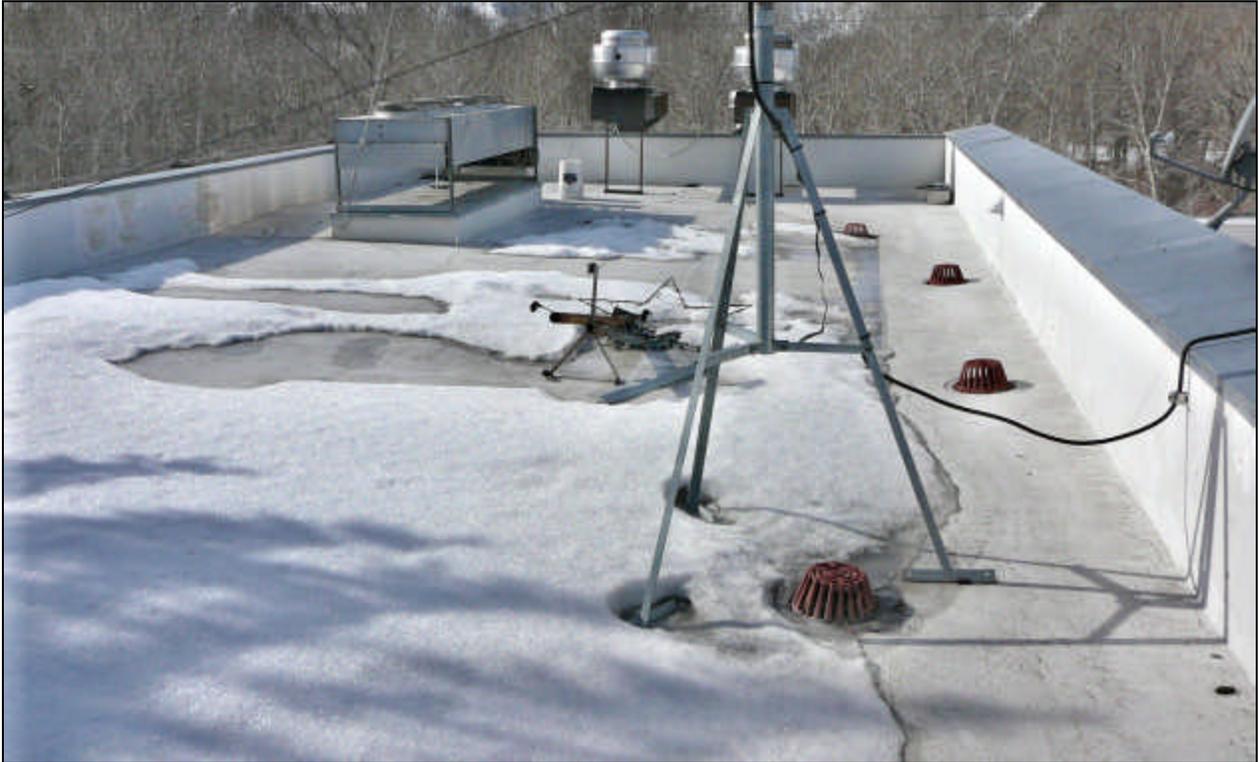
61. This photo is of the south half of the rooftop, looking westward. This roof covering appears to be a little older. It consists of a “snow-coated” cloth membrane apparently “mopped” onto a previous roof surface. It appears to be in good condition. I cannot estimate its age, however. Therefore, I suggest asking for further information from the current owner.

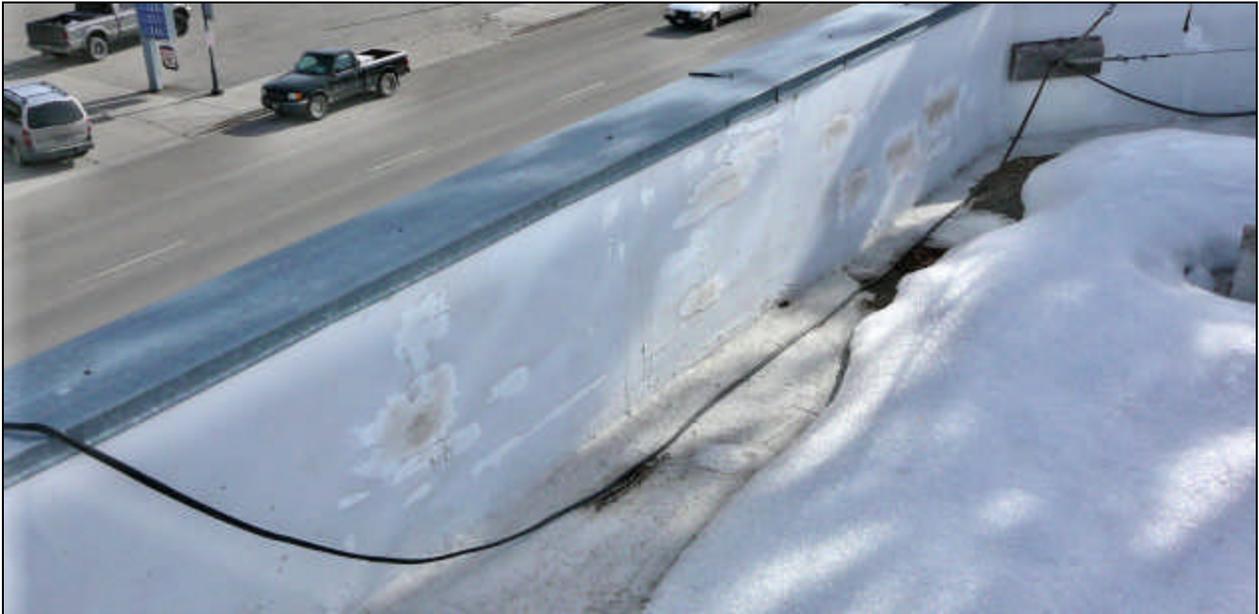
69. This photo focuses on the interior side of the parapet wall at the front of the building (over the south half). Please note what appear to be repair patches. Please note, also, that I was unable to see all roof covering surfaces because of partial snow cover.

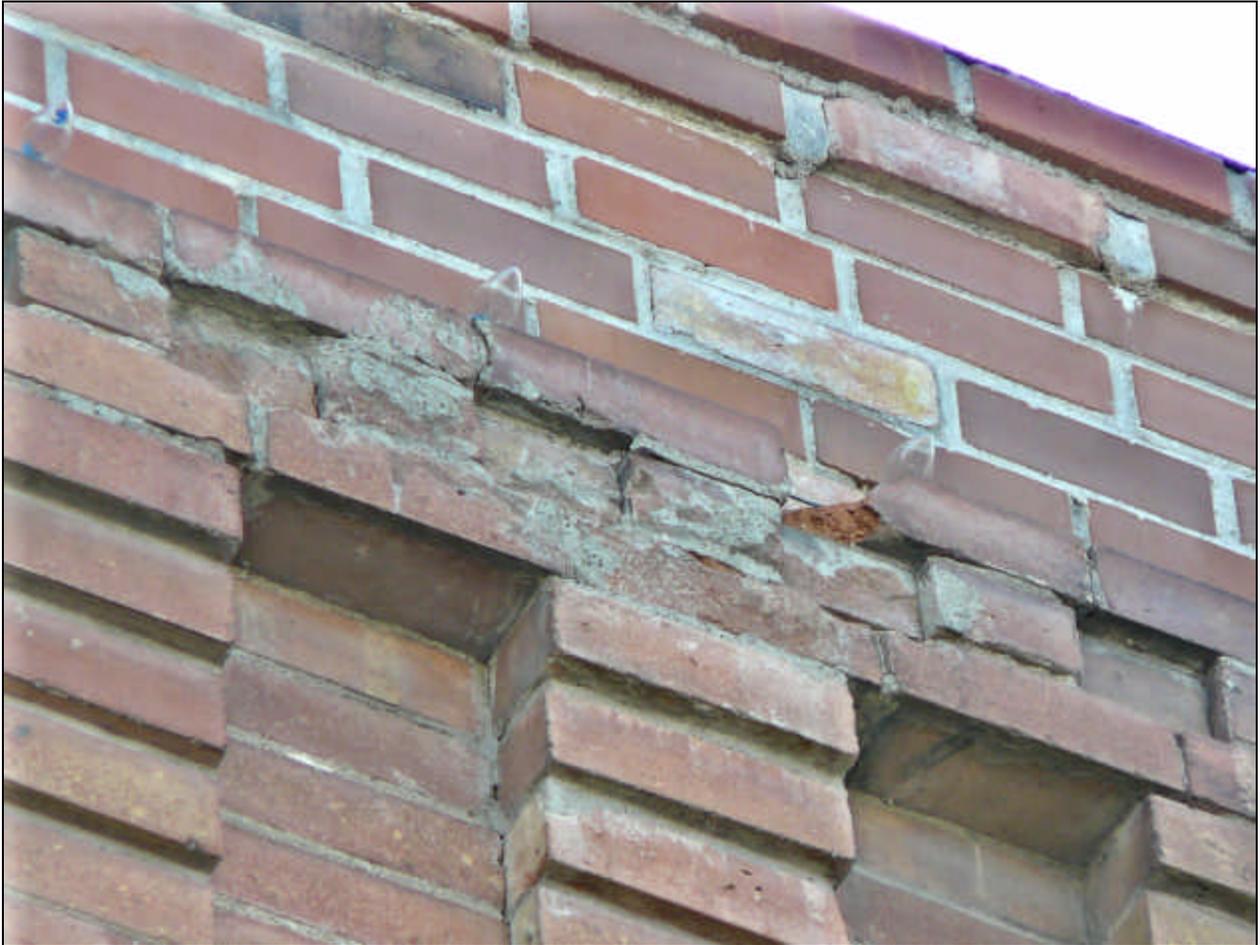
72. The following photo focuses in on the only small section of eroding bricks that I could see around the entire exterior of the building. It appears to me that sections of the brick exterior have been repaired in timely fashions through the years. The following photo also seems to indicate that the original building was made taller, or that the present parapet wall was extended or remade since original construction. (The brick in the top half of the following photo appear newer than those of the rest of the building.)
