Commercial Inspection Report

**200 S. Main Street
Bellevue, Idaho**

Inspection Date: 02/10/2007

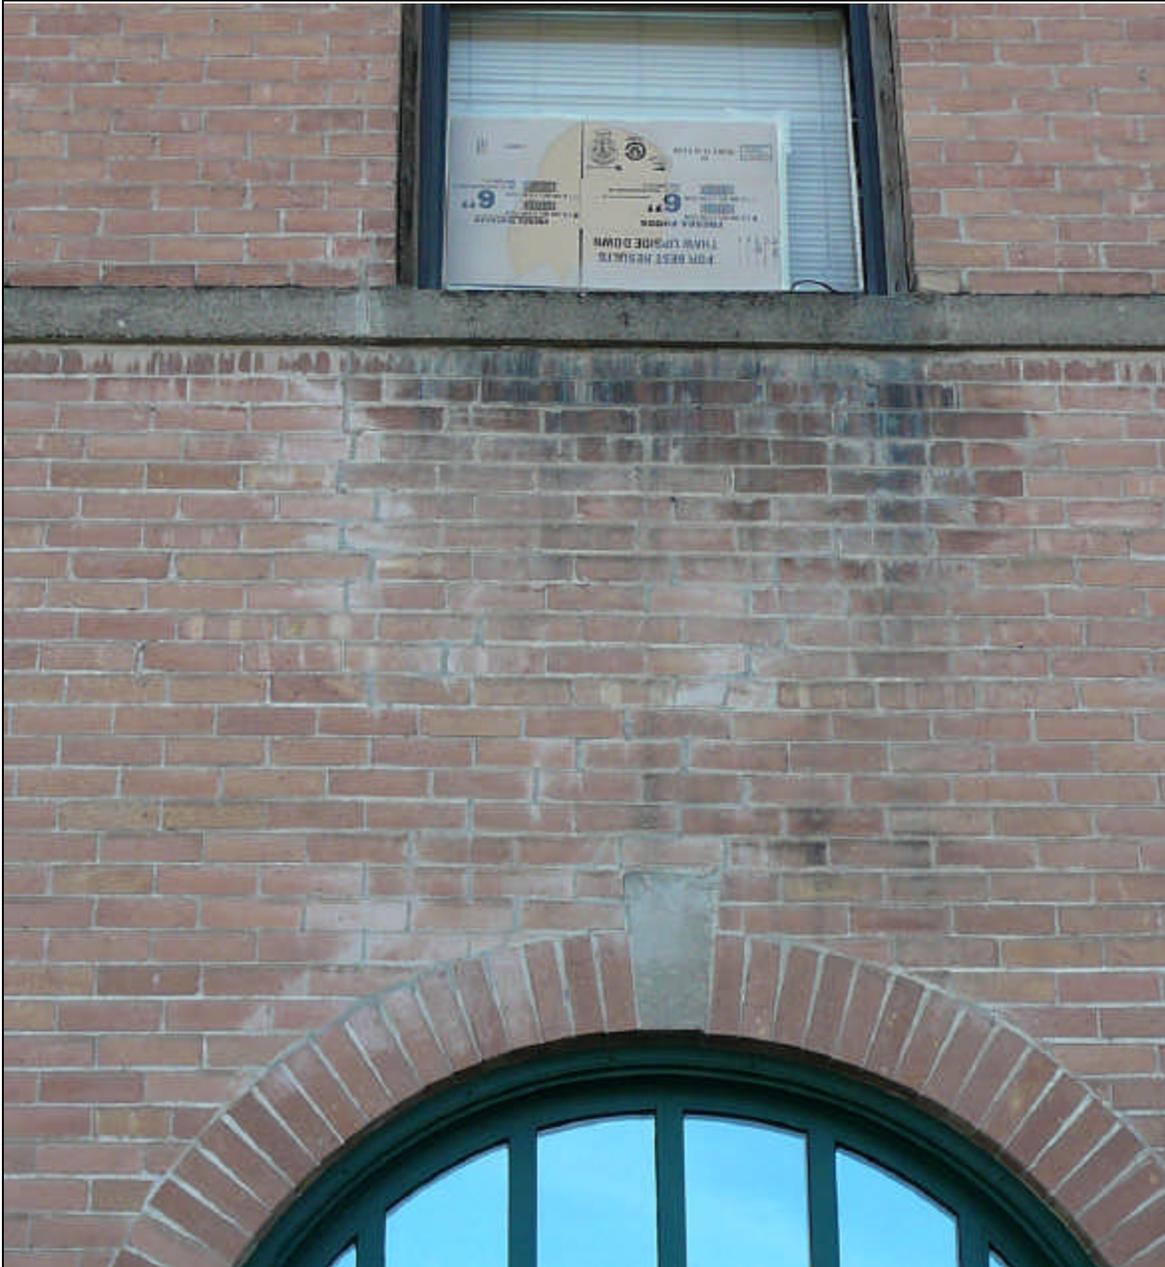
73. The following three photos focus in on the north wall sections by each of the windows, showing some recent grout repointing and possible replacement of whole sections of brick. (Notice the different glazes on some of the brick sections under the window in the third photo.)

(Notice the broken window sash glass in the photo above.)

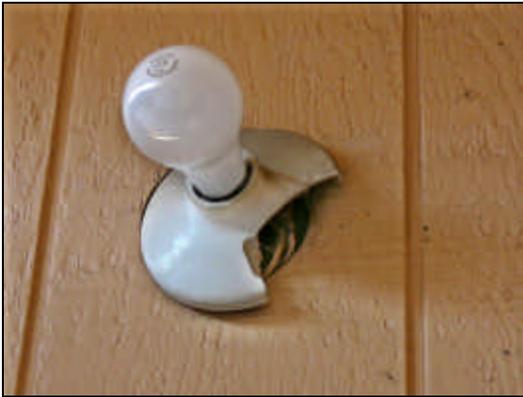
82. The exterior light fixture just outside the rear exit from the south kitchen has a broken base that should be replaced. A qualified electrician should address and/or correct this issue, as necessary.

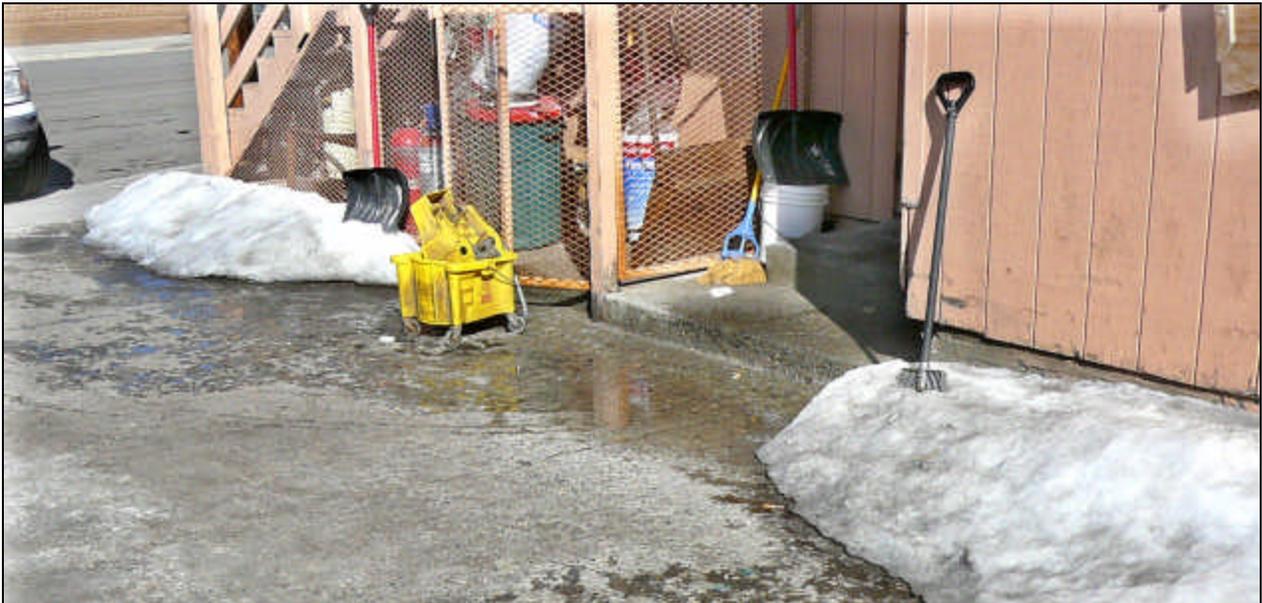
83. The concrete parking area behind the building has spalled surfaces (most likely due to the continued use of deicers containing salt). However, the concrete still seems to be sound. Please note that this area tends to stay wet because of ice and snow melting from the roof. The section of roof over the north half of the building drains to the rear eave of the sloped sheetmetal roof over the rear addition. Since snow and ice must slide off this roof, no gutter can be kept in place. I suspect it might even be somewhat dangerous at times under this rear eave of the roof when employees must use this entrance.
