**AAD Inspection Corp.**

# Home Inspection Report

**1234 Any Street  
Boise, ID 83700**

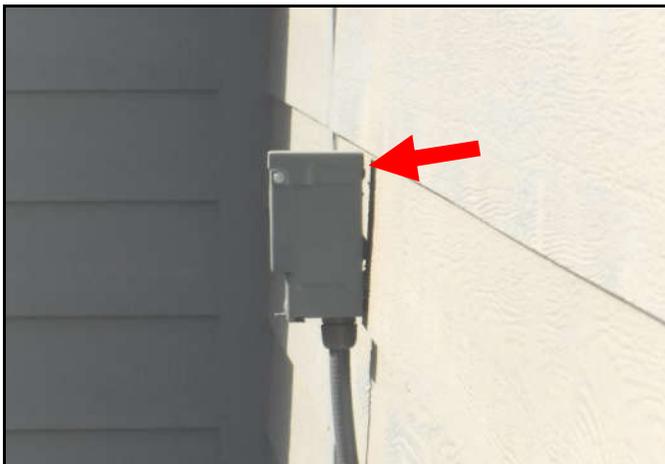
2. The local shutoff box for the condenser coil is a little loose at its connection to the siding, as shown in the following photo.

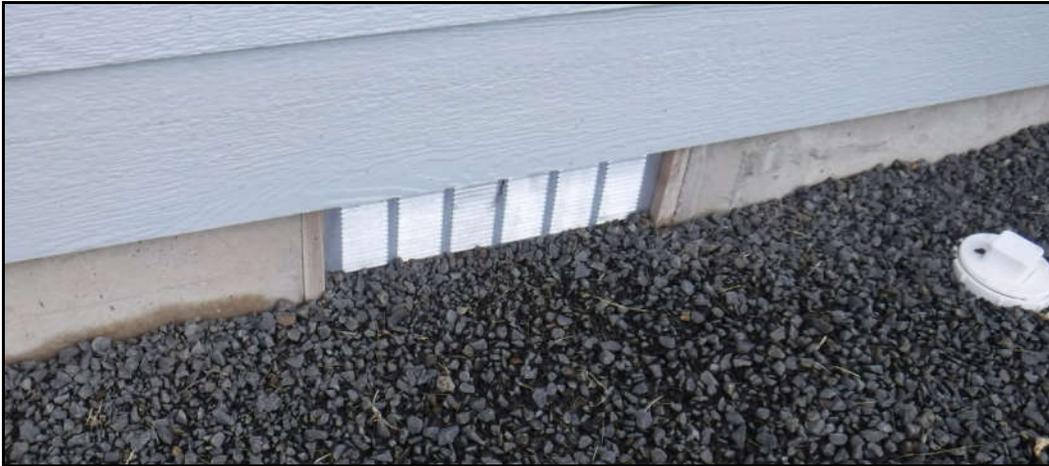
3. One or more of the foundation's perimeter vents have soils and/or landscaping materials either touching or partially covering them, as exemplified in the following photo. Placing vent wells (small dams) in front of them would help keep their wooden frames from being subjected to various forms of wood-destroying organisms and help prevent partial restriction of the important cross-flow ventilation intended for the crawl spaces under the home.

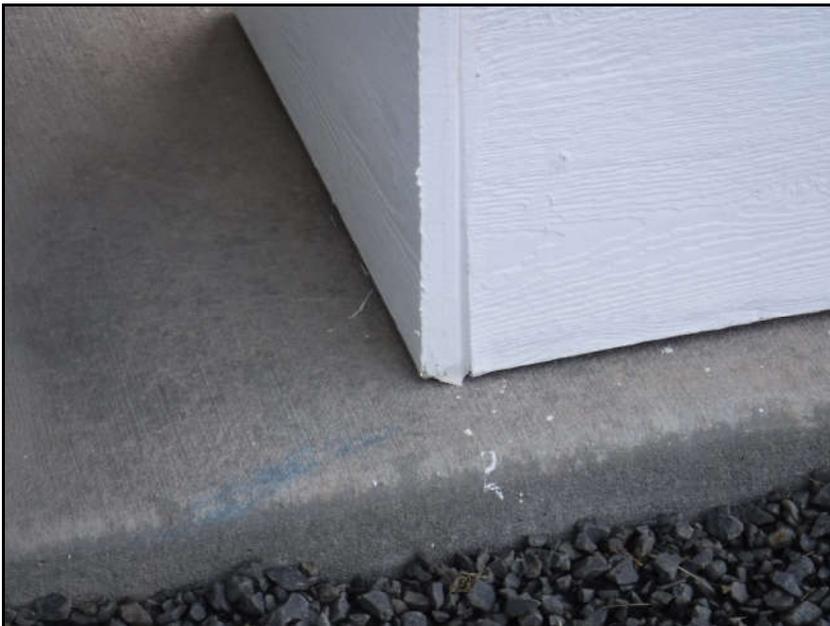
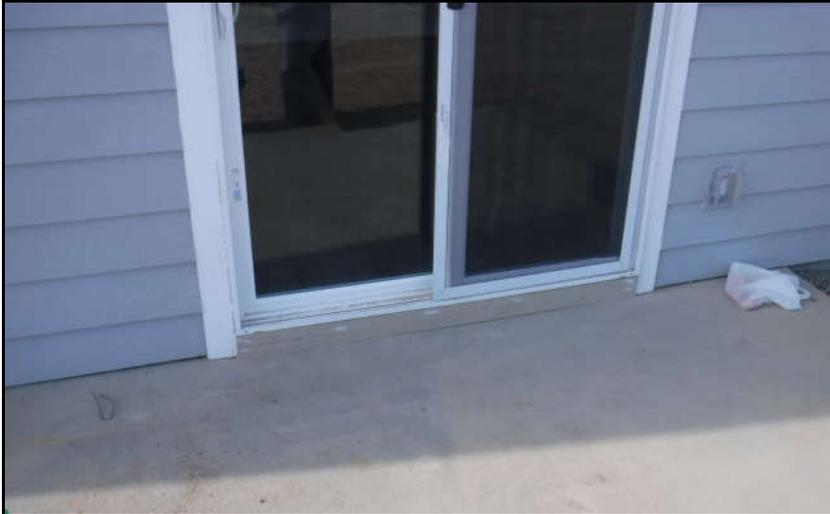
4. The trim wrap of the front entry support posts and the rear patio siding/ledger board are contacting the concrete slab below them, as exemplified in the following two photos.

This can encourage moisture to wick up into the trim, which can lead to possible deterioration. Siding and trim should be held at least 1 inch above concrete to help prevent such issues. Furthermore, the materials behind and below the siding and trim should be protected with flashing designed and installed to effectively prevent water entry behind the concrete.

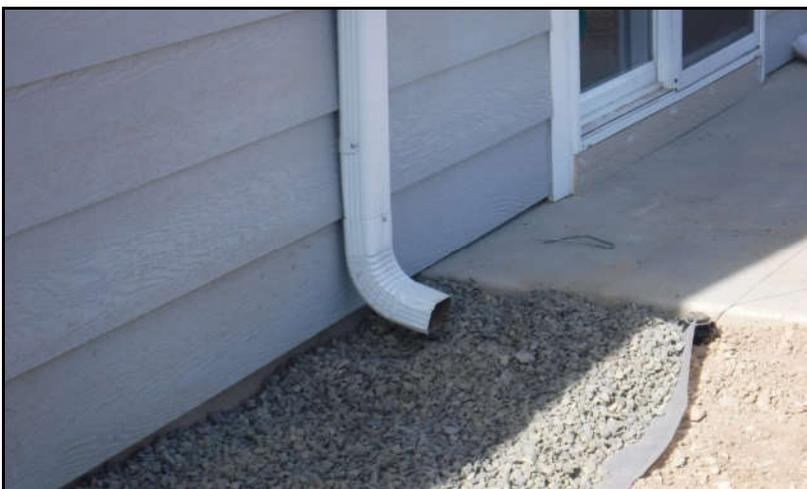
5. One or more gutter downspouts discharge where their water cannot continue to flow adequately away from the foundation, as exemplified in the following photo. I suggest modifying the downspouts or the grading to help keep water from ponding against the house. I also suggest monitoring any adjacent below grade spaces for evidence of exterior surface water infiltration after periods of heavy rains or intense irrigation.

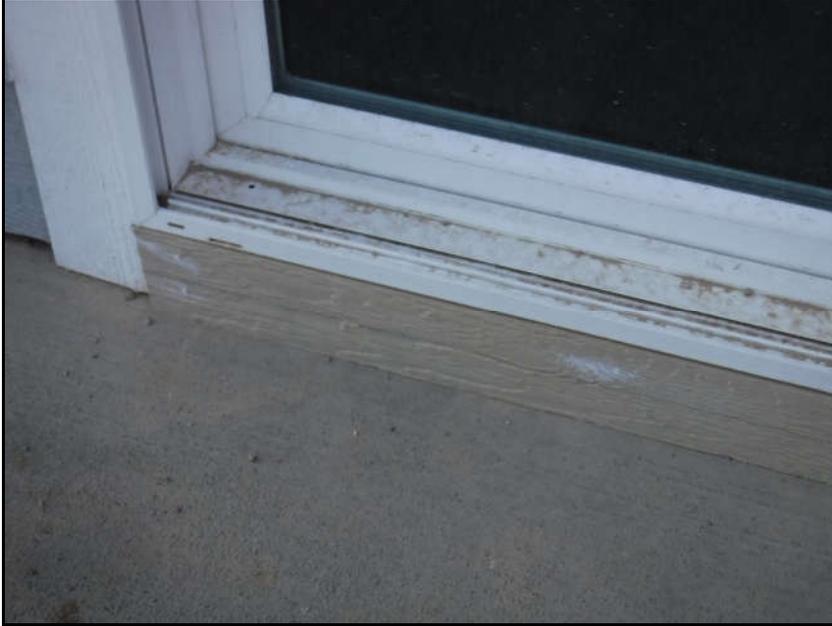
6. The ledger board for the rear-facing sliding glass door has been caulked, but not yet painted to adequately protect it against the elements, as shown in the following photo.

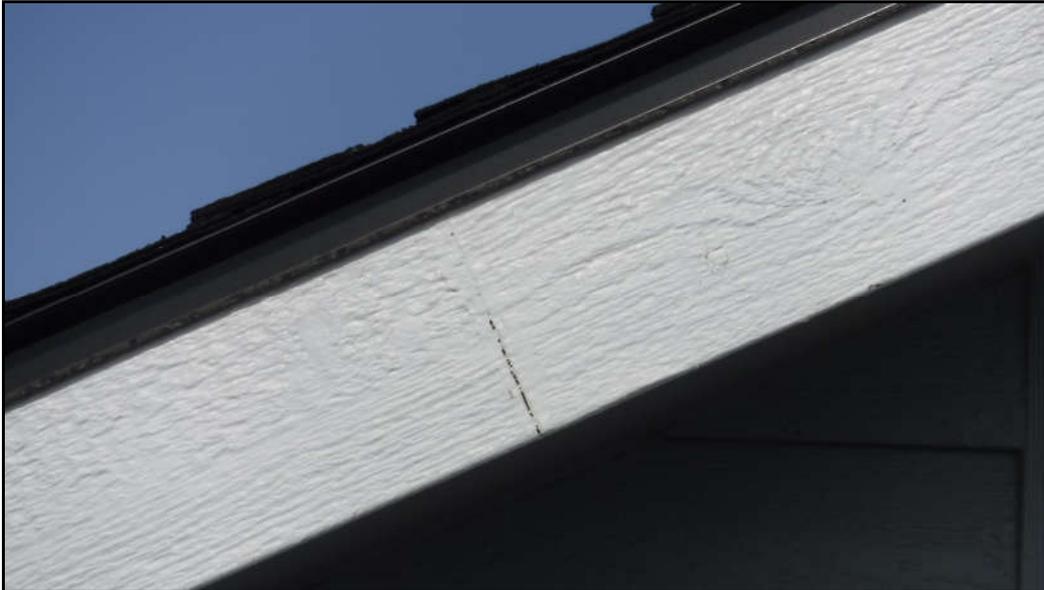
7. Some of the caulking is starting to split along the seams of the siding and trim around the home, as exemplified in the following photo. This can eventually allow water entry resulting in swelling.

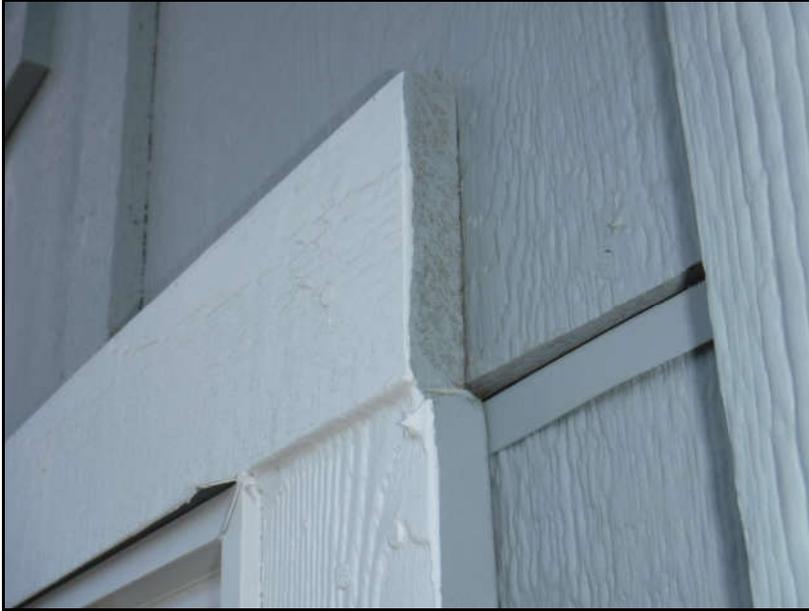
8. Some of the saw-cut edges of the window trim around the home are partially unpainted, as exemplified in the following photo. This can allow water entry and resultant swelling.

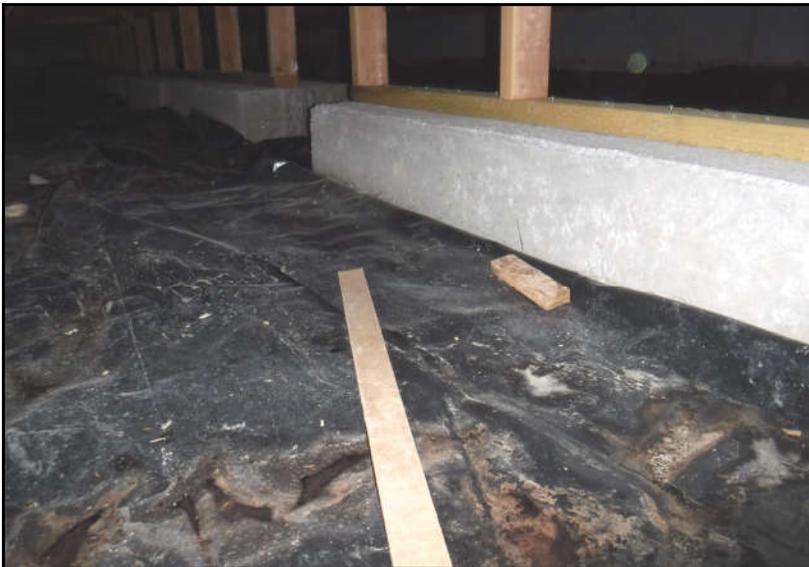
9. Construction scraps containing cellulose (wood or paper products) have been left in the crawl spaces under the structure, as exemplified in the following photo. Since these scraps can eventually attract various wood destroying organisms, I recommend that they be removed.

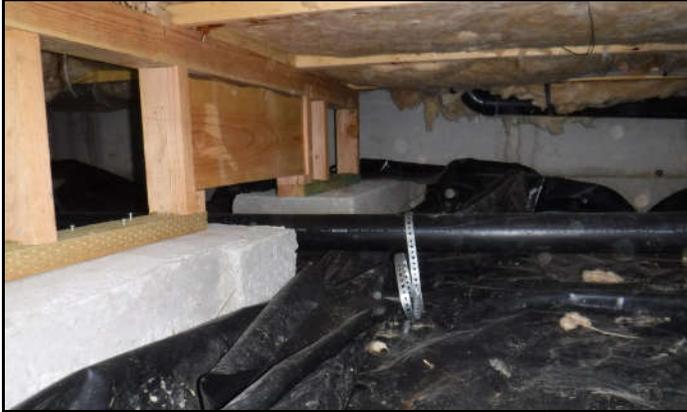
10. One of the mounting straps has come loose from a drain pipe in the crawlspaces under the main-floor front left living room, as shown in the following photo. These steel plumbers straps should be installed every four feet along horizontal runs of plastic drain pipe to maintain adequate support and consistent slope for the drain system.

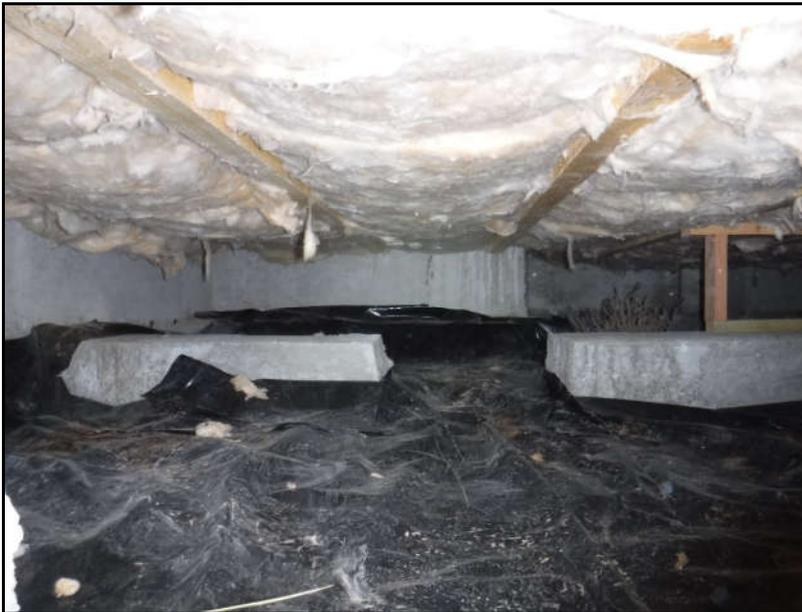
11. I found two sections of interior footing curbs in the crawlspaces under the front entry with no pony wall supports, as shown in the following photo. Occasionally, I find footing curbs in the crawlspaces that are not part of the original blue prints, and were poured needlessly. However, I suggest verifying with the builder/framing contractor whether or not pony wall intermediate supports are necessary at this location.

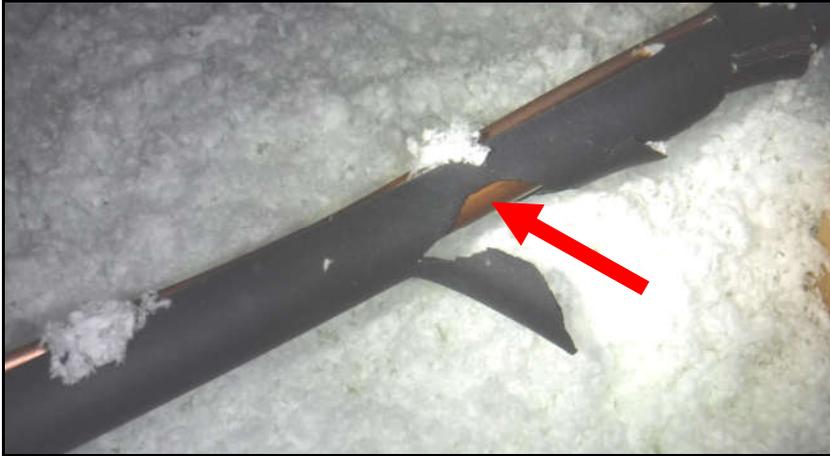
12. The foam insulation along the larger of the two A/C refrigerant lines in the attic has been torn in a few areas, as exemplified in the following photo. This can cause condensate to form and drip onto the insulation and sheetrock below. Therefore, I suggest repairing the insulation to cover essentially all the copper surfaces.

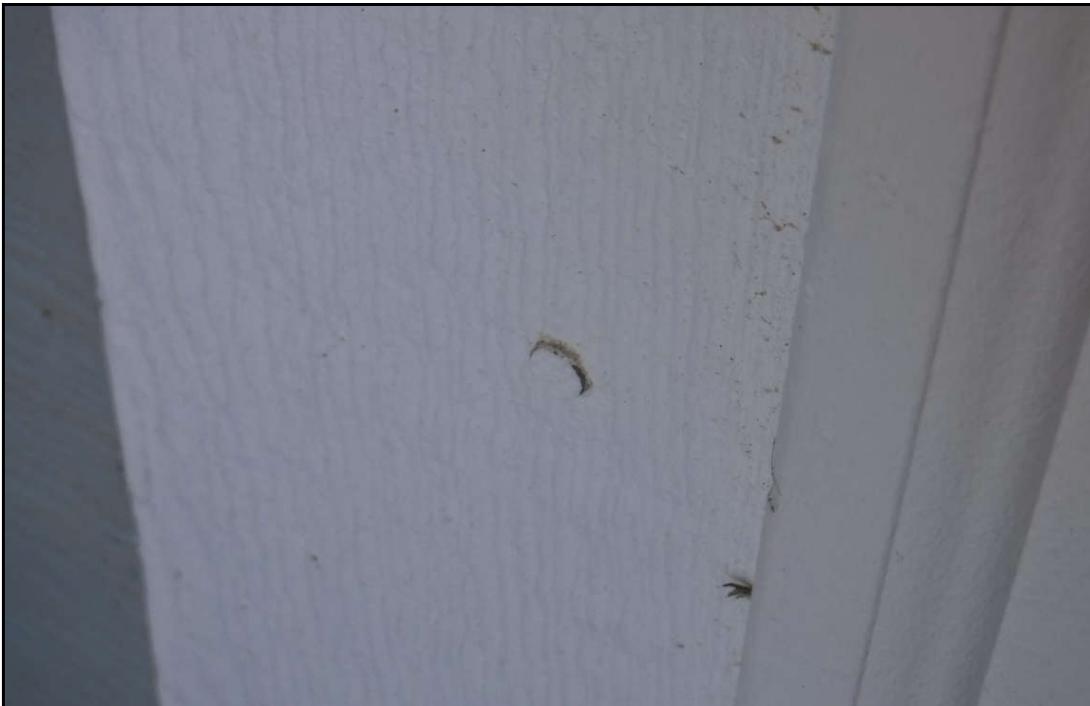
13. One or more nail heads are not flush with the siding material around the home, as exemplified in the following photo. This can more easily allow the nail heads to back out and let damaging moisture into the siding materials.

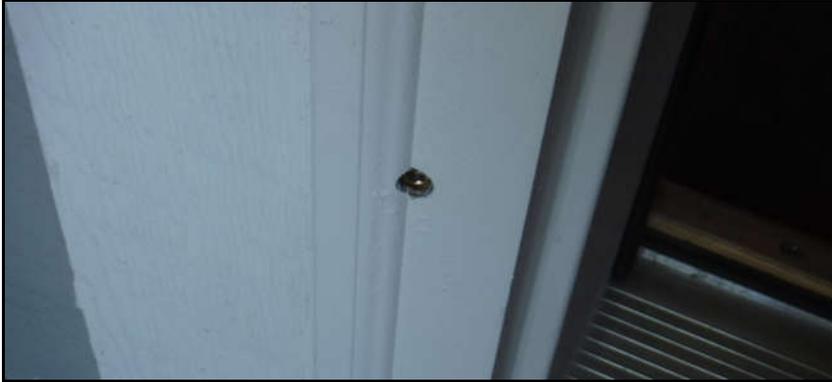
14. One or more screw heads are uncaulked on the trim at the front entry, as exemplified in the following photo. These can be possible entry points for moisture that will eventually lead to swelling.

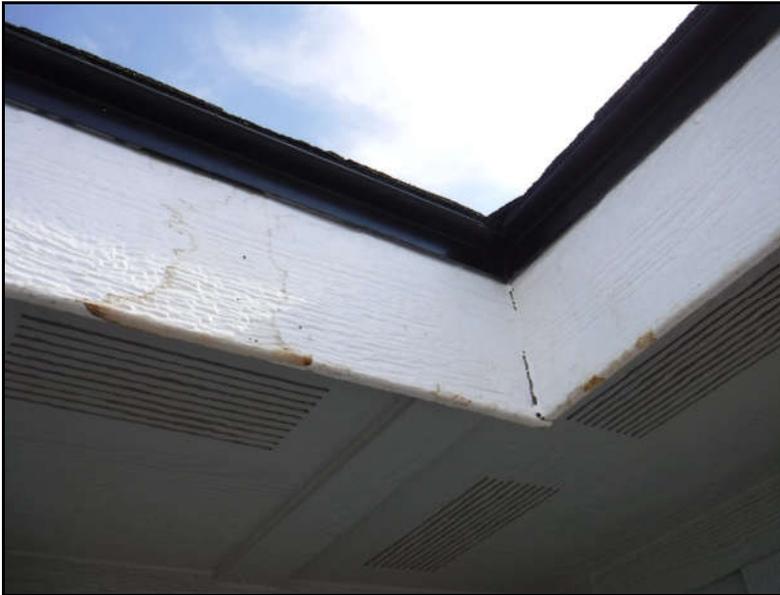
- a. I found staining on some of the fascia boards where no gutters are installed, as exemplified in the following photo. Gutters are not required, but could help prevent this condition.

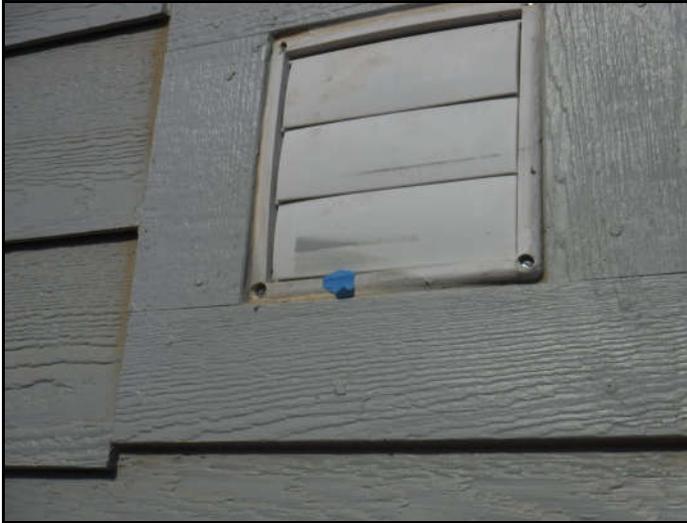
b. I found some paint splatter on the louvers of the kitchen exhaust vent cap, as shown in the following photo.

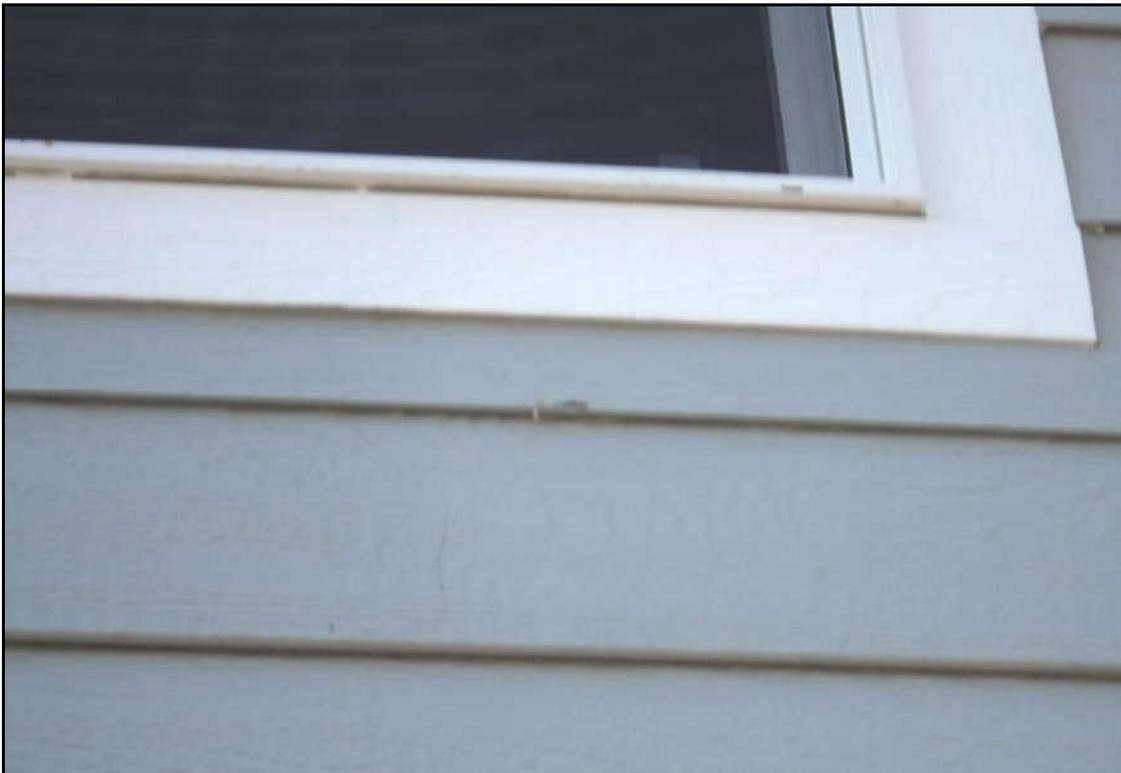
c. I found a few nicks and dings in the siding and trim around the home, as exemplified in the following photo.

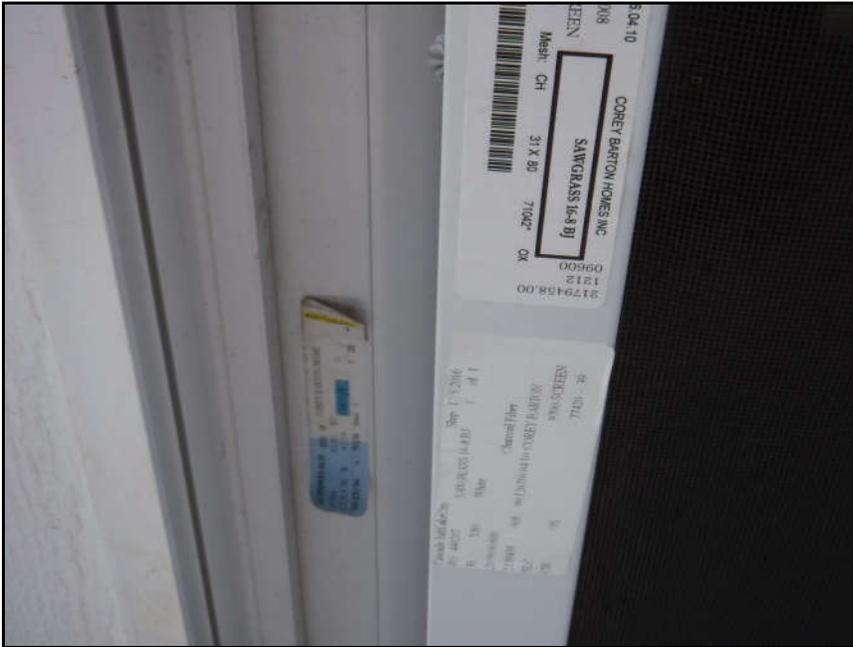
- d. The manufacturer tags are still on some of the window and door frames, as exemplified in the following photo. If they are removed soon enough, they might not leave so much mastic residue and/or paper behind. (Their removal at this time would also allow touch-up painting, if necessary.)

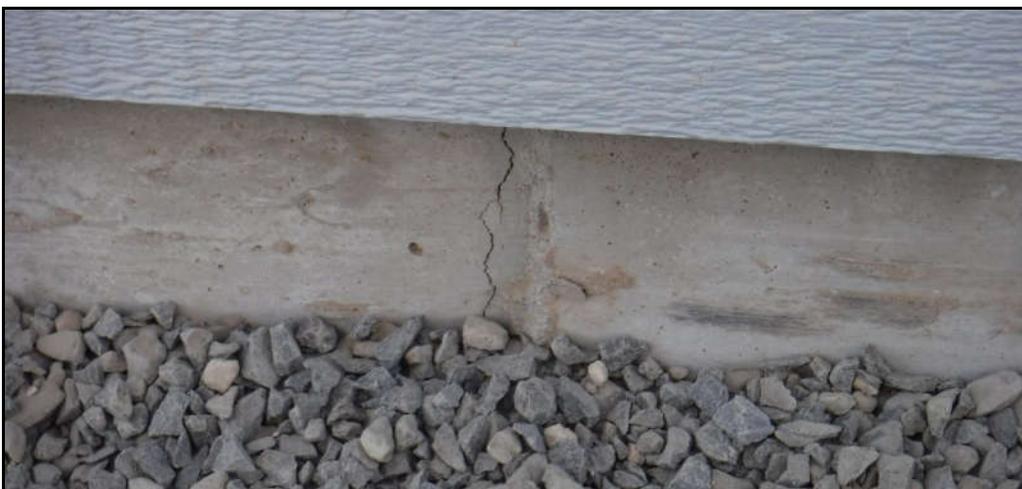
- e. The concrete foundation walls have some minor vertically oriented cracks that should be considered “cosmetic”, only, as exemplified in the following photo. Such cracks are typical for this climate and do not indicate any structural deficiencies.

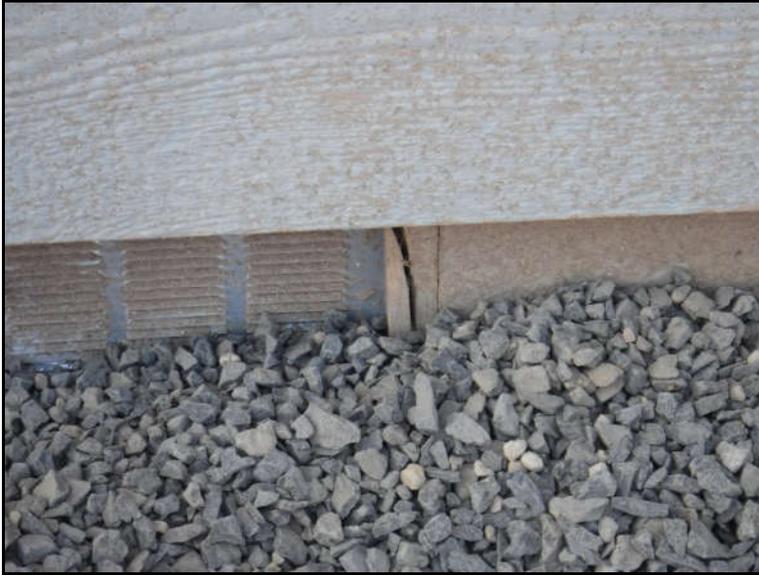
- f. I found one or more small cracks and/or splits in the wooden frames for a foundation vents around the home, as exemplified in the following photo. These do not indicate structural deficiencies. In fact, they could be easily glued/repared, so that the screens do not come loose.

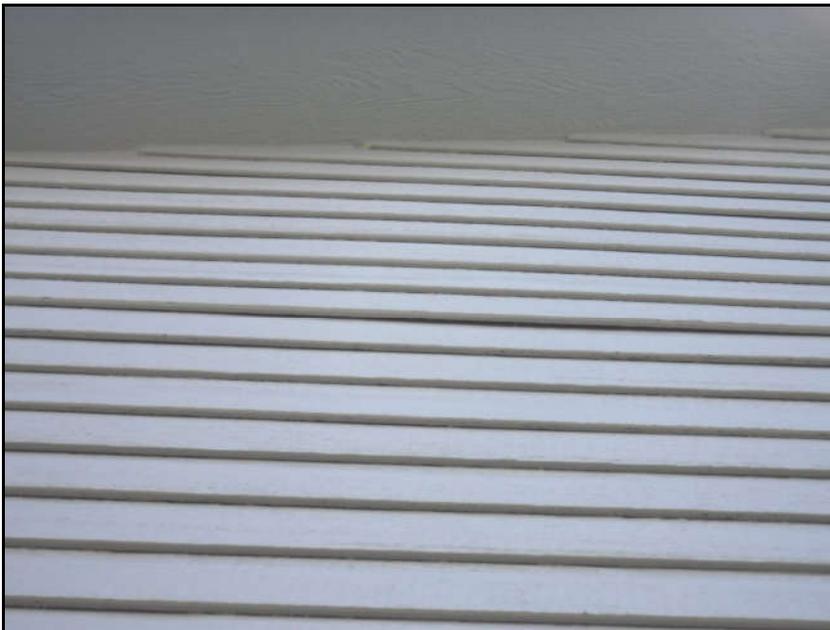
- g. One or more of the siding boards are a little “wavy” at the left exterior, as exemplified in the following photo. However, this is only a cosmetic concern.

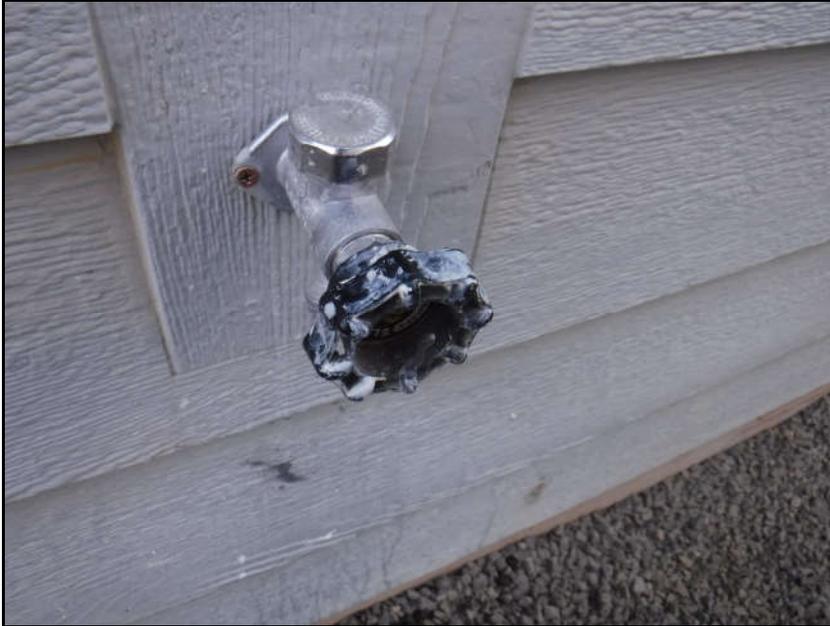
- h. I found what appears to be paint splatter on the freeze-proof sill cock (exterior garden hose valve) at the left exterior, and on the siding below it, as exemplified in the following photo.

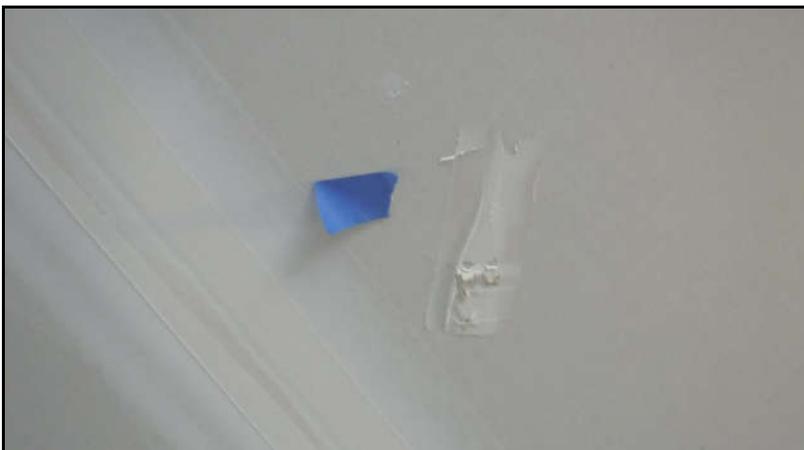
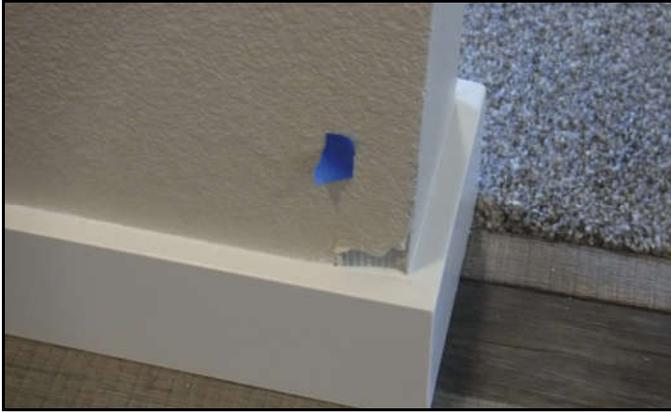
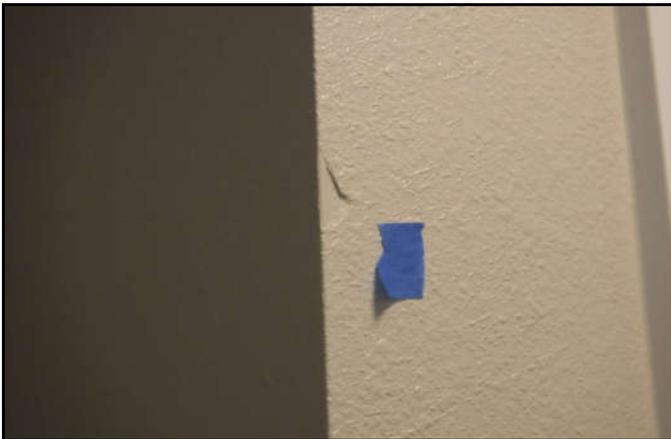
- i. Blue masking tape has been placed by others at many of the existing (remaining) cosmetic imperfections to indicate intentions to address these issues, as exemplified in the following three photos. This report may mention some of these or other cosmetic issues. However, this report does not intend to list all such cosmetic issues, as the blue masking tape, alone, is a very effective communication tool.

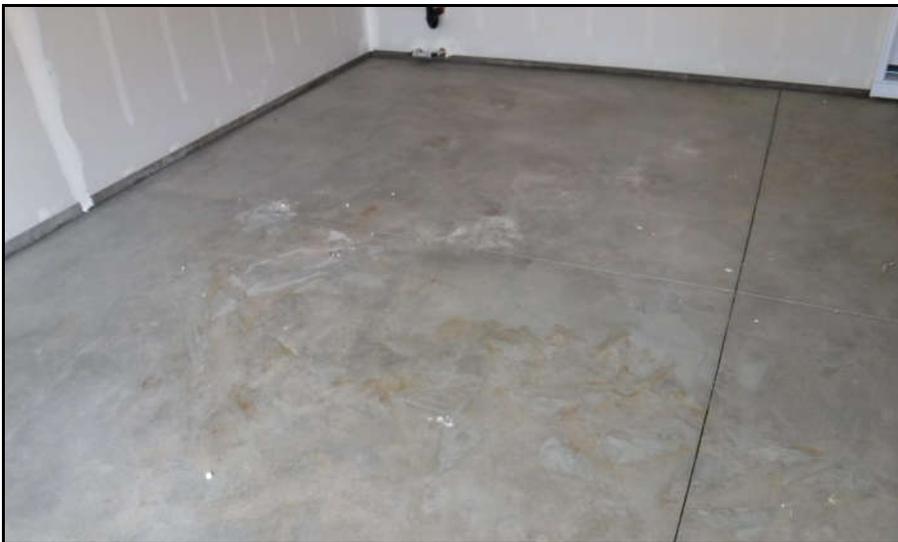
- j. The concrete floor inside the garage is a little soiled, as exemplified in the following photo. However, this will likely be addressed during the final cleanup.

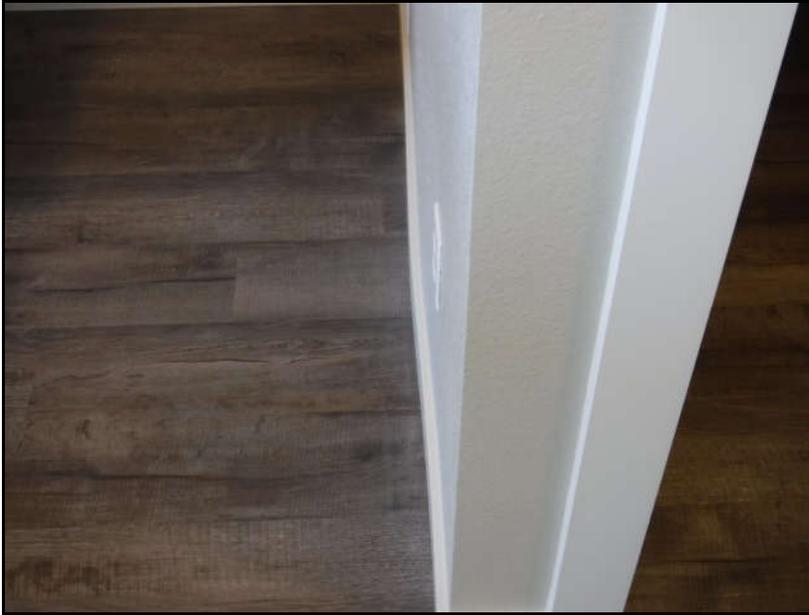
- k. The baseboard molding and sheetrock surfaces throughout the home are not perfectly straight, as exemplified in the following photo. However, this condition likely falls under the quality guidelines set forth by the NAHB (National Association of Home Builders), which is an industry-wide, self-regulating standard of care. With respect to the straightness of wall, they should not be more than  $\frac{1}{4}$  inch crooked within any horizontal span of 4 feet. Nonetheless, this is a cosmetic consideration, only.

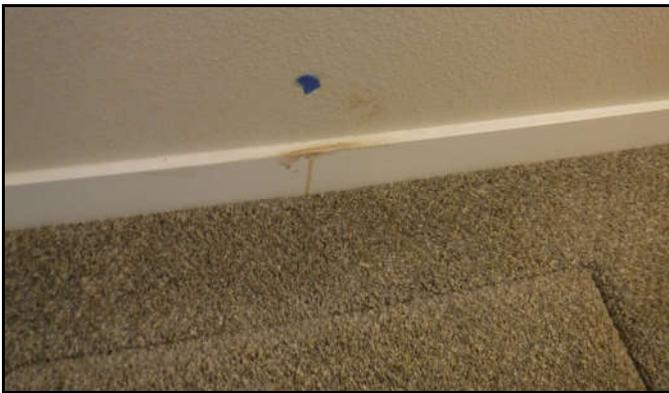
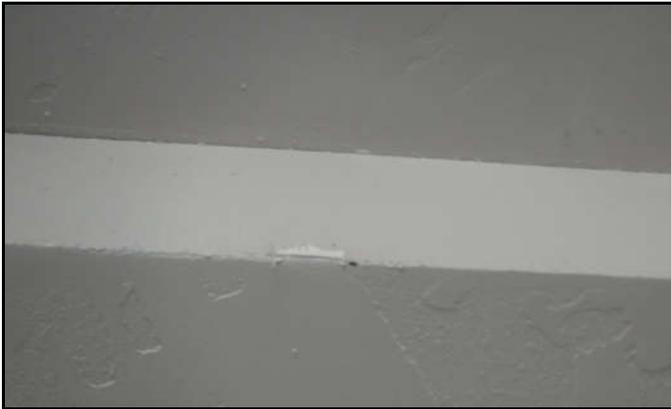
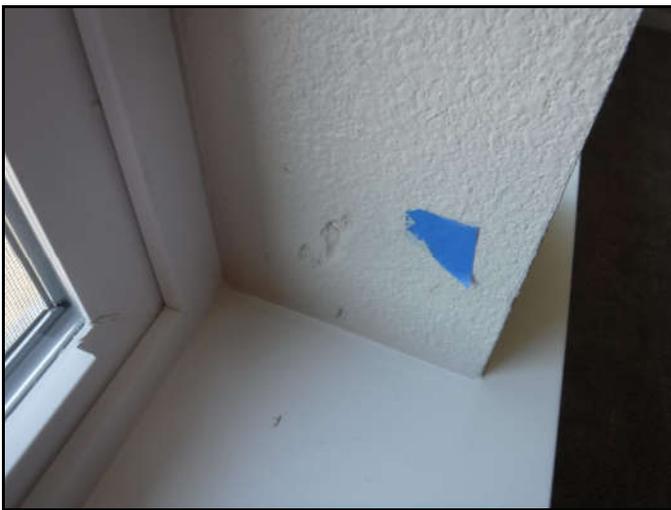
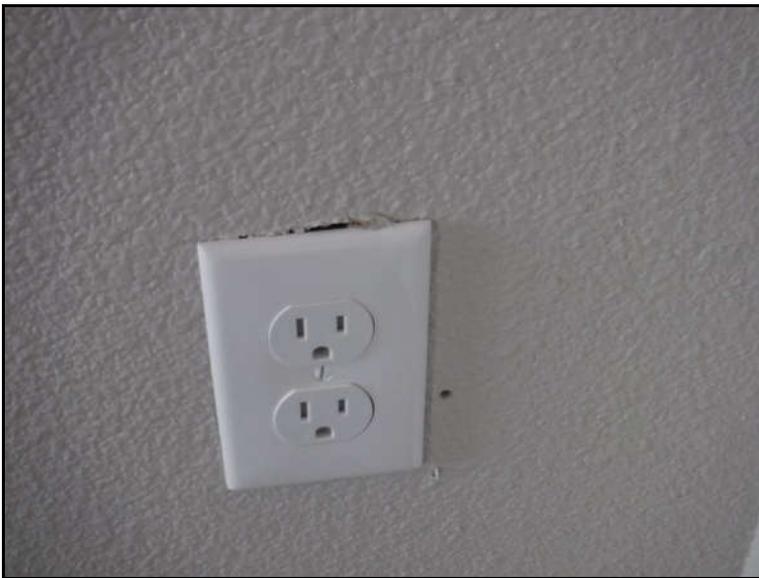
- l. The interior surfaces of this property have less than the typical amount of blemishes, scratches, dents, scuffs, or dings that may require repair in order to present the best possible visual appearance, as exemplified in the following four photos.

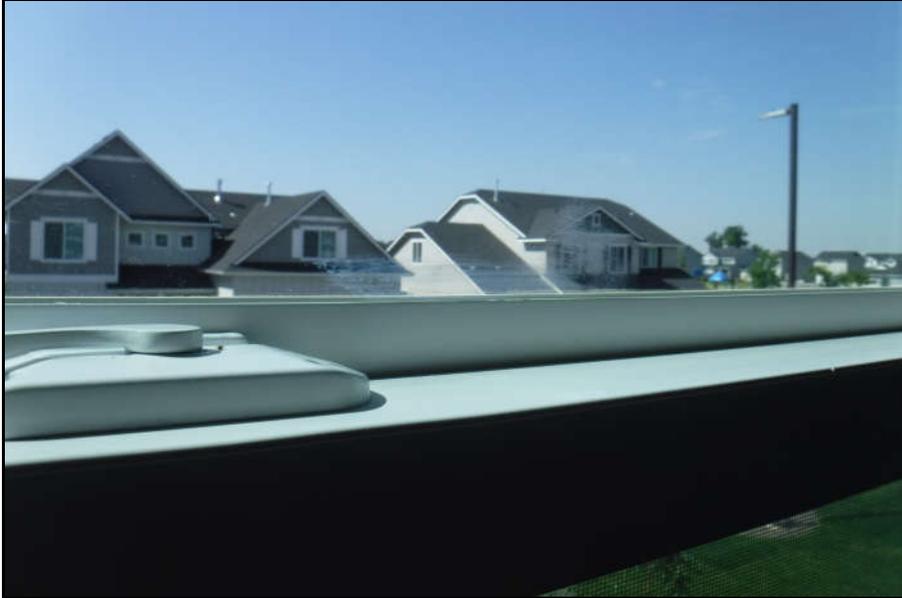
- m. I found a few smudges of potential paint splatter on some of the window glass around the home, as exemplified in the following photo.

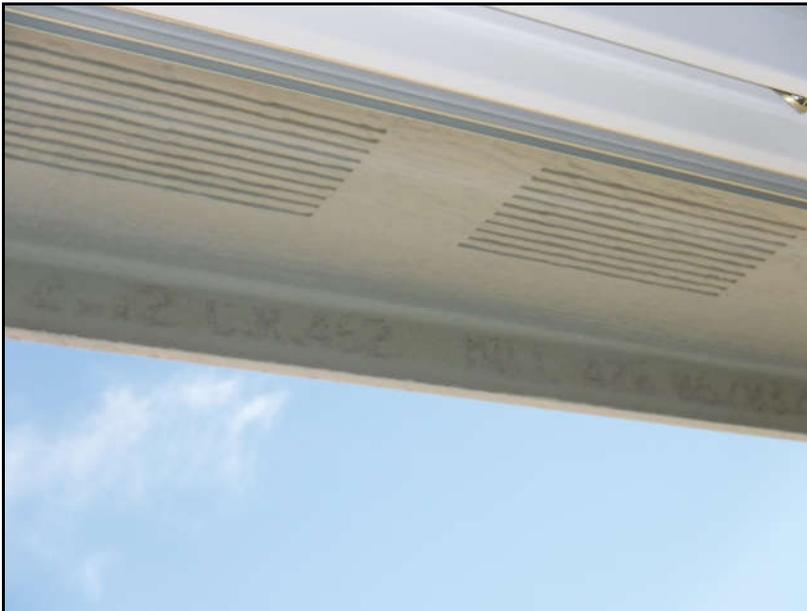
- n. The manufacturer's ink stamps are "bleeding" through the paint on the soffit sides of the fascia around the home, as exemplified in the following photo. Some of these areas are visible from the interior of the home. I believe that thicker paint coatings would effectively mask the printing, if desired.

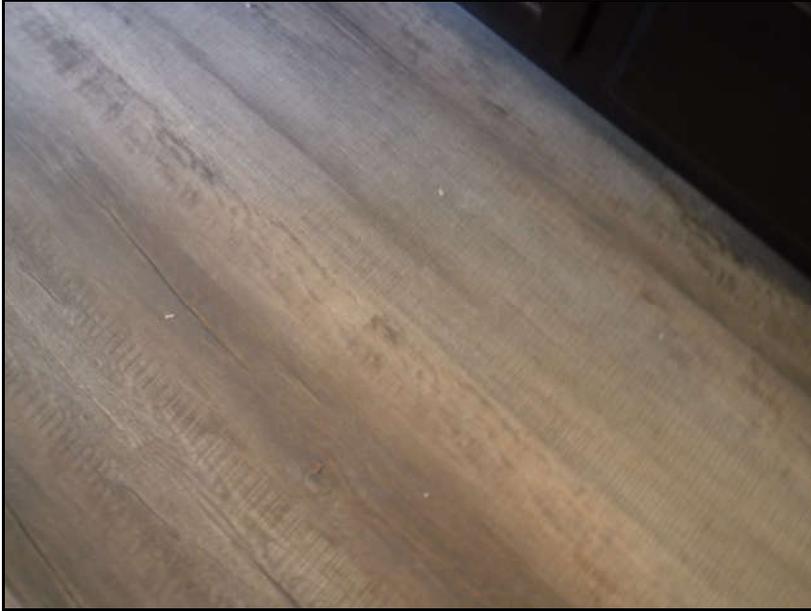
- o. I found a few specks of paint chips and other small pieces of debris throughout the interior, as exemplified in the following photo. However, this will likely be addressed during final cleanup.

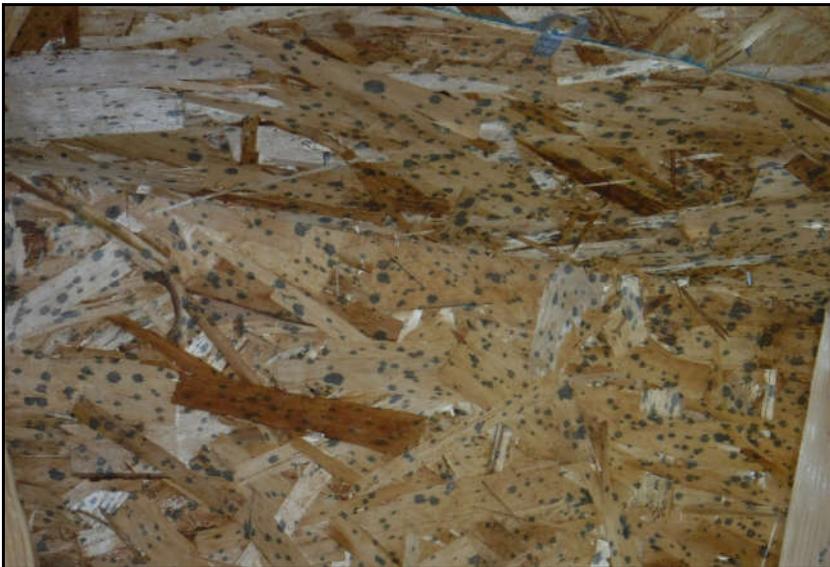
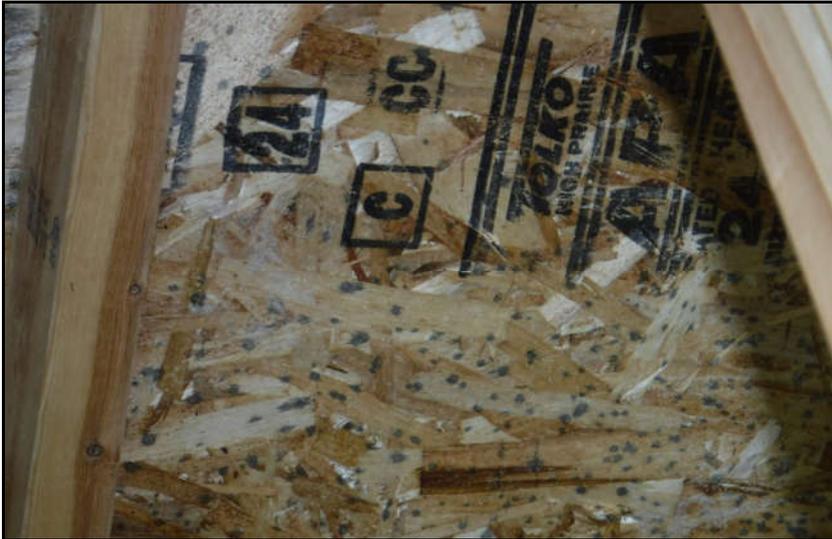
- p. I found specks of ink splatter on the attic side of the OSB roof sheathing, as exemplified in the following two photos. This occurs during manufacture, and is strictly cosmetic. (Some people may erroneously mistake these splatters as biogrowths.)

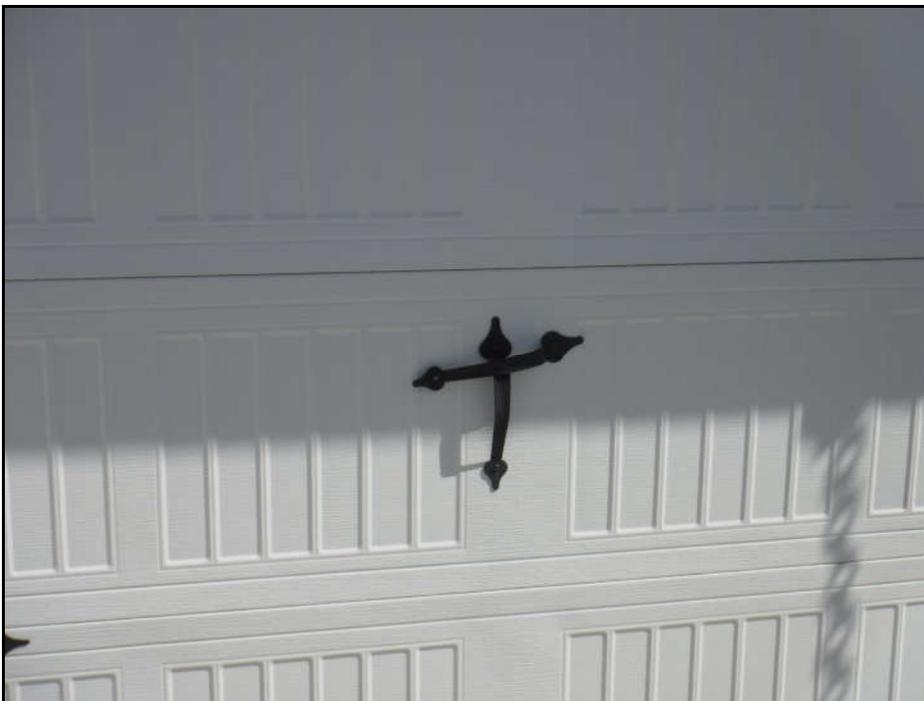
- q. The partition wall at the front of the garage interior between the left and right bays is not centered above the concrete footings. However, this should be considered mostly cosmetic.
- r. The decorative handle is loose on the exterior side of the smaller overhead door, as shown in the following photo.

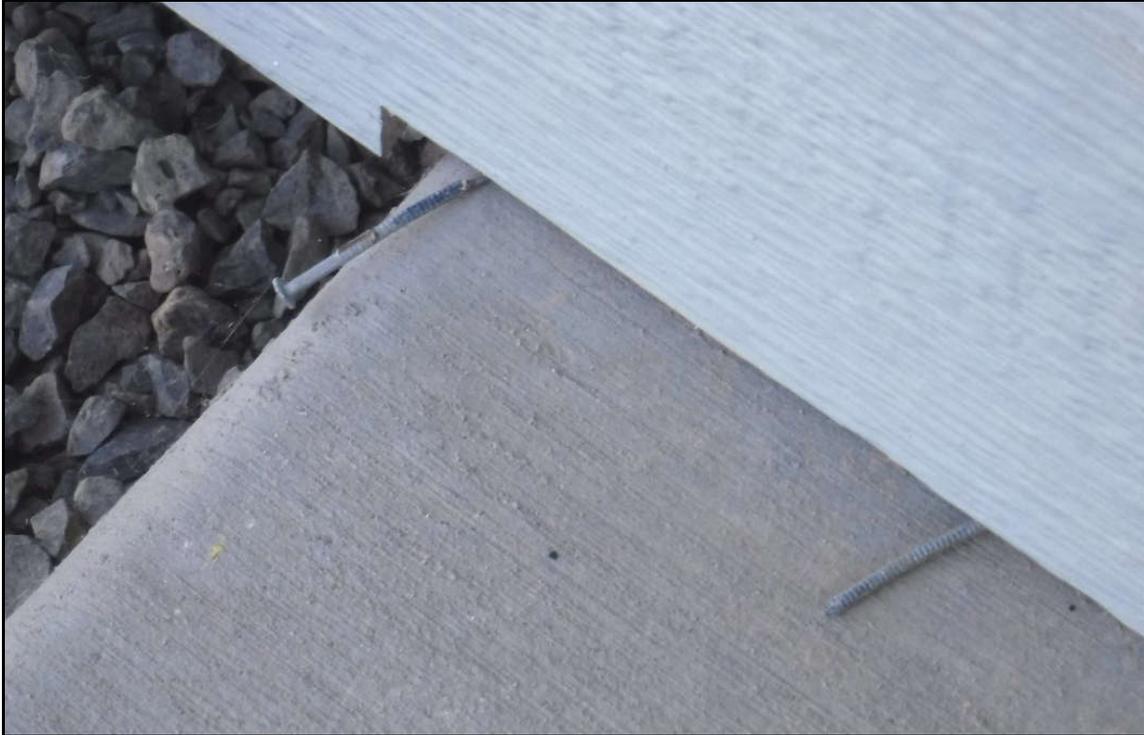
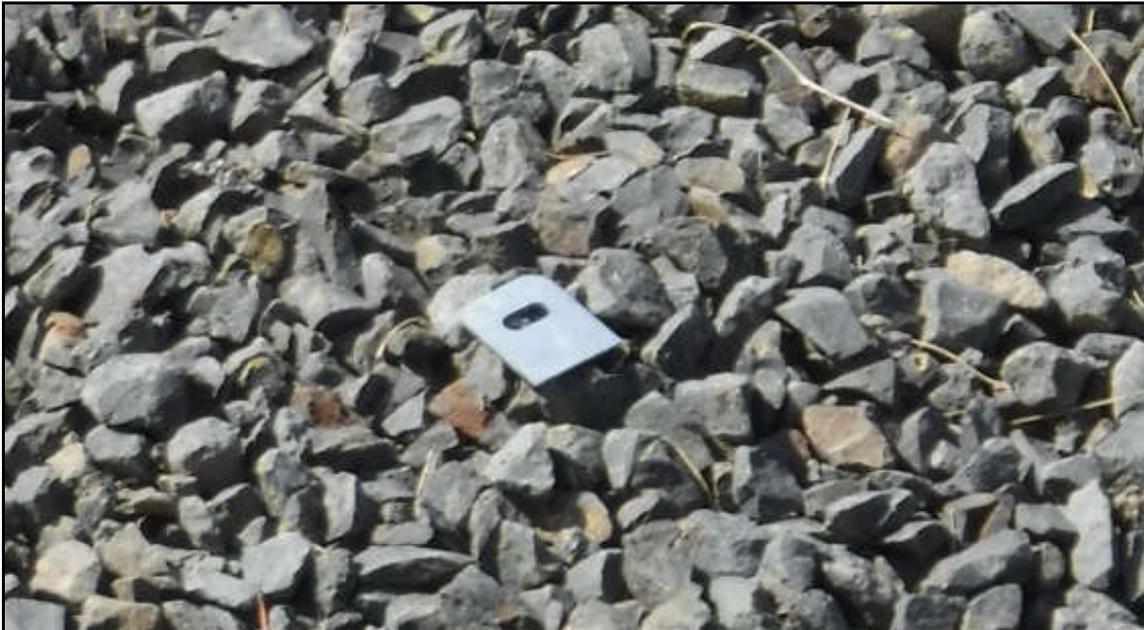
- s. I found a few nails and other construction debris in the landscaping around the property, as exemplified in the following two photos. However, this will likely be addressed prior to closing.

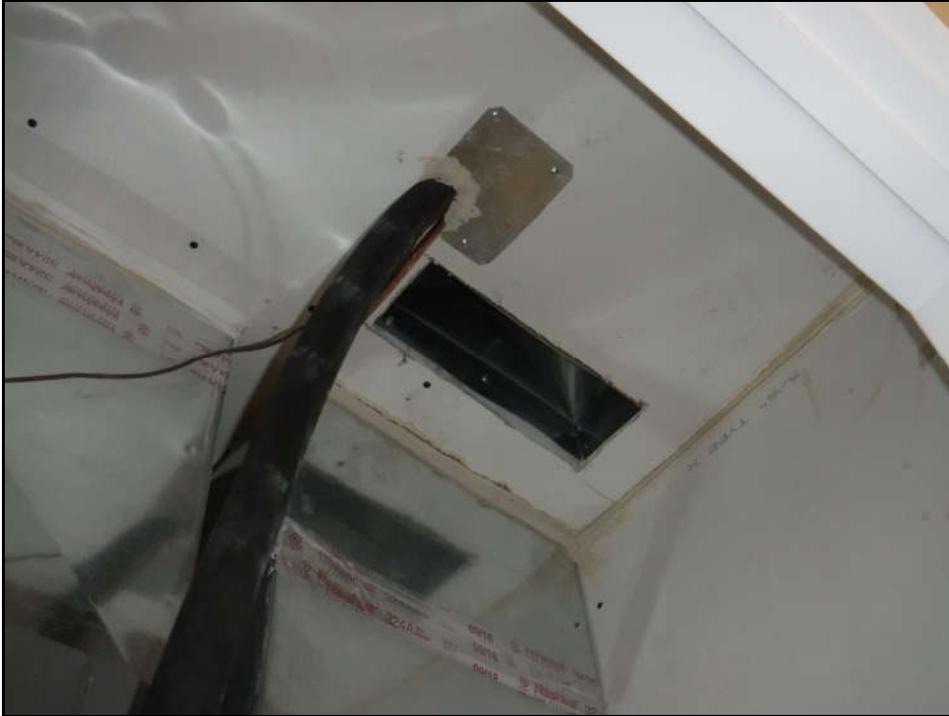
- Gutters are not installed on all eaves of the home. However, none are required by codes.
- The air inlet in the ceiling of the mechanical closet for the furnace does not have a register cover or a mesh screen to prevent potential pest access to the interior of the home, as shown in the following photo. (Typically, a ¼-inch mesh screen is placed over the exterior opening of this combustion-air path.)

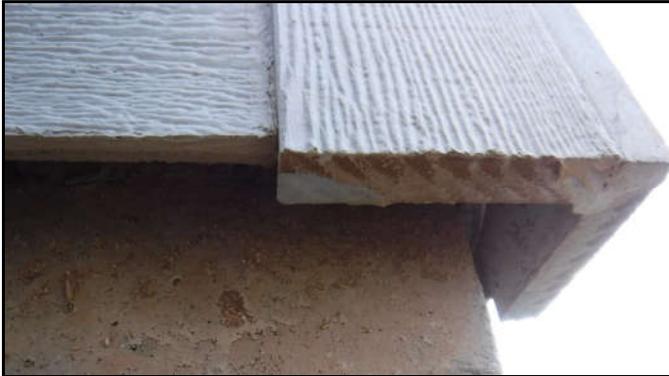
- The bottom edges of the siding and trim are somewhat unpainted in several locations, as exemplified in the following photo.

This often leads to water absorption and eventual swelling. Therefore, I suggest adding primer and paint to the bottom edges of all siding and trim adjacent to the foundation and around windows to help protect against water damage.

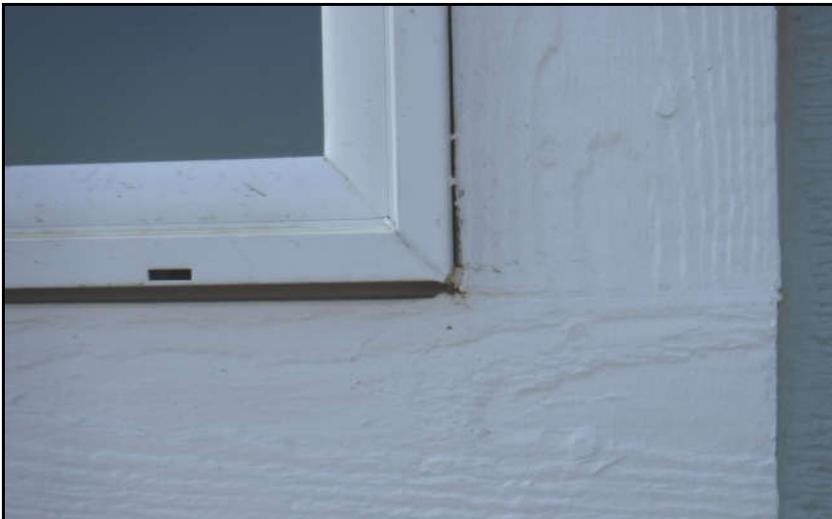
- One or more windows have little or no caulking around their frames at the exterior, as exemplified in the following photo, as exemplified in the following photo.
