Commercial Inspection Report

**200 S. Main Street
Bellevue, Idaho**

Inspection Date: 02/10/2007

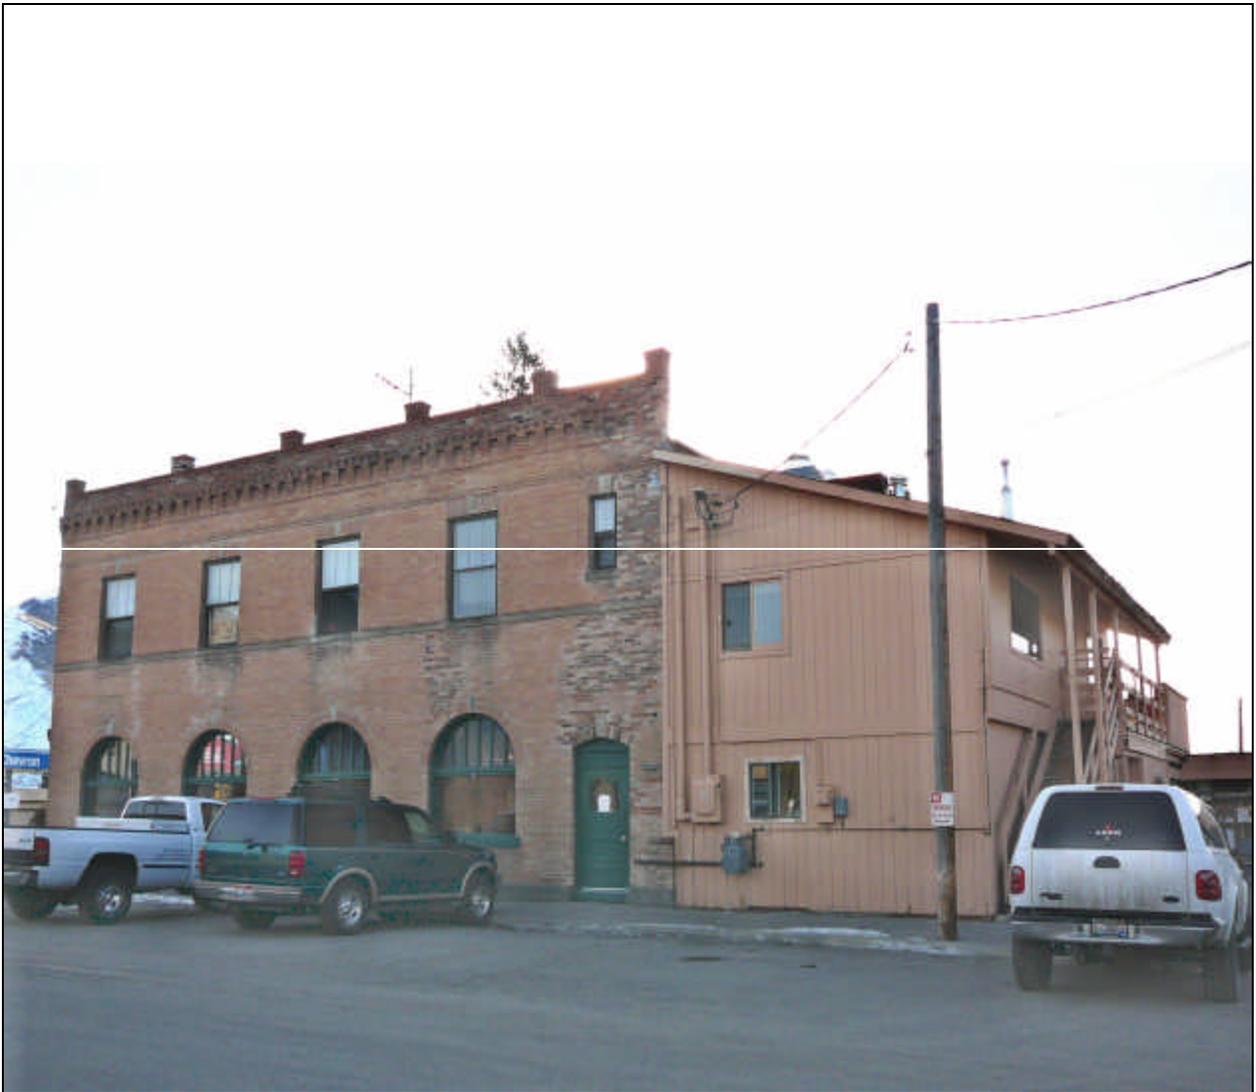
1. The following photo shows the right (north) side of the building. While I believe the north half of the brick portion of the building was probably built just after the turn of the century; the rear addition appears to have been built around 1979. The south half of the brick portion of the building appears to have built in the 1930's, I believe.

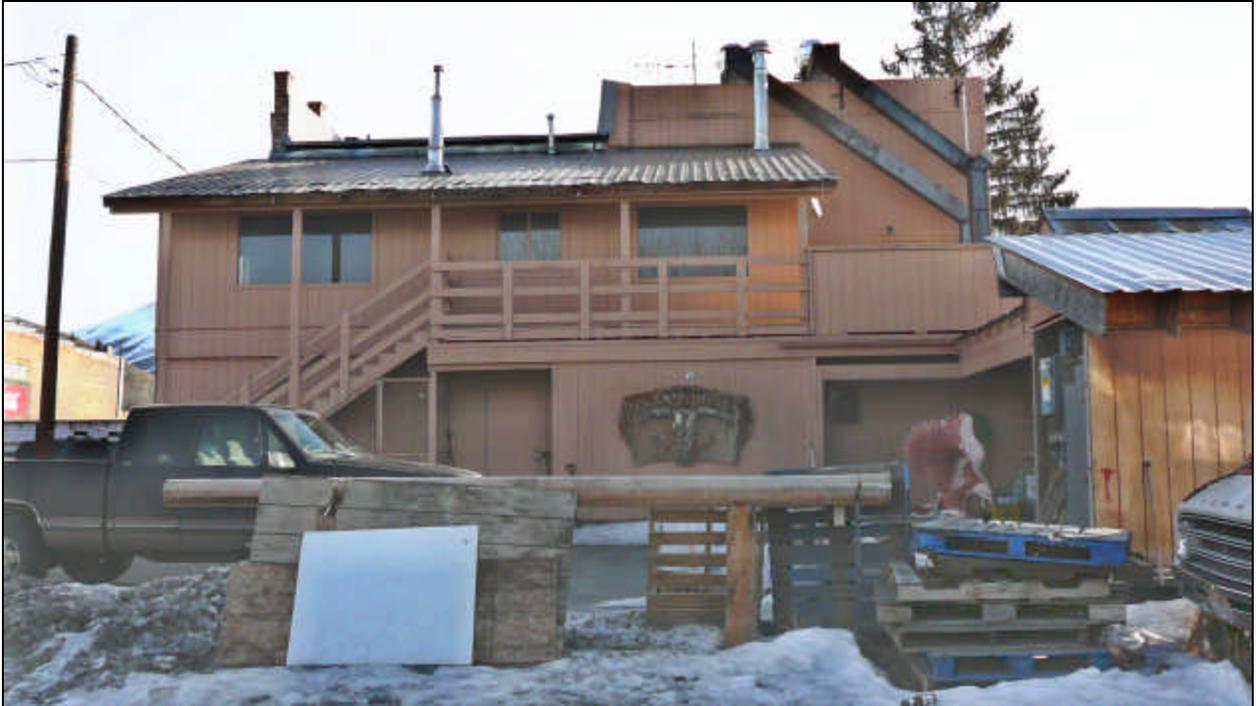
2. This is the rear of the building. The roof in the right foreground is over the box bailing machine.

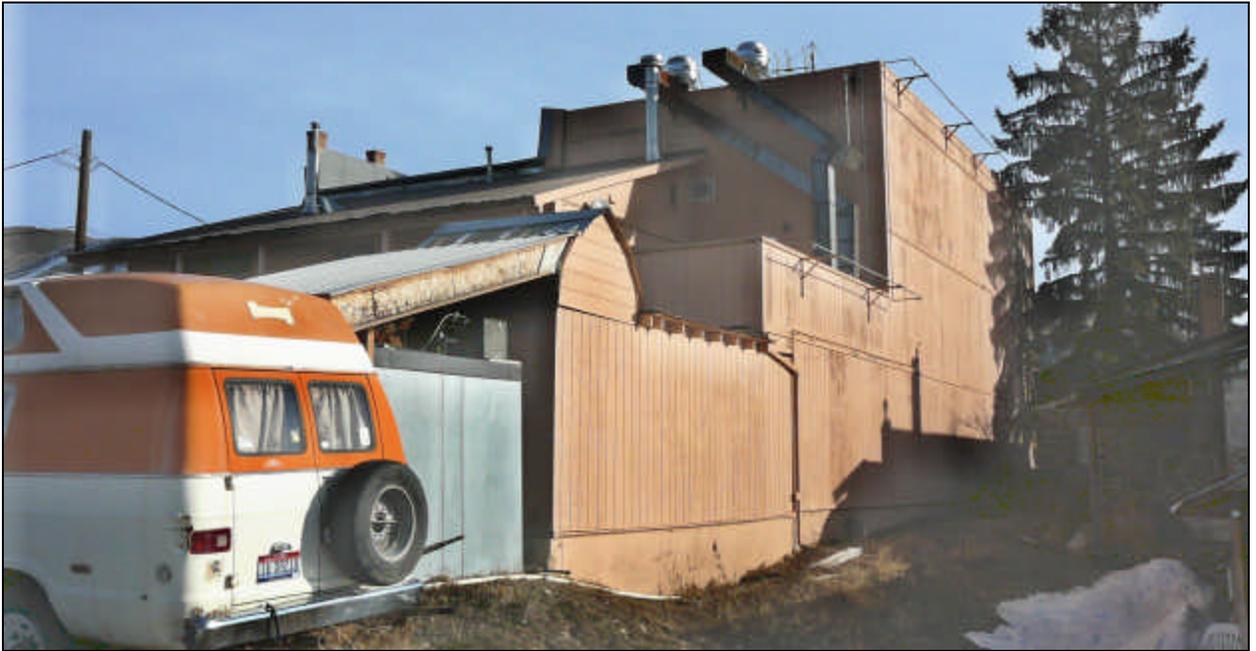
3. This photo is of the left (south) side of the building, taken from the rear.

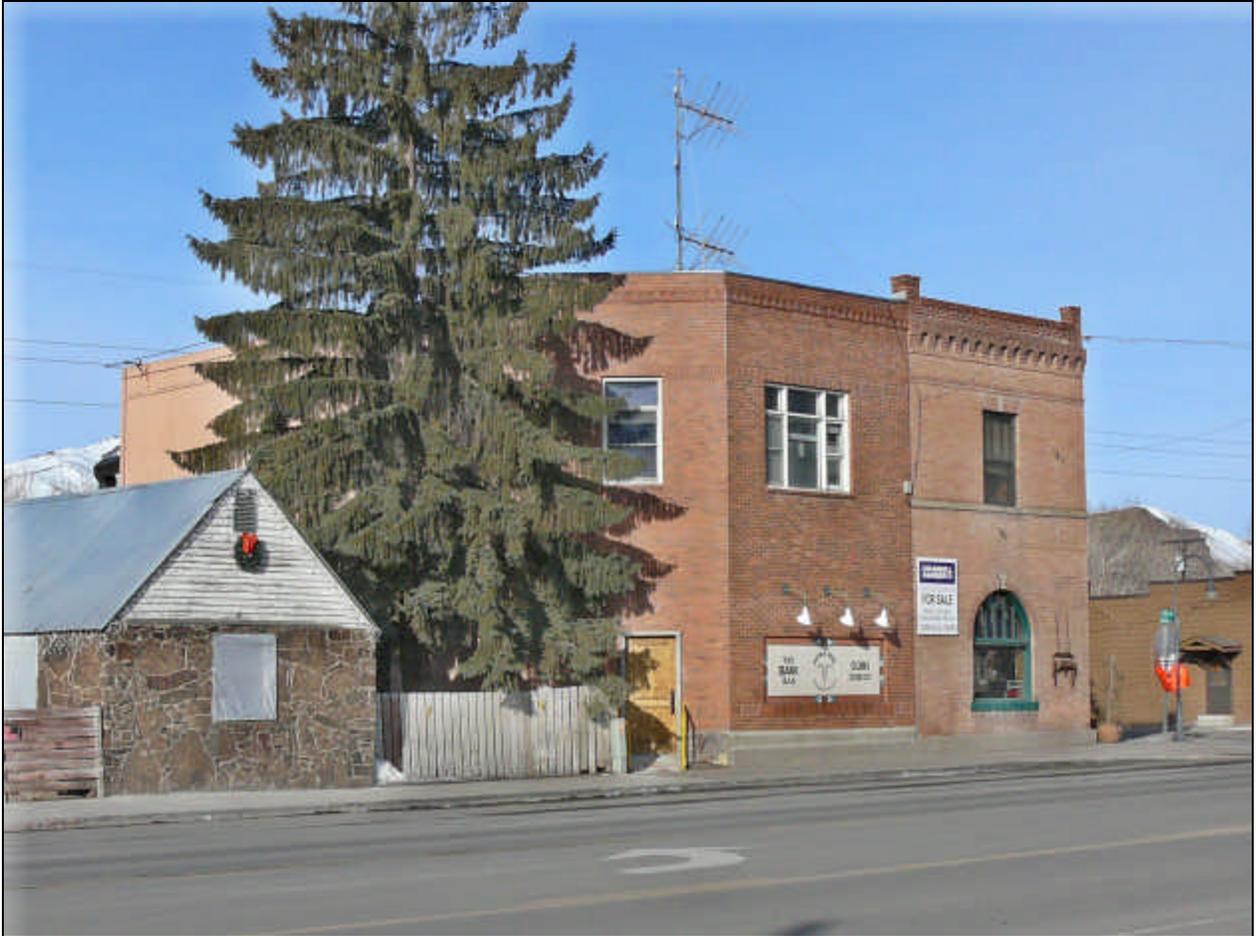
- This photo is of the front and left side of the building, taken from across Main Street. (The photos showing this building from all angles that customers might approach strike me as being rather devoid of signage that might help perspective patrons recognize that this building houses one of the state's best Mexican restaurants. At this time, the Coldwell Banker real estate sign makes a larger statement than the restaurant sign.)

The photo, above, also shows that the right half of the building was built a number of years before the left half. (Actually, there is a structural brick party wall down the center of the present property that once separated the building.) The style of brickwork in the left half indicates a construction period closer to the 1930's

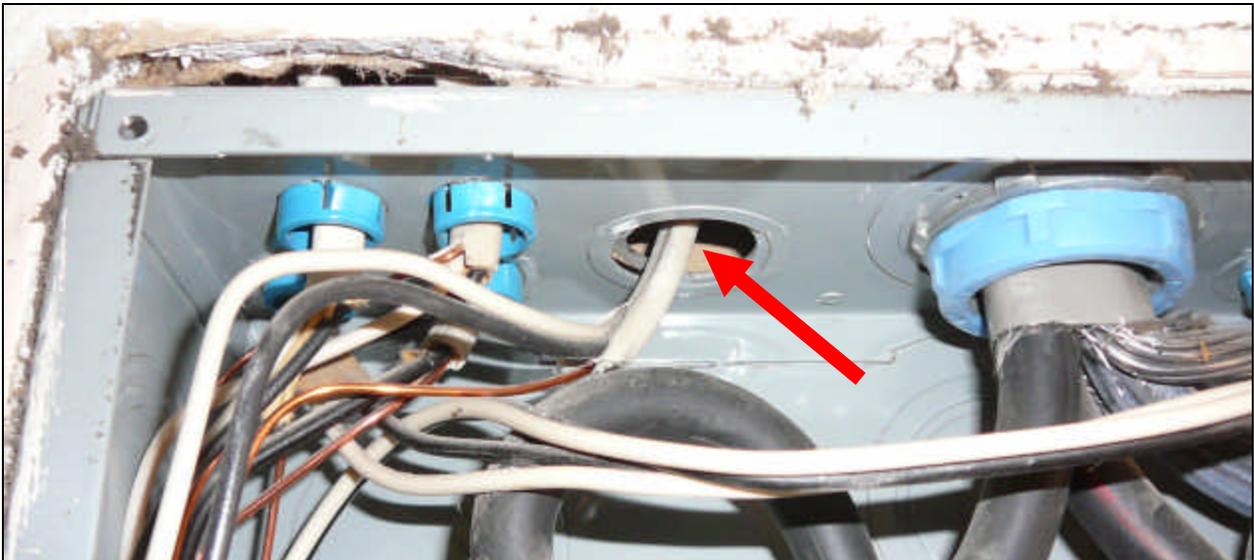
10. A branch circuit has been inappropriately added from the distribution panel across from the kitchen of the upper rear apartment. The photo, below, shows the Romex® - style cable leaving the panel without a required clamp bushing. This indicates work done by someone other than a qualified electrician. A qualified electrician should address and/or correct this issue, as necessary.

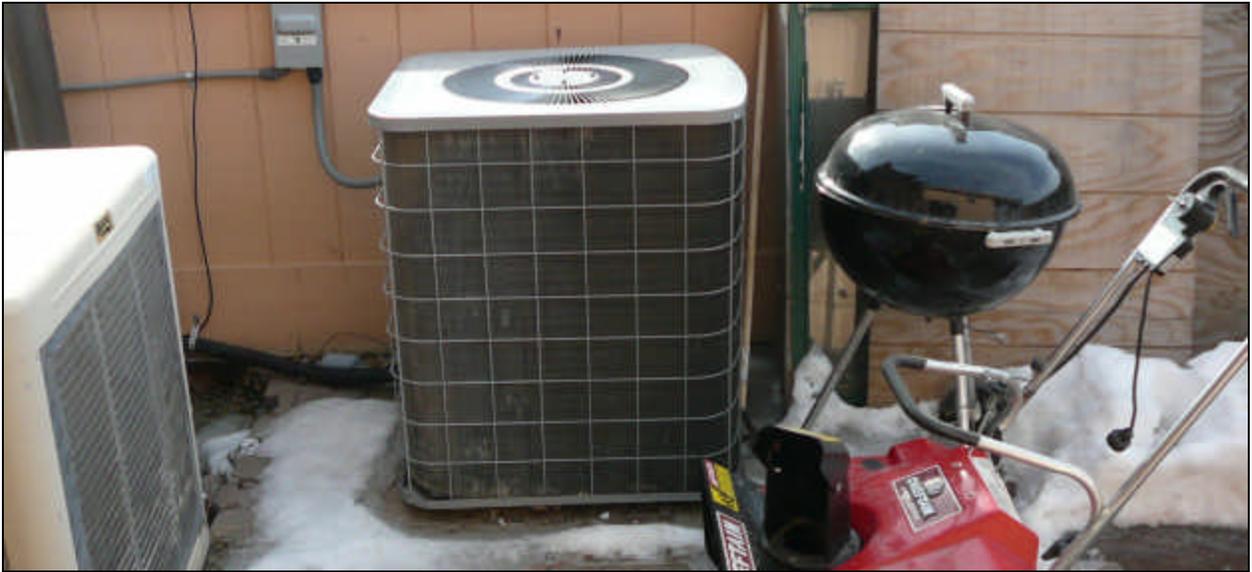
19. The air conditioner compressor unit sitting on the balcony of the upper rear apartment appears to serve the apartments, in general (although I was not able to verify this). I believe it is associated with the natural gas furnace found in the small

closet south off the landing area of the interior stairway. NOTE: I did not attempt to operate this compressor unit, as the outside air temperatures were too cold. This is a 5-ton compressor unit with a 2003 manufacture date.

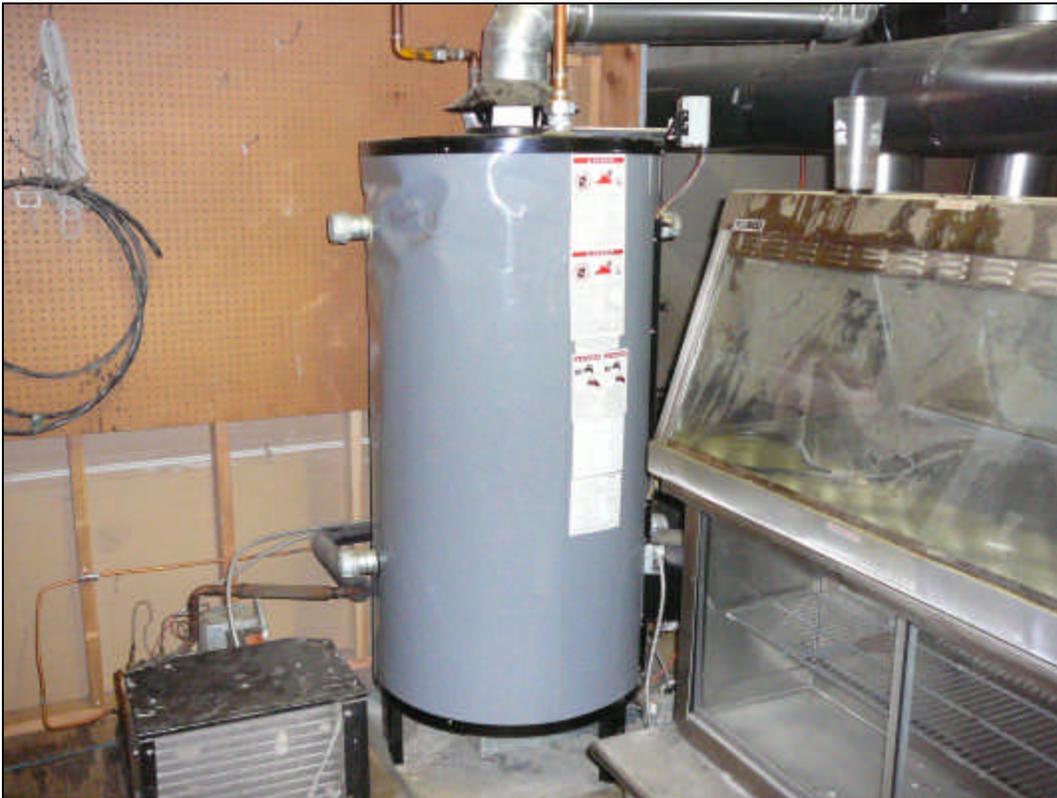
23. The following photo shows the 100-gallon natural gas water heater that seems to supply hot water for the restaurant and the apartments. (I believe this water heater recently replaced several other electric water heaters.) It has a year 2002 manufacture date indicated on it labels.

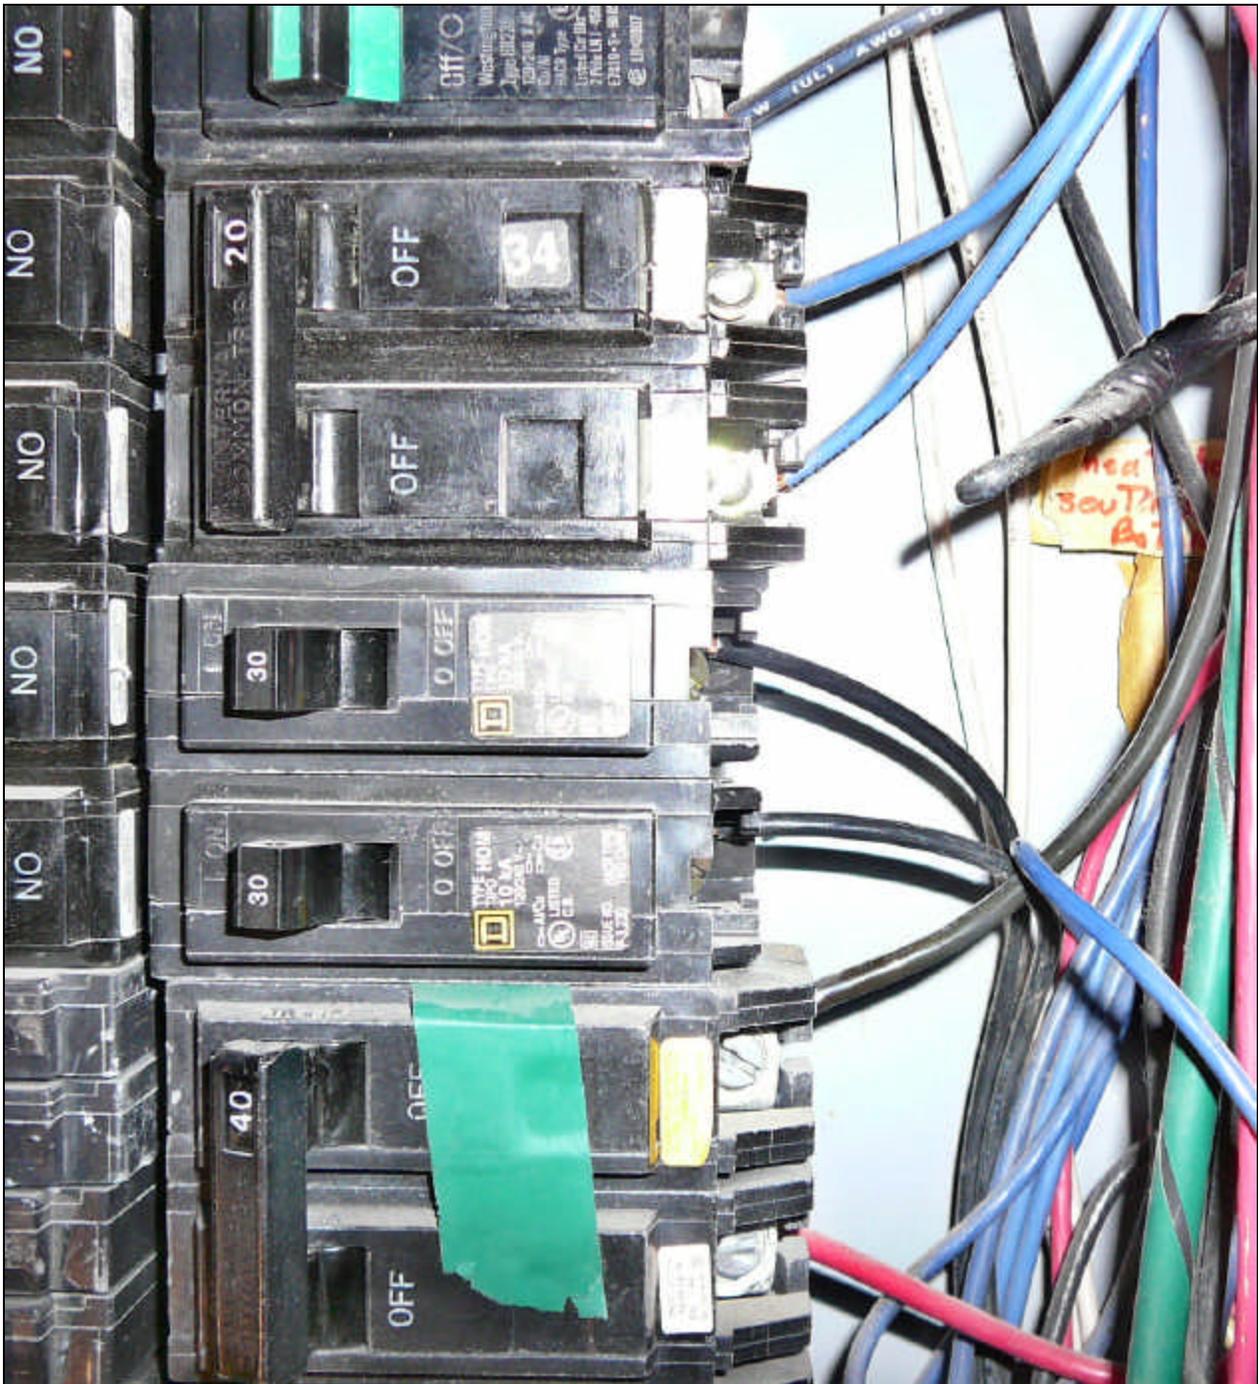
36. The two 30-amp circuit breakers in Panel #1 shown in the photo, below, feed 12-gauge branch conductors. A qualified electrician should address and/or correct this issue, as necessary.

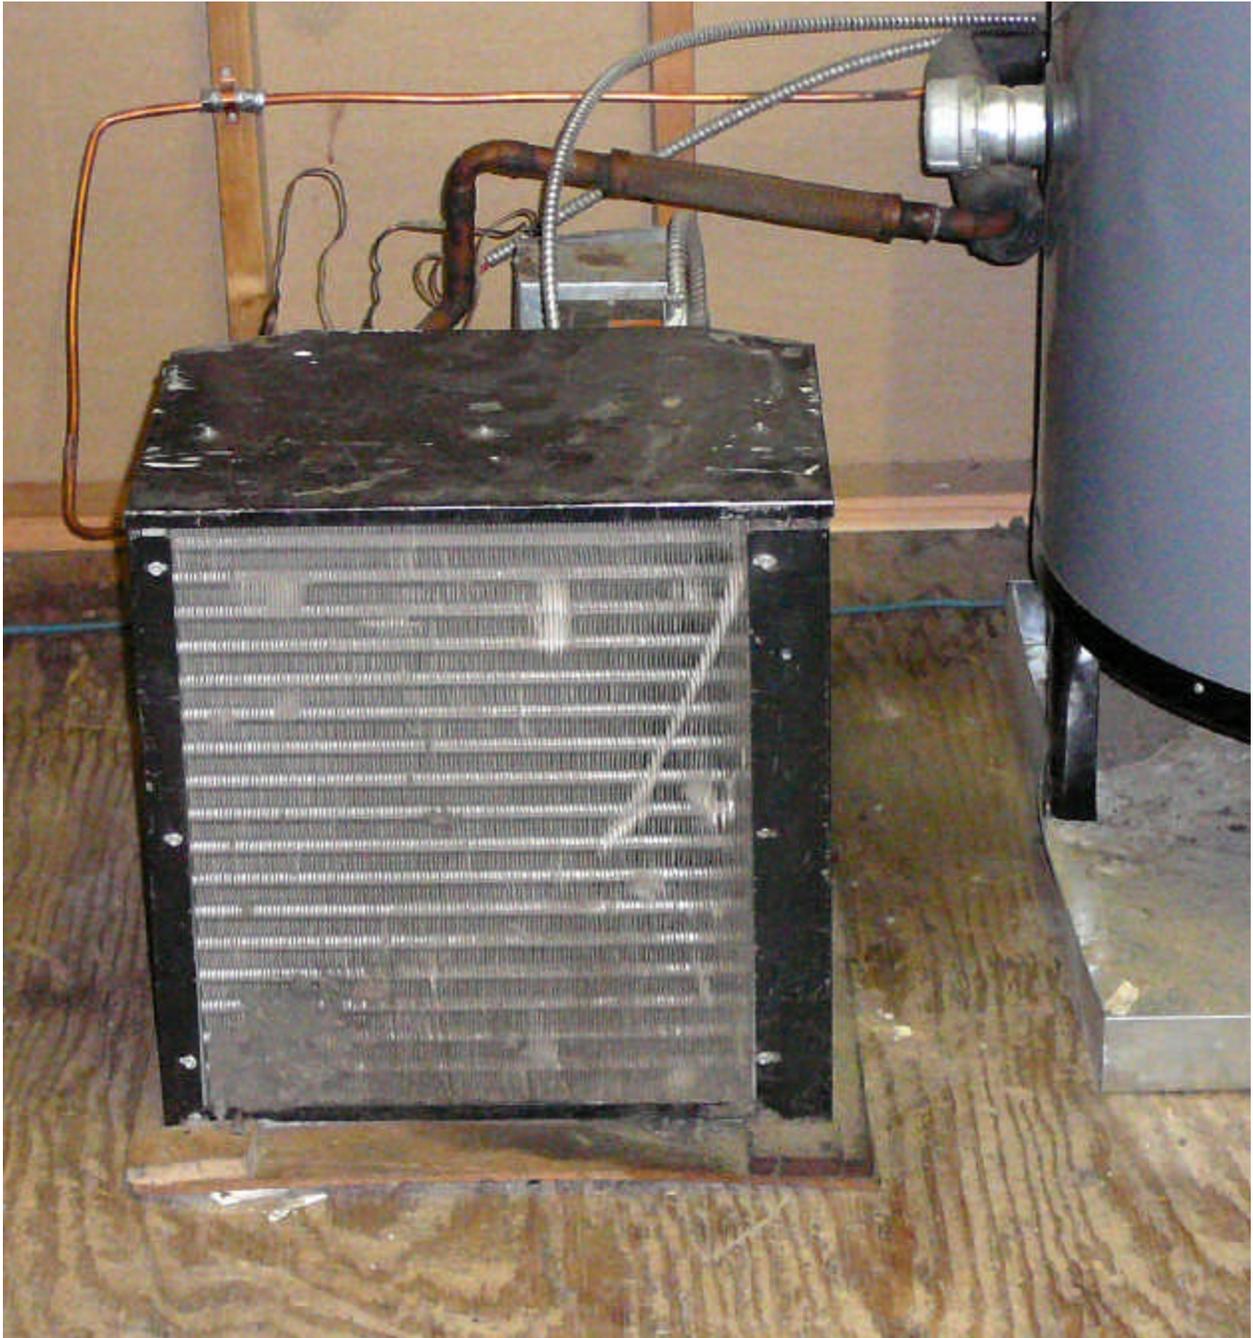
37. The compressor unit on the floor of the HVAC room near the water heater has dust accumulated in its fine metal fins. This will soon begin to lower its efficiency and shorten the life of the compressor. I suggest having this (and all other similar compressor units) serviced at this time and at regular intervals, hereafter.

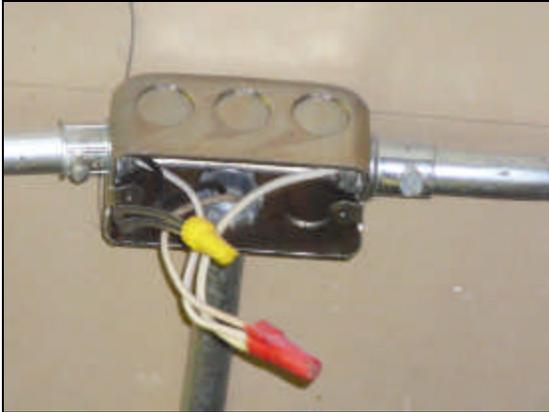
40. The following photo shows an open junction box on the ceiling of the HVAC room. A qualified electrician should address and/or correct this issue, as necessary.

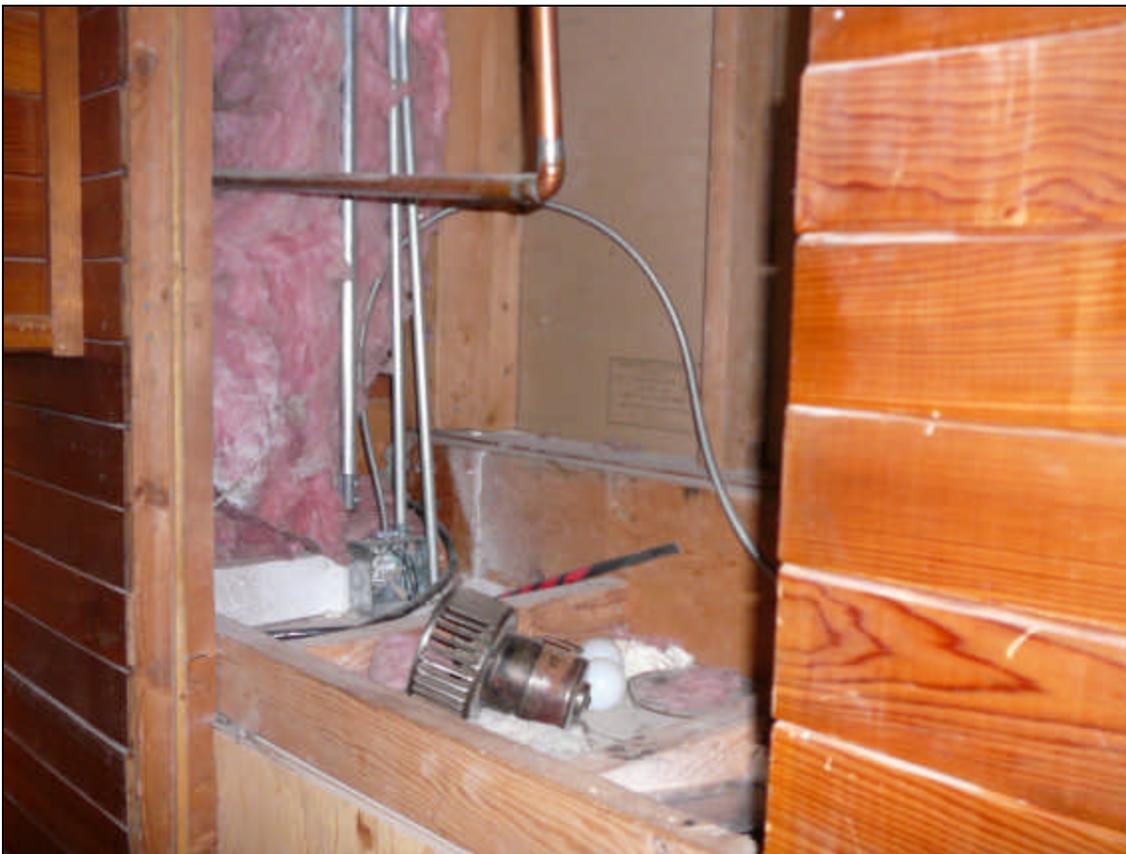
41. The following photo shows an open junction box in the cubby accessible over the stairs near the north central entry door to the building. This cubby is behind a hinge-down trap door in the east wall of the stairway.

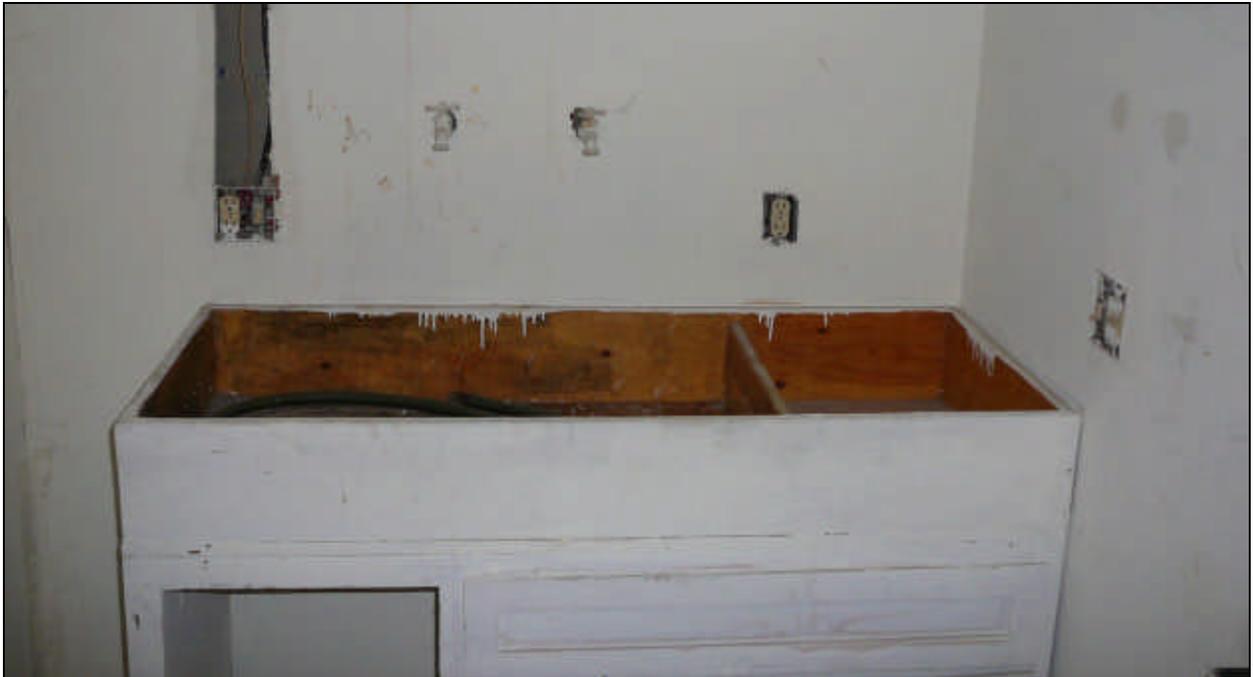
43. The “dark room” (now abandoned) over the mid landing of the interior stairway has numerous wall outlets and switches without cover plates.

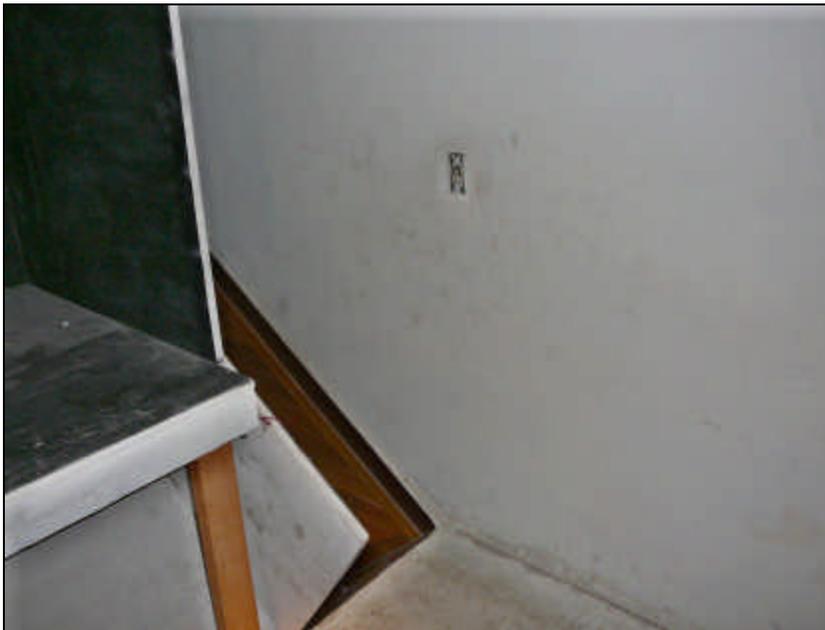
44. This photo was taken from within the “dark room”, looking back towards its short, open stairway back to the main interior stairway.

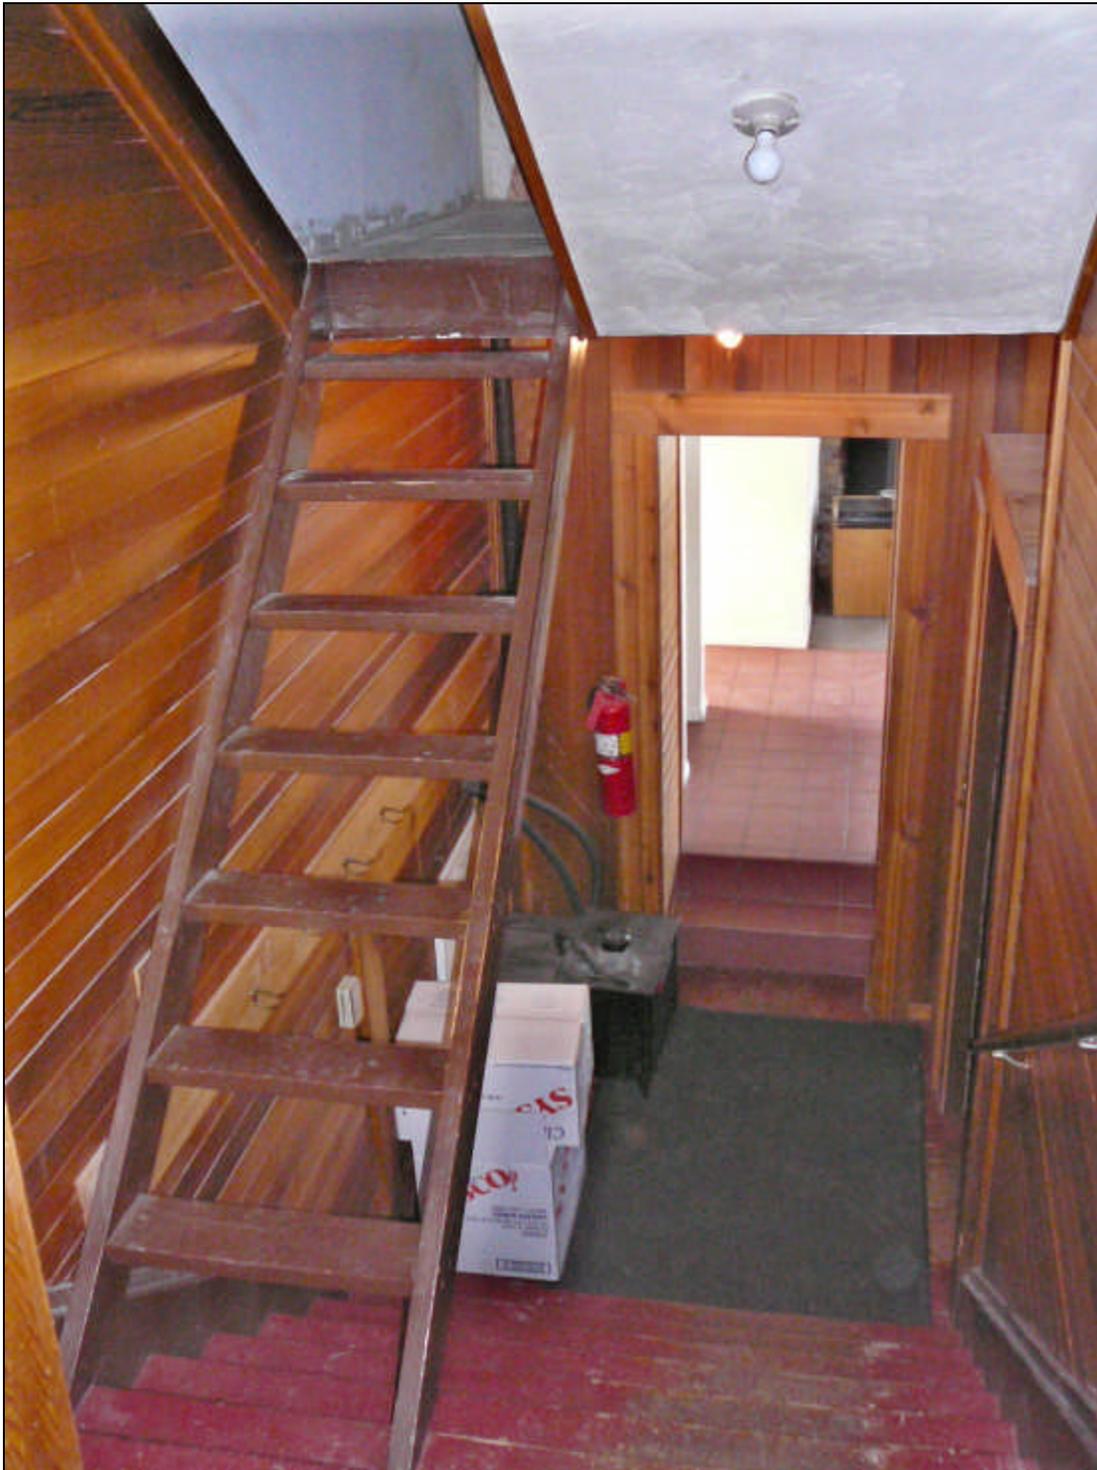
46. This photo simply shows the same stairway, from its lower end.

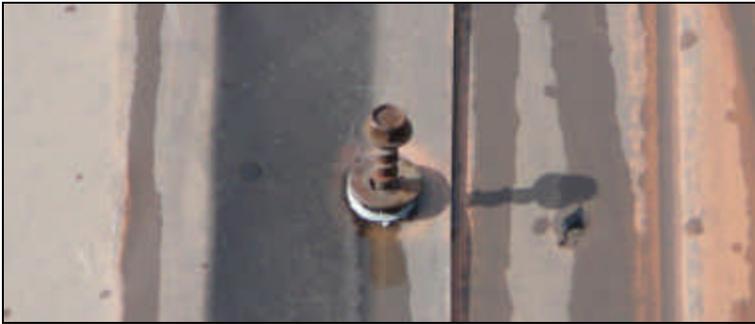
59. The sheetmetal roof covering over the rear addition of the building has numerous washer-head screws that are backing out, as shown in the following photo. I suggest resetting (or replacing) these screws annually.

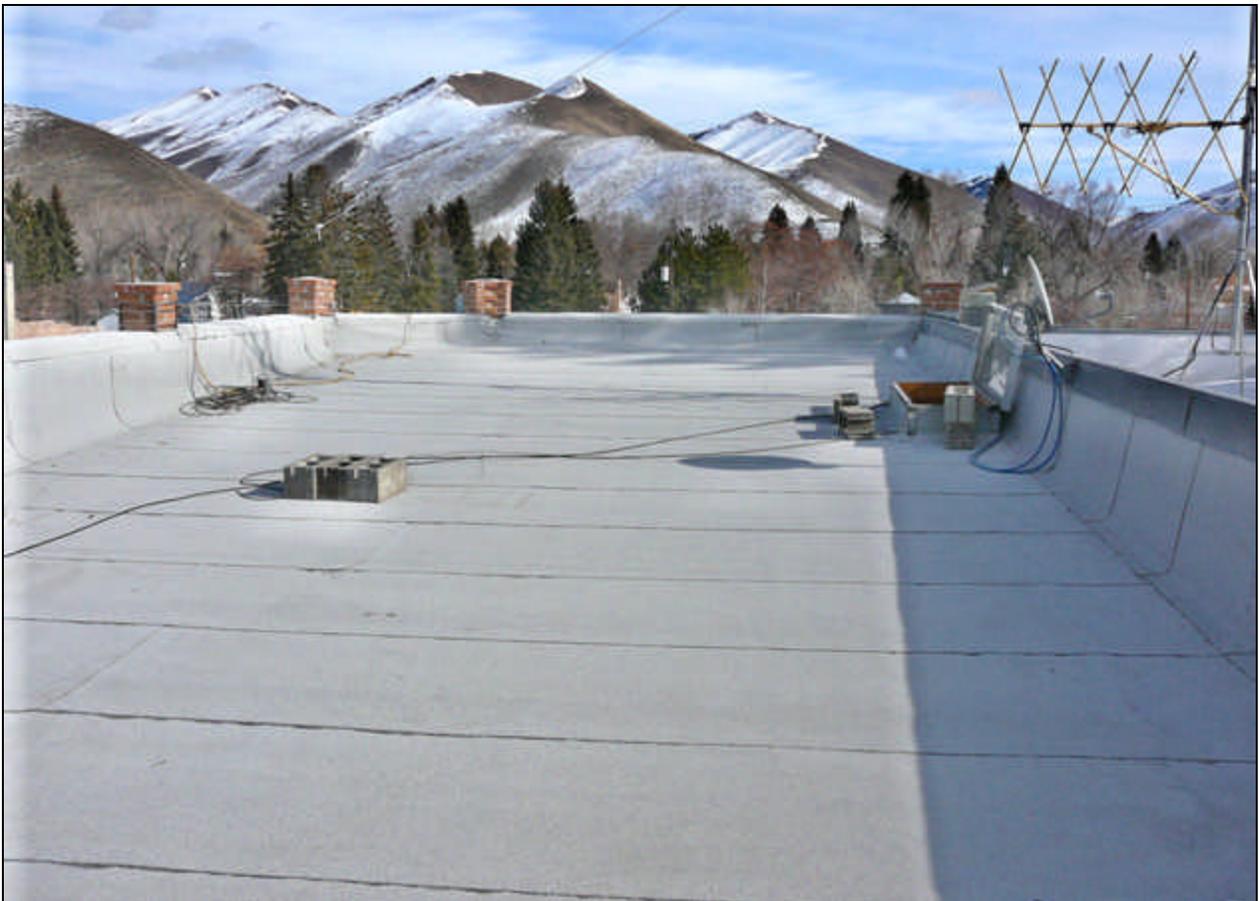
60. The following photo is of the north half of the rooftop, looking eastward. It shows a fairly new (about 6 to 7 years old) mineral-surfaced, modified bitumen ("torch-down") roll roof covering that was very expertly applied.

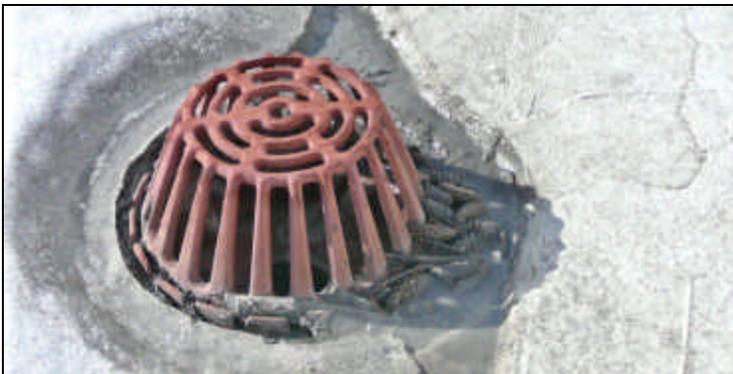
62. This south half of the rooftop has a number of drains, as shown in the following photo. These drains are connected to piping in the attic spaces that let the water out to the exterior.

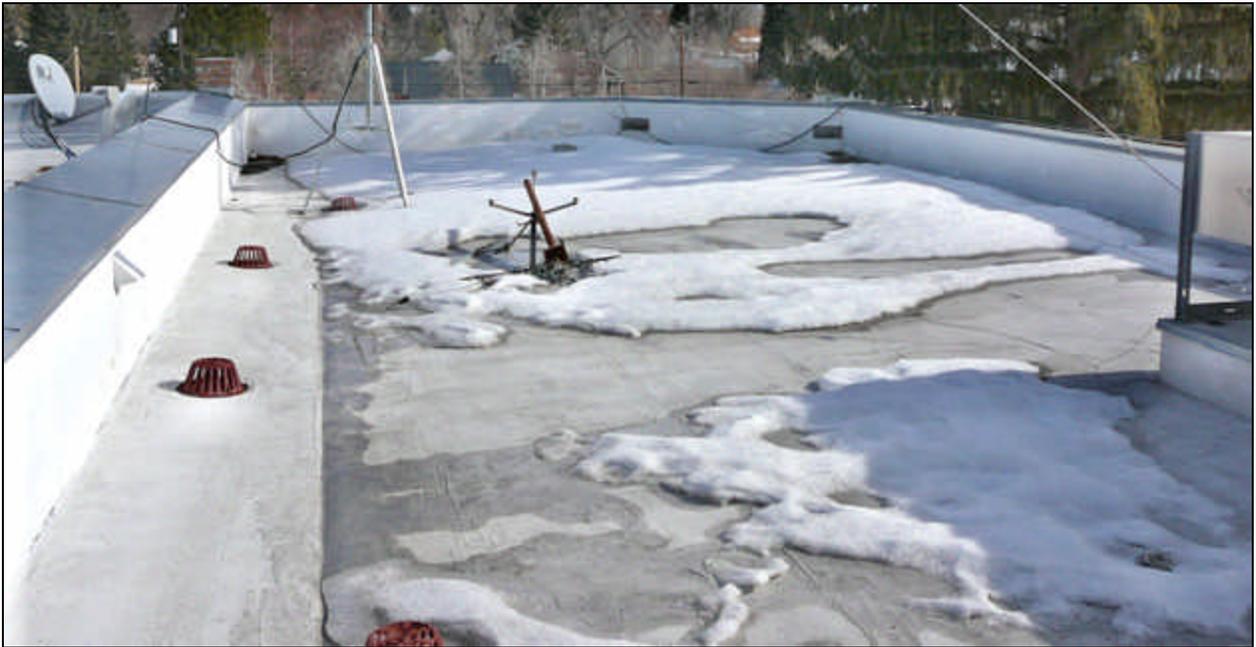
63. This photo is of the south section of the rooftop, looking eastward.

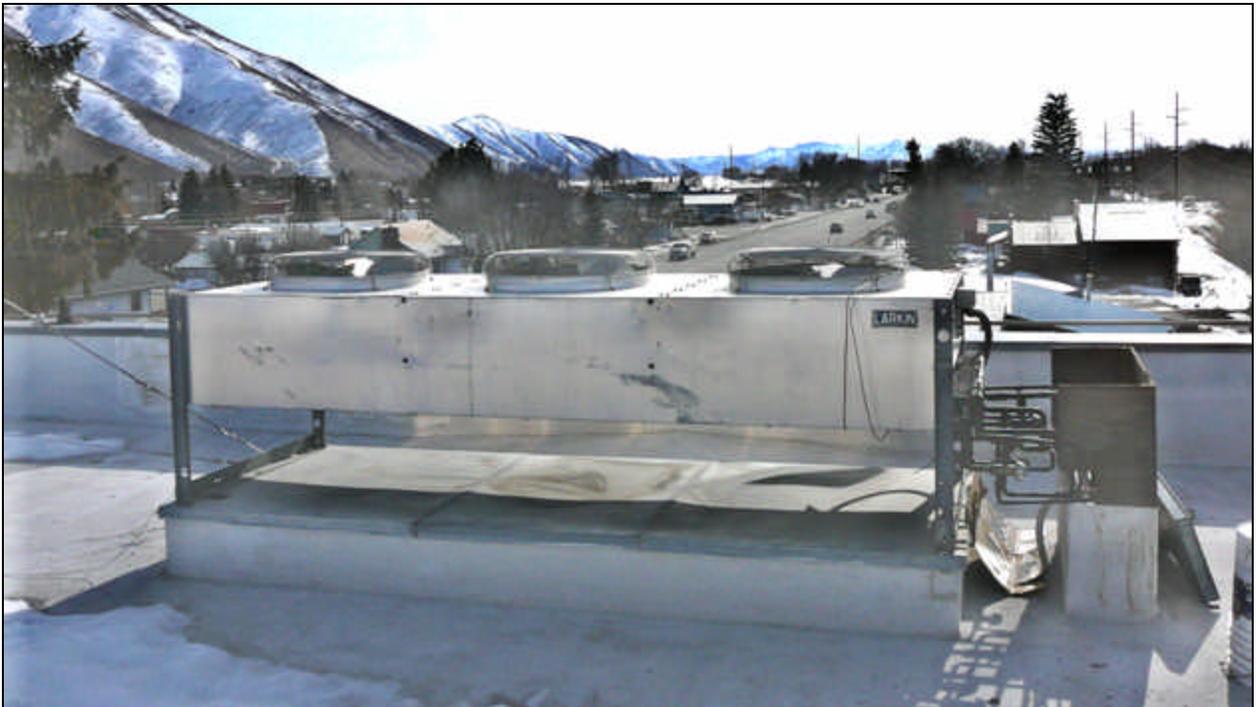
64. This photo shows a closer view of the cooling fans associated with the main HVAC air handler for the restaurant and bar.

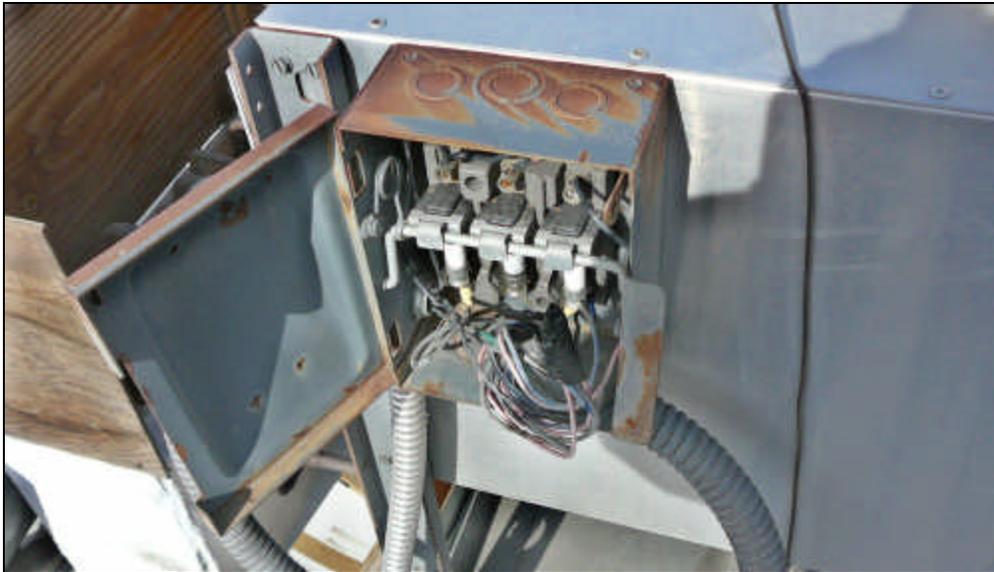
65. The local fused disconnect box for the cooling fans that are shown in the preceding photo is open, with wires hanging out. I suggest keeping this box closed.

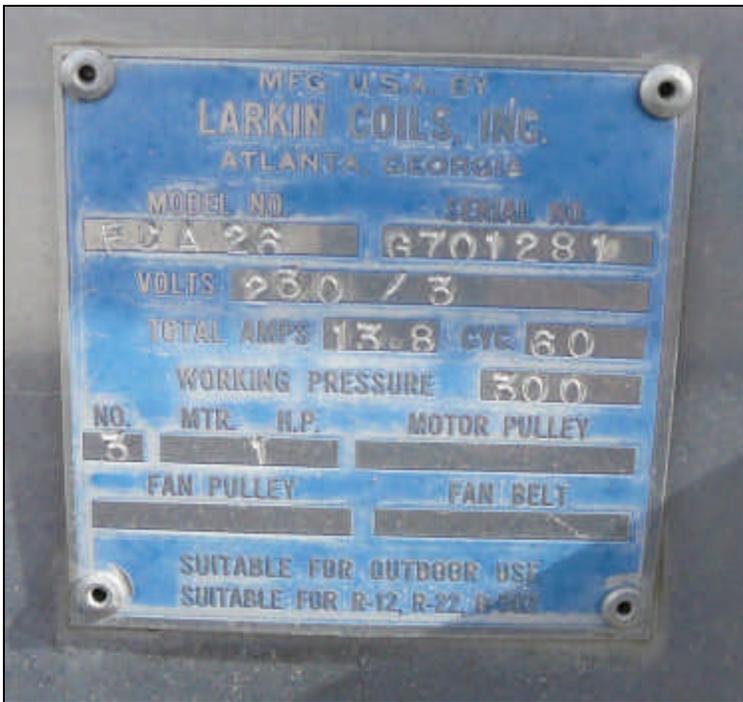
66. This is the nameplate on the exterior of the cooling coils that are shown in the previous photos. (This information may come in handy when communicating with HVAC contractors.)

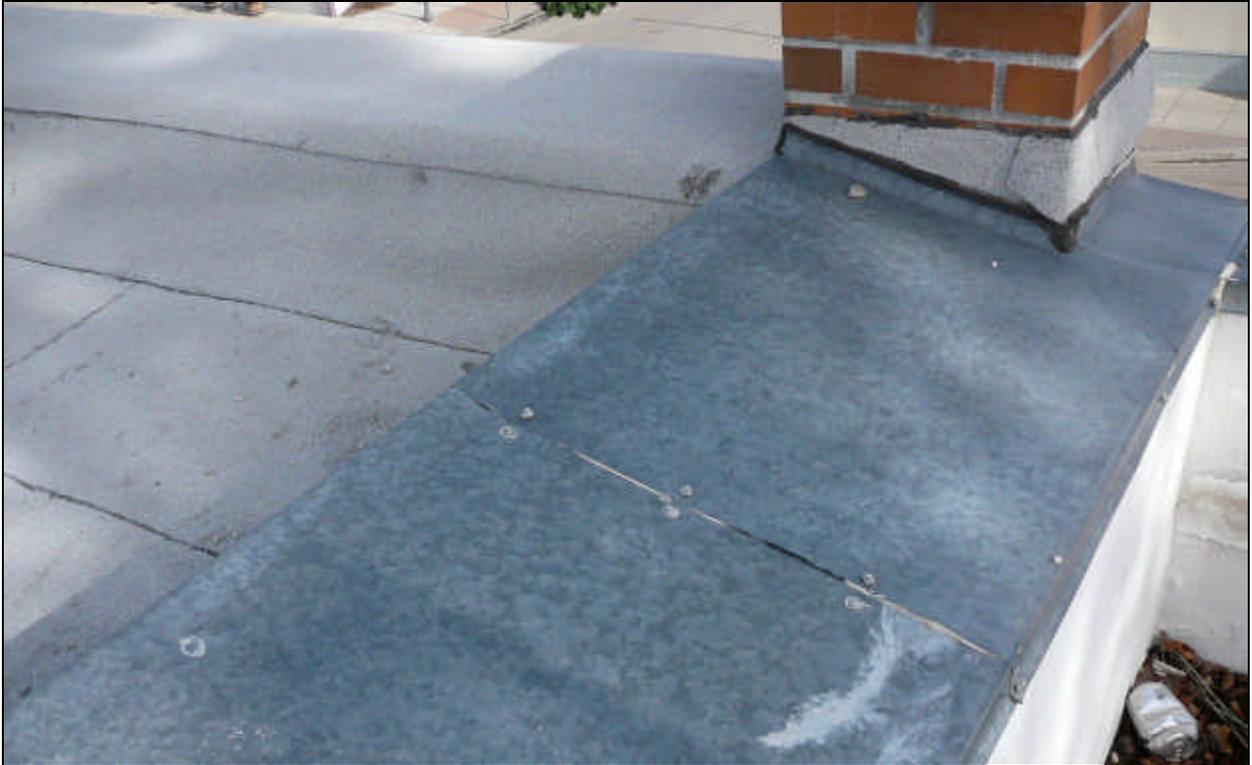
67. The parapet wall between the two original buildings has a sheetmetal cap with joints that need to be periodically sealed against water entry.

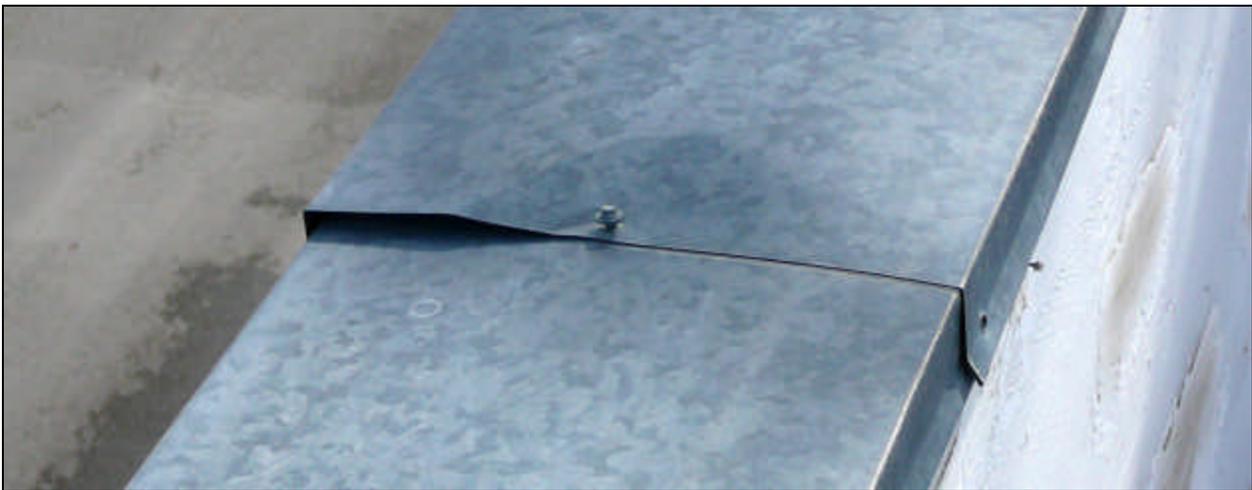
68. This photo shows yet another joint atop the parapet wall over the party wall between the two building sections. This joint must be kept sealed against water entry.

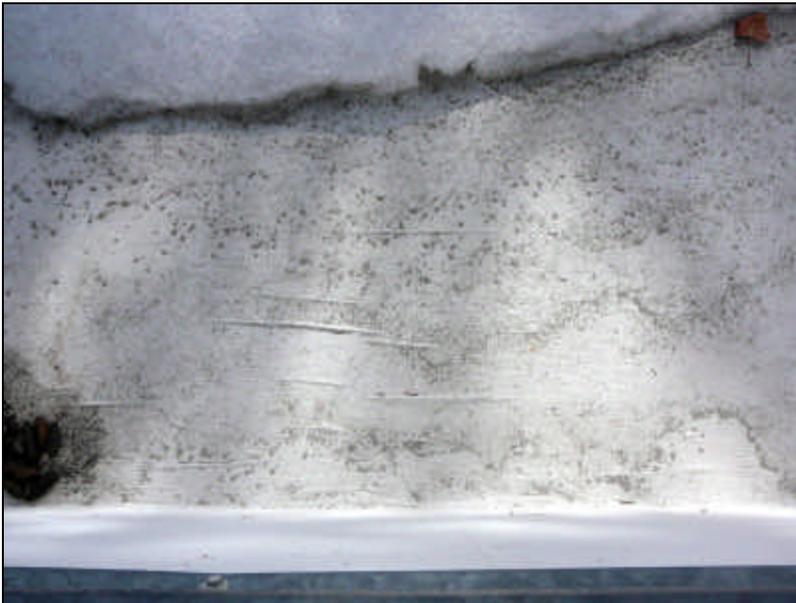
70. This photo shows a close-up view of a typical section of roof covering over the south half of the building.
