Commercial Inspection Report

**200 S. Main Street
Bellevue, Idaho**

Inspection Date: 02/10/2007

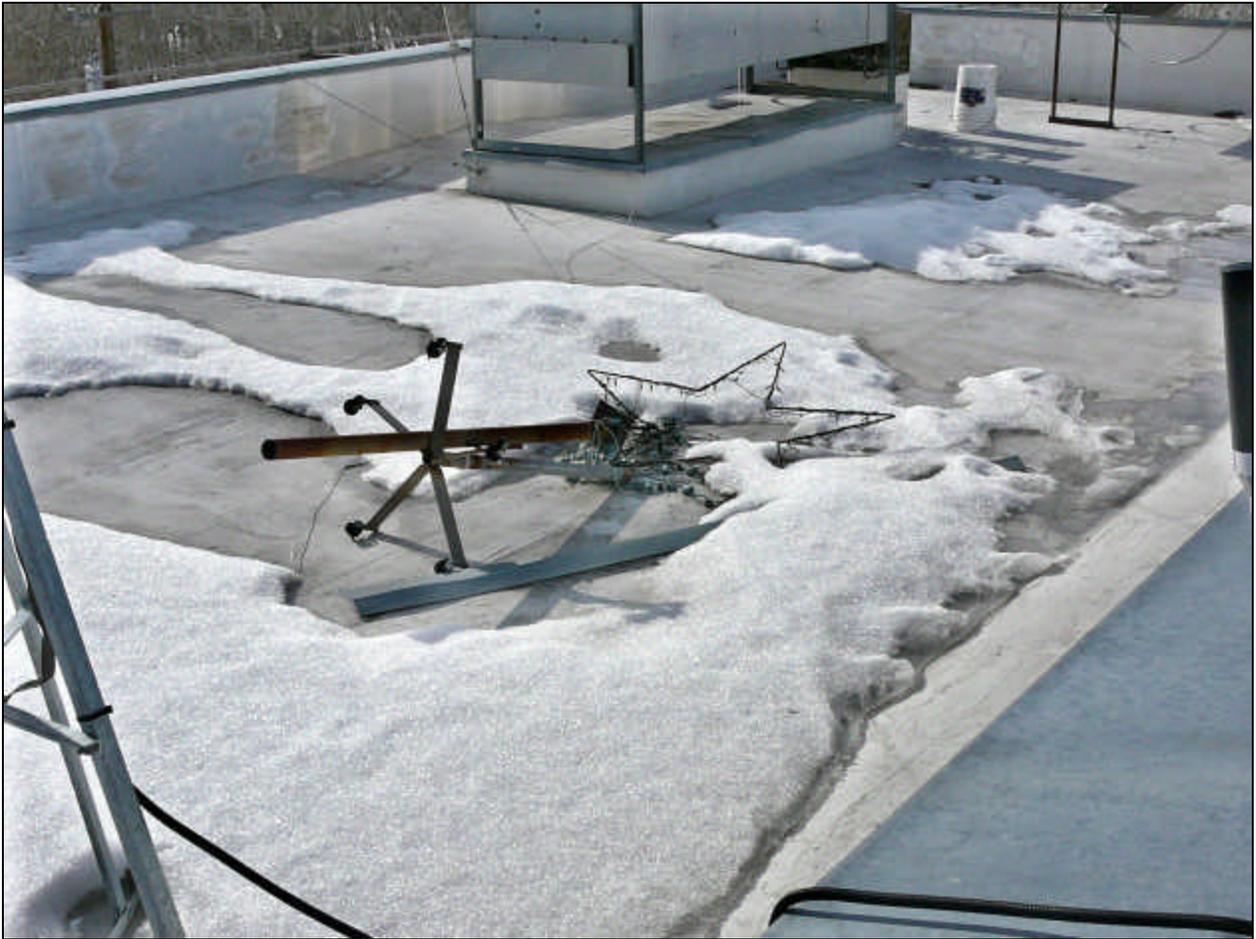
71. The abandoned steel tower that appears to have held holiday season lights was left atop the roof covering. I strongly suggest not allowing any objects with sharp edges to be left anywhere atop either of the two flat-sectioned roof.

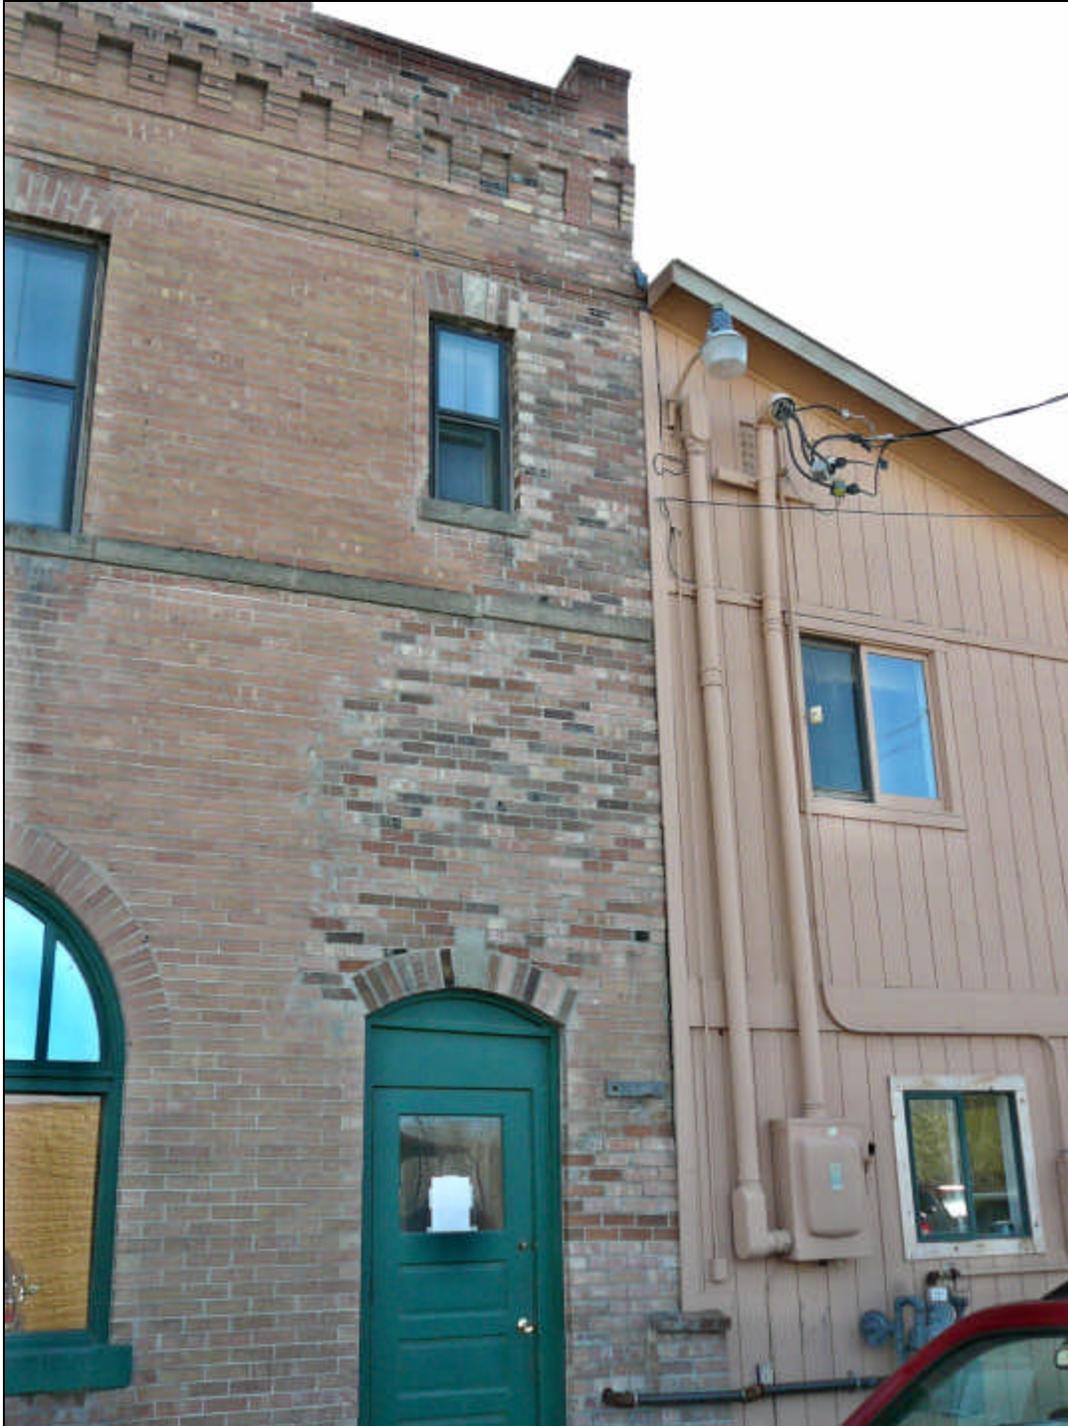
74. The following photo focuses in on the right rear (northwest) corner of the original building, where newer bricks were added in the past.

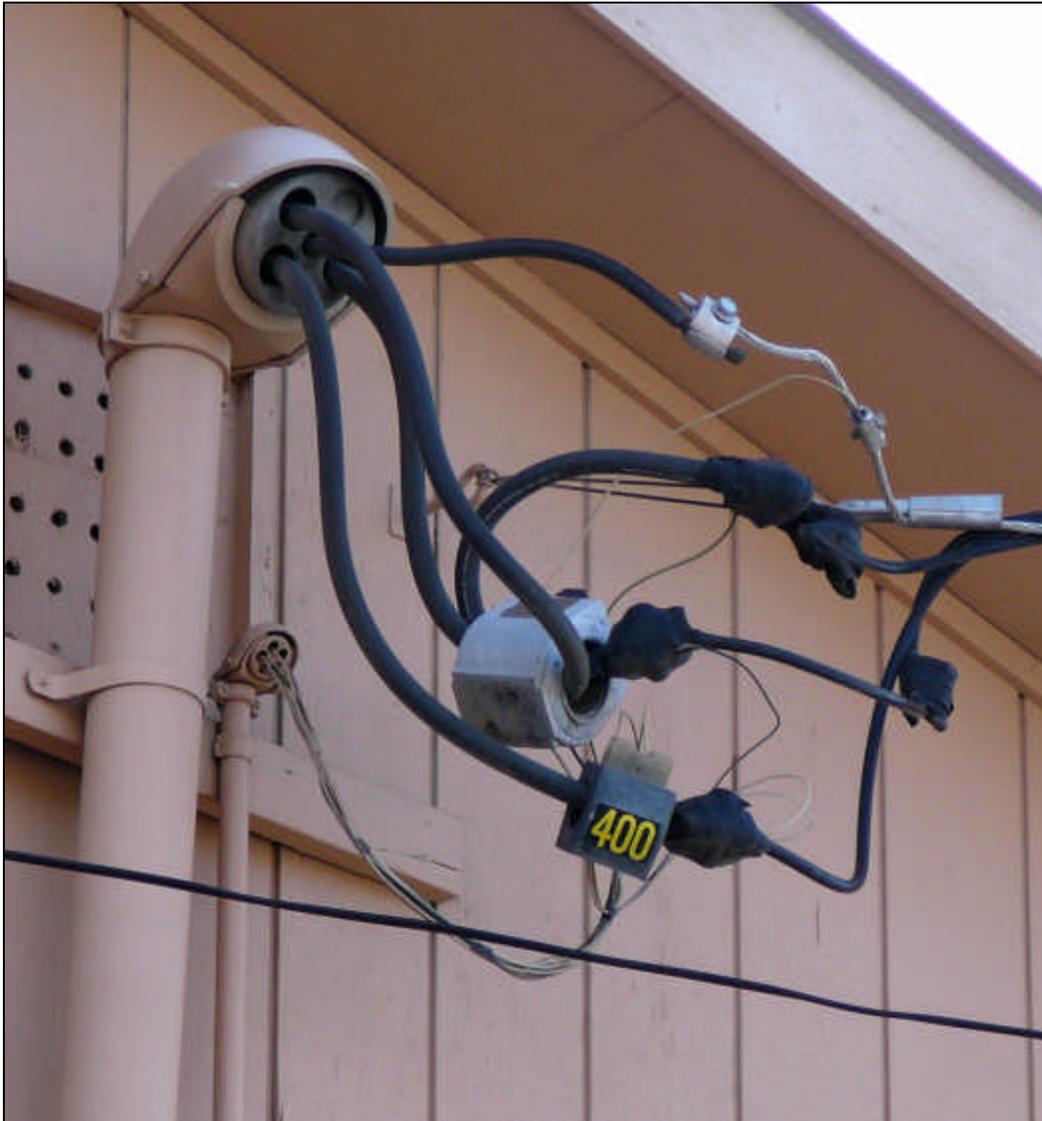
75. This photo shows the incoming overhead power lines from the nearby transformer pole, where they meet the weatherhead at the right rear corner of the older section of the building. (Note that this is a 400-amp overhead service drop.)

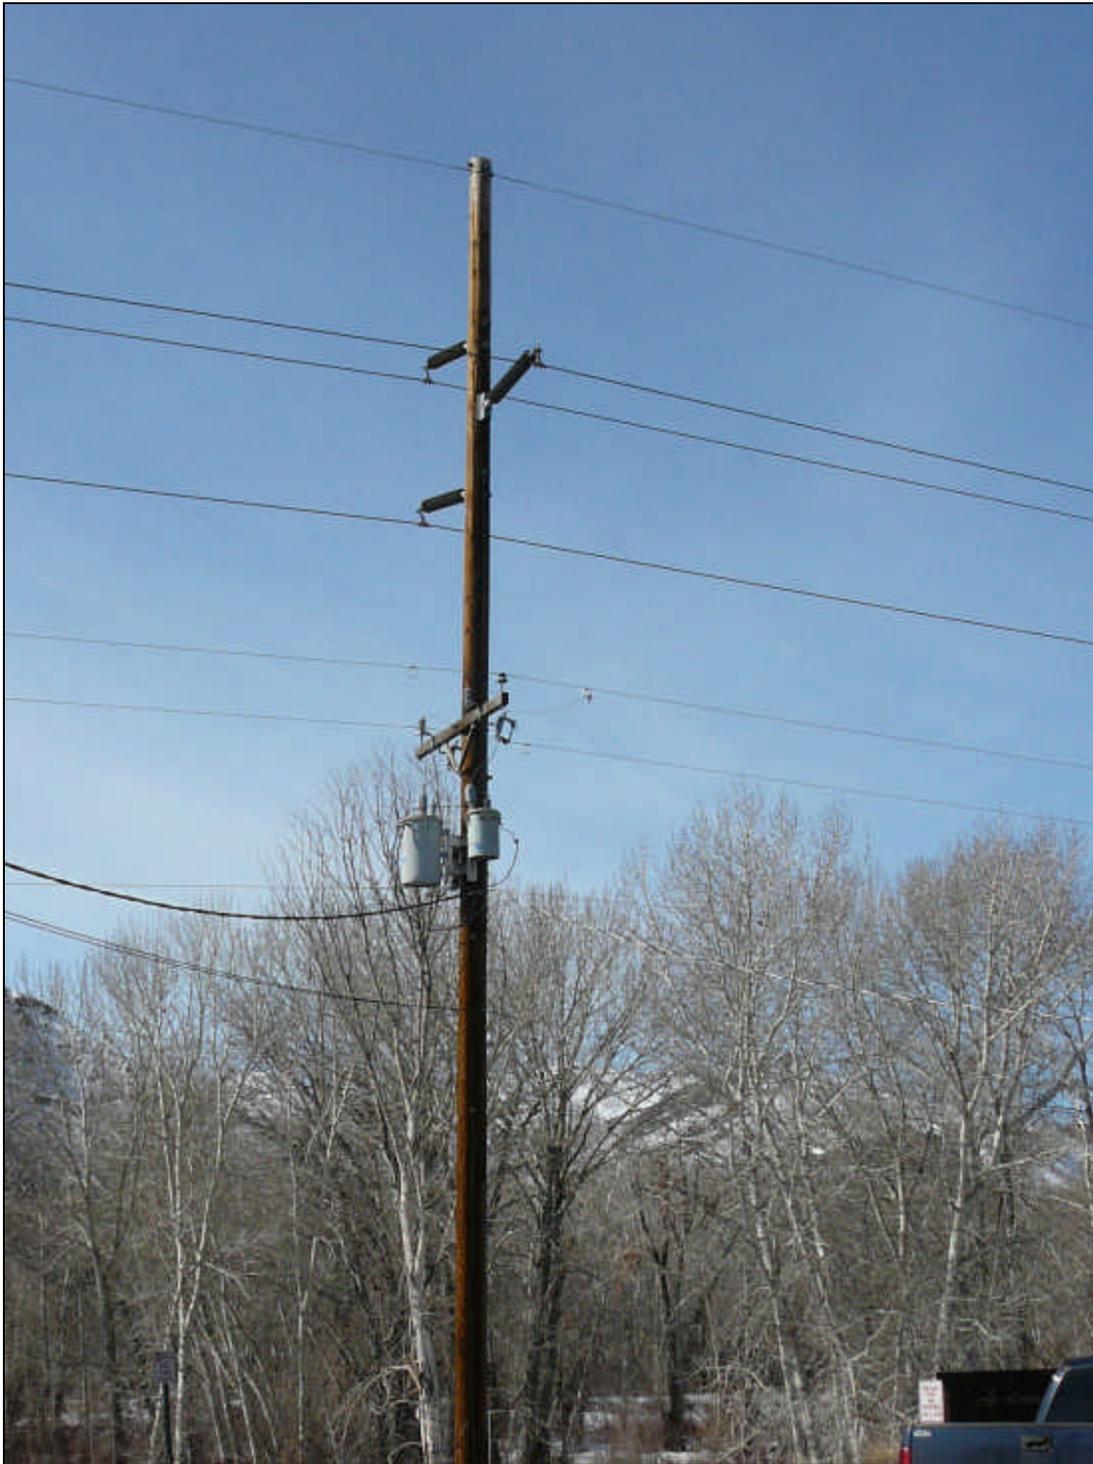
76. Power for the entire building is brought from the transmission/distribution pole about 100 feet northwest of the building's right rear corner. This transformer bank consists of a 50-kVA and an approximate 25-kVA transformer wired to provide the equivalent of 3-phase power to the building from the 2-phase overhead distribution line. The building is provided with 3-phase, 240-volt, open-delta power on Idaho

Power's Rate 9, according to the Idaho's PUC regulations.

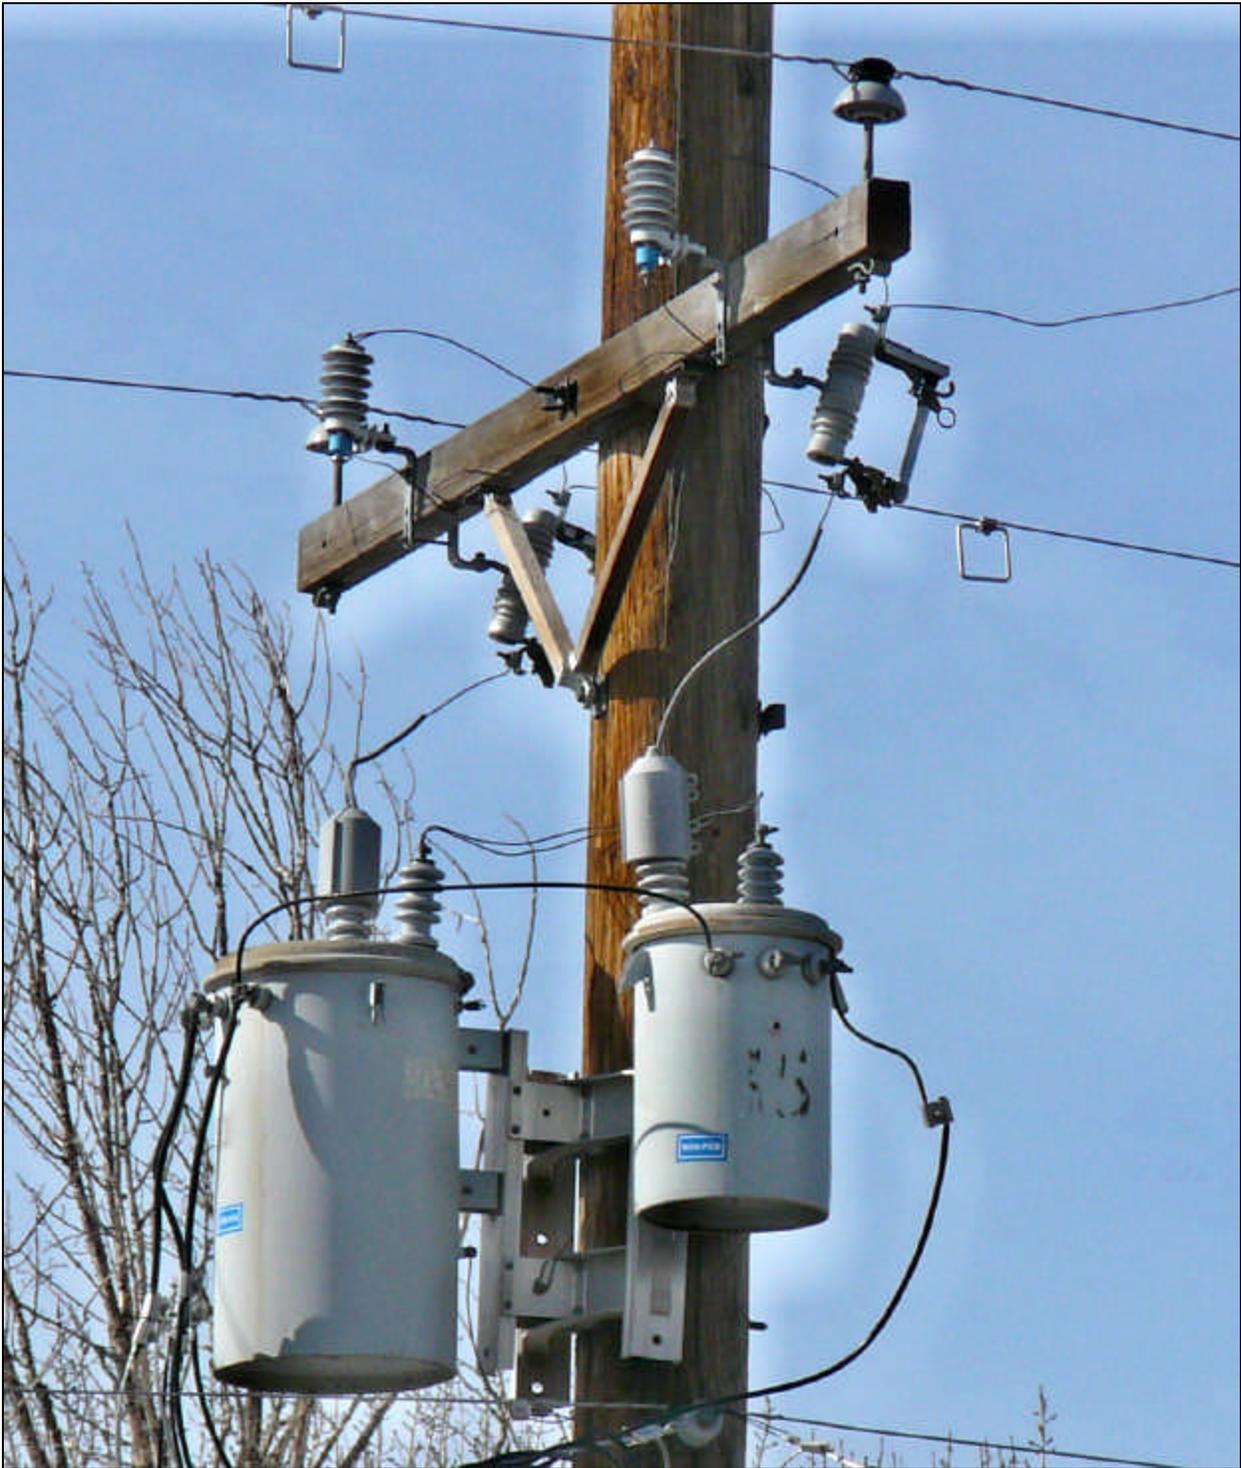
77. This photo shows a close-up of the two transformers that serve this property.

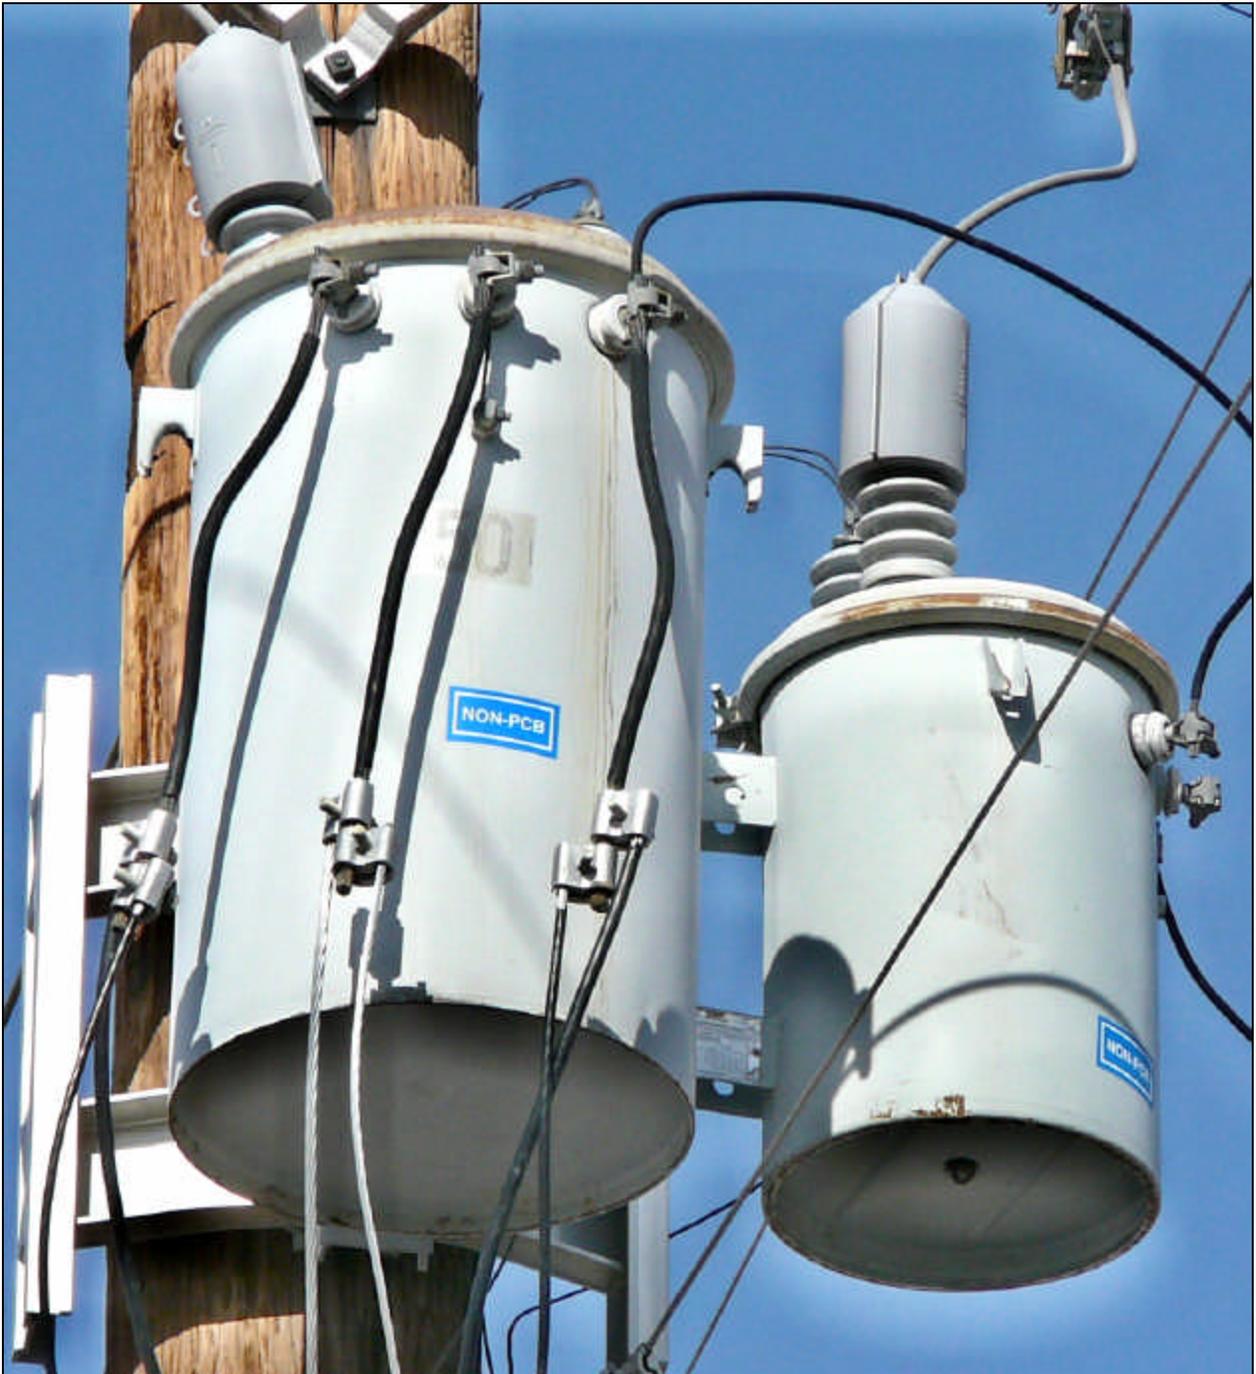
78. This is an even closer view of the transformers.

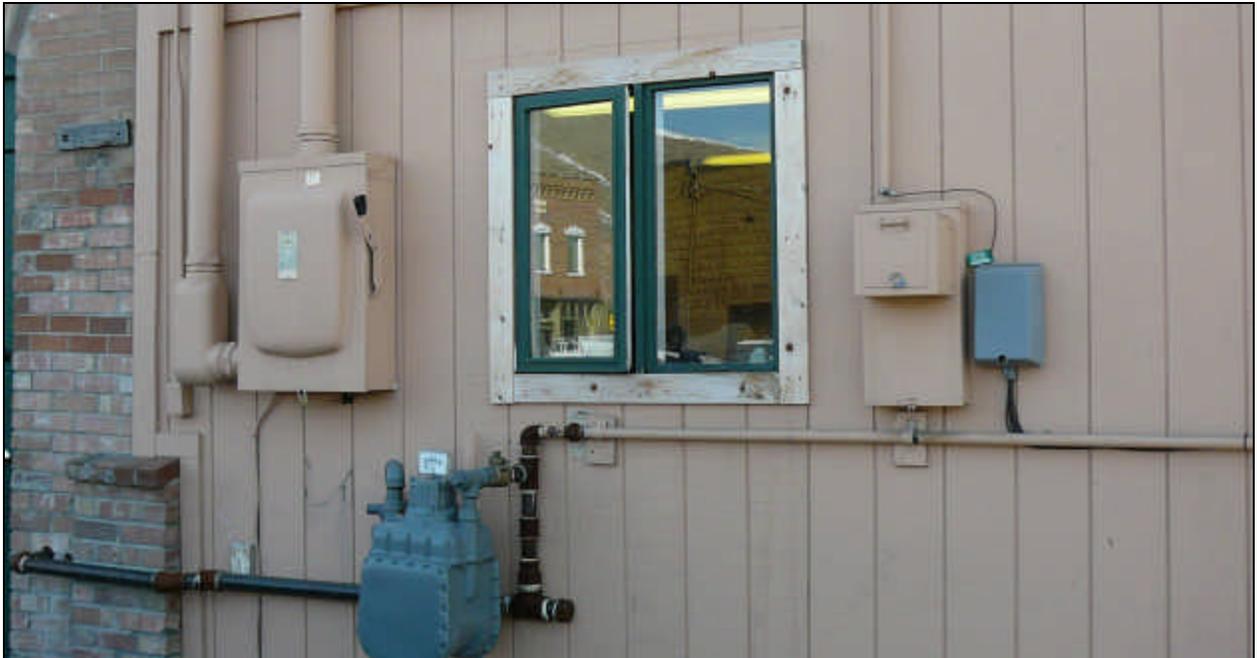
79. The overhead electrical power is brought down from the weatherhead into a 400-amp main switch in the large box left of the window in the following photo.

The CT-style electric meter (Current Transformer Meter) is in the box immediately to the right of the window.

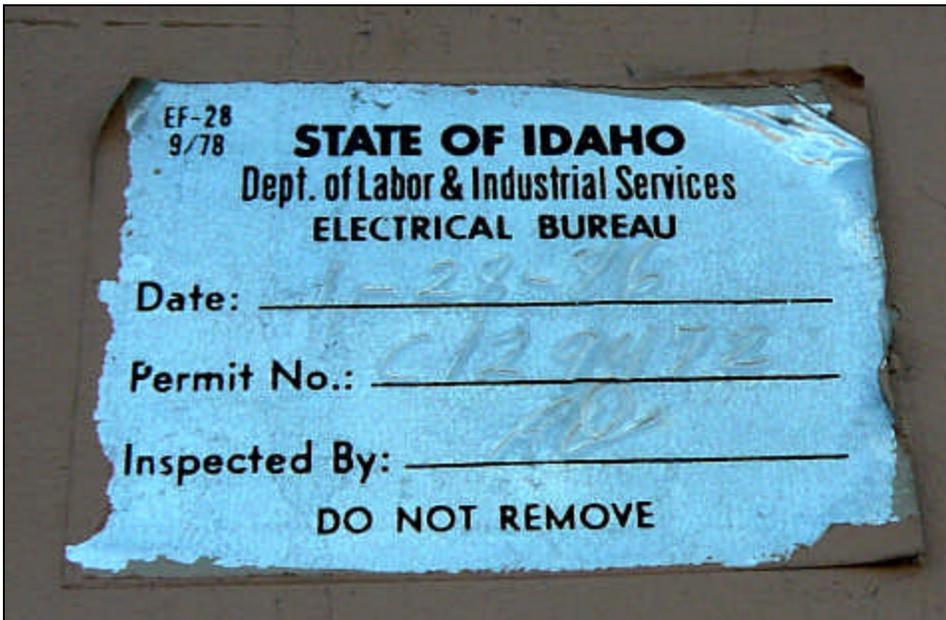
80. The code sticker on the front panel of the main fuse disconnect box is shown below. The date of the inspection indicates that the present configuration of overhead service was established in 1986.

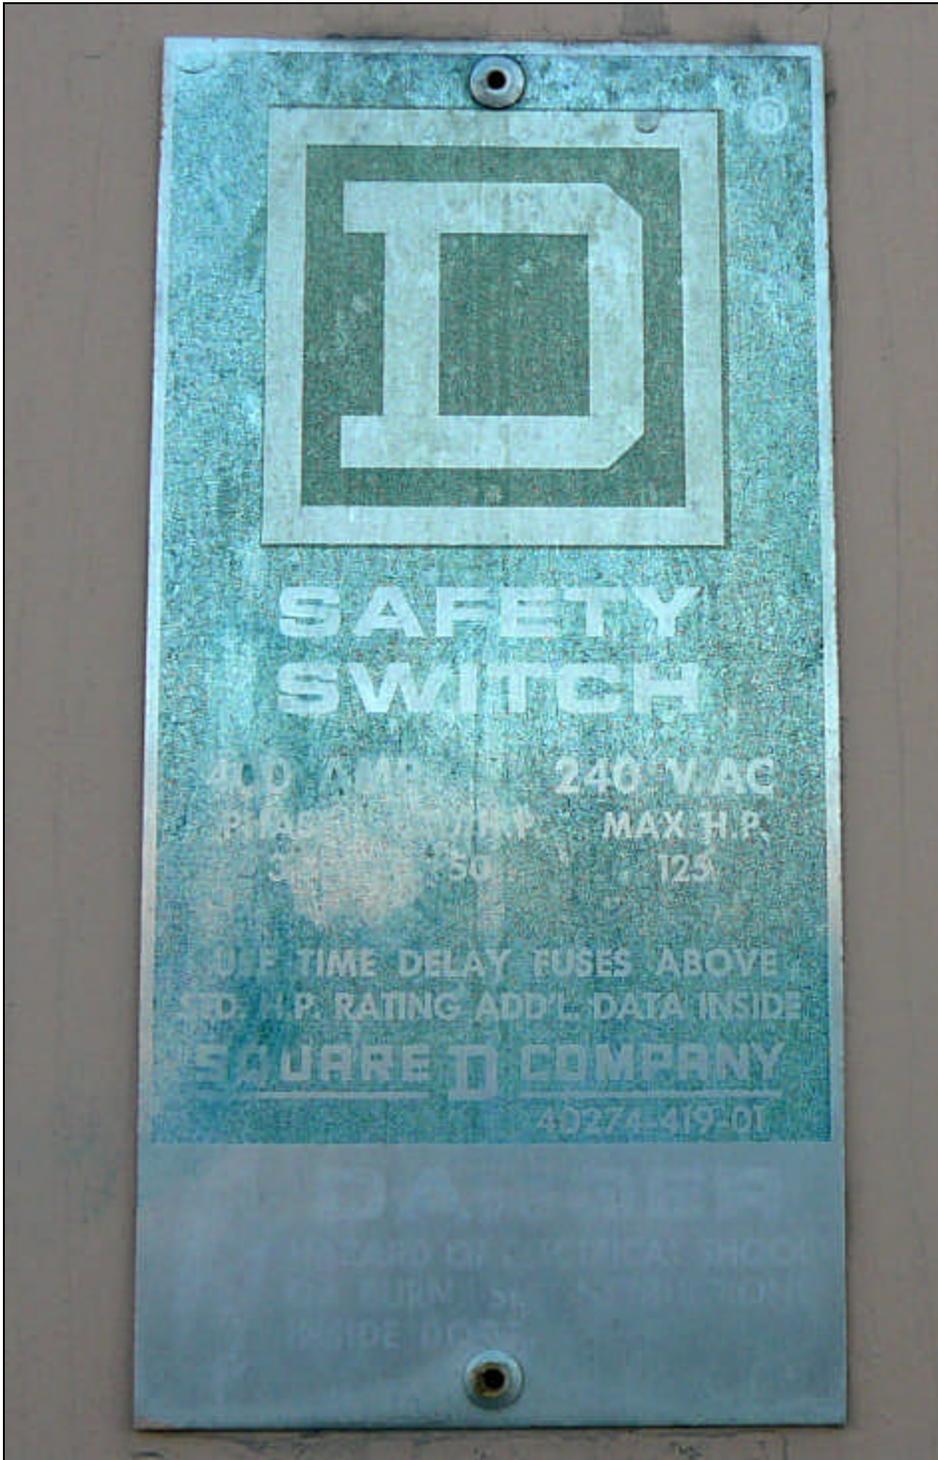
81. The following close-up of the main fused disconnect box shows its ratings.

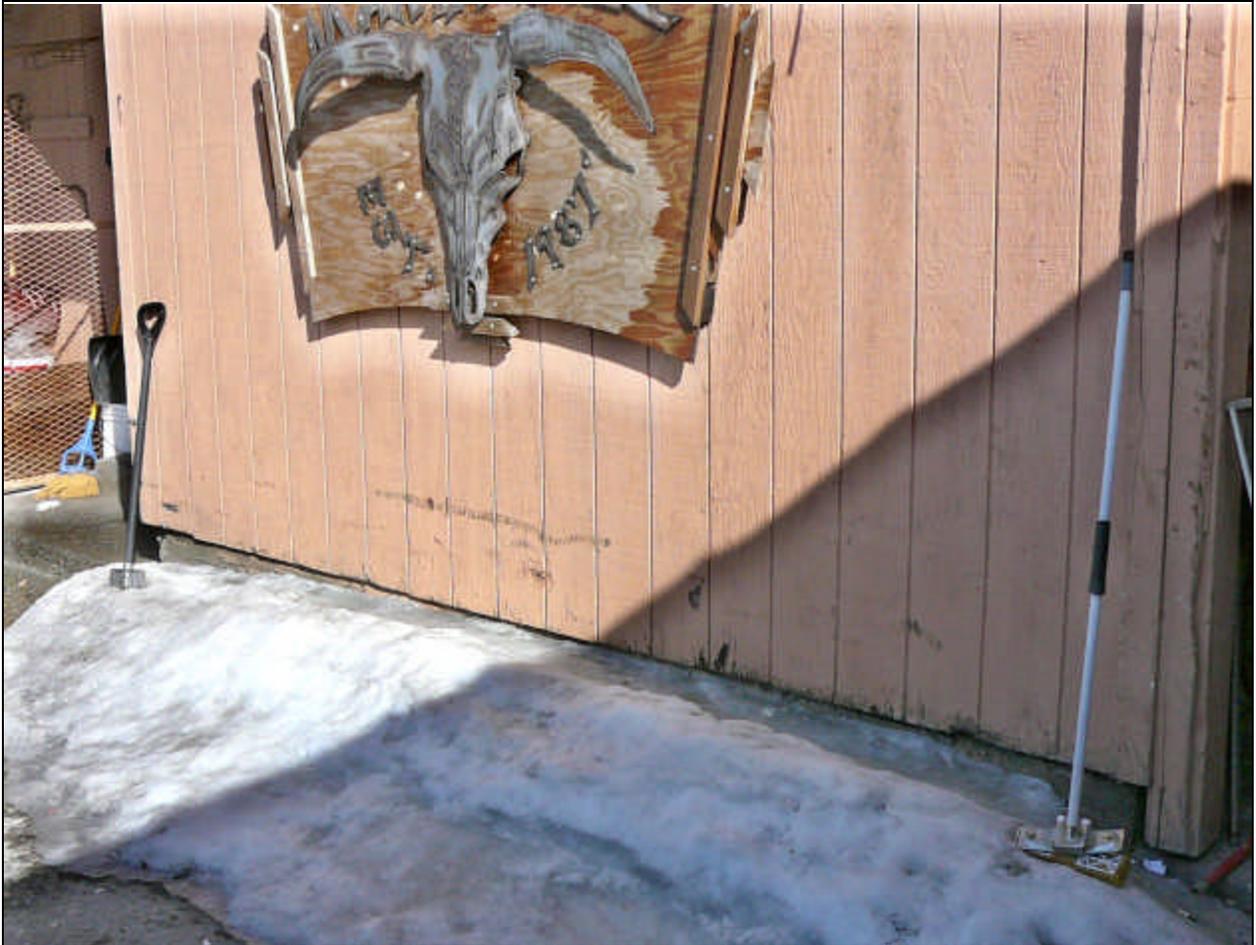
84. As can be seen in the following photo, the vertically applied T1-11 plywood siding at the rear of the building would benefit from repainting at this time.

Since this type of rough-sawn fir plywood veneer tends to “open” its grain to the weather through the years, I suggest considering brushing or mopping on a sealer to fill the coarse grain openings. Such a sealer can be rather easily made by mixing drywall dust with an oil-based primer to the consistency of warm butter. By brushing the sealer back and forth over the surfaces numerous times, the drywall dust works its way into the pores of the open-grained surfaces, filling them. Then the oil-based primer in the mixture has a chance to truly use its surface tension to bridge the fine pores and form a weatherproof coating. After the mixture cures, any good quality water-based alkyd or latex exterior paint may be applied.

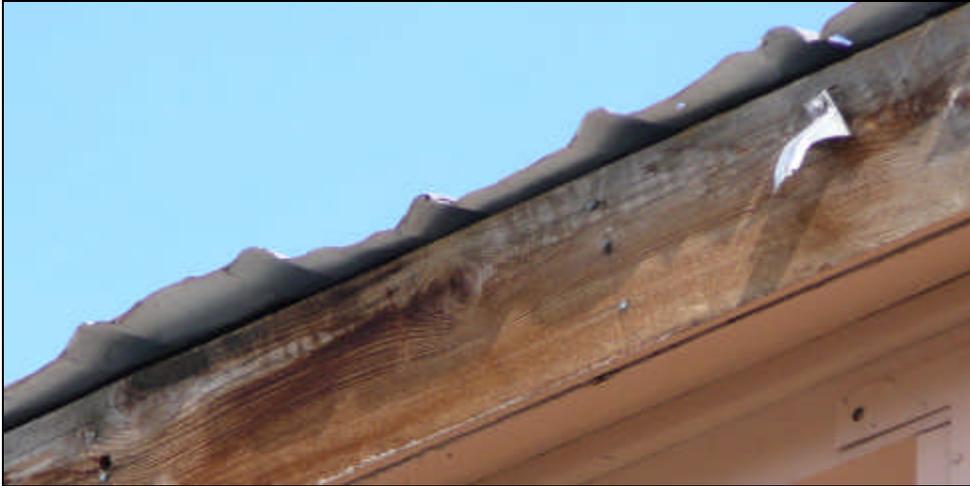
85. The following photo shows the unpainted eave fascia along the rear of the building. I suggest painting this wood.

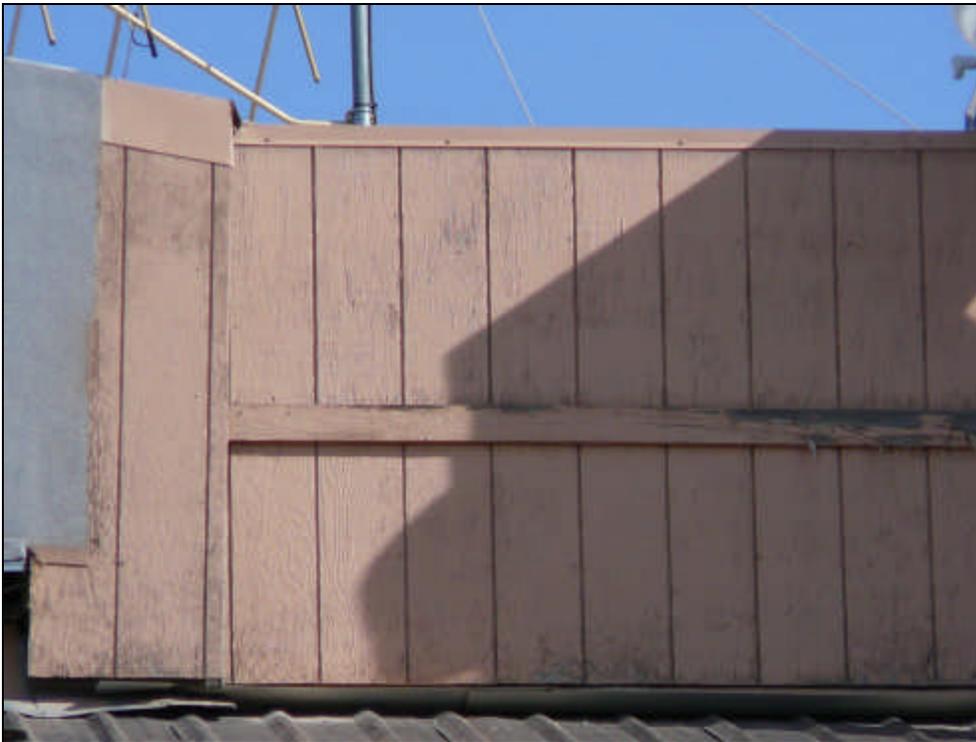
86. This photo shows the same type of T1-11 fir plywood siding at the upper level at the rear of the building (at the rear of the 2nd-story HVAC room). One can see that the plywood siding is “thirsty” for more paint. Therefore, I suggest filling and repainting all such plywood exterior surfaces in the near future.
