**AAD Inspection Corp.**

# Home Inspection Report

**1234 Any Street  
Boise, ID 83700**

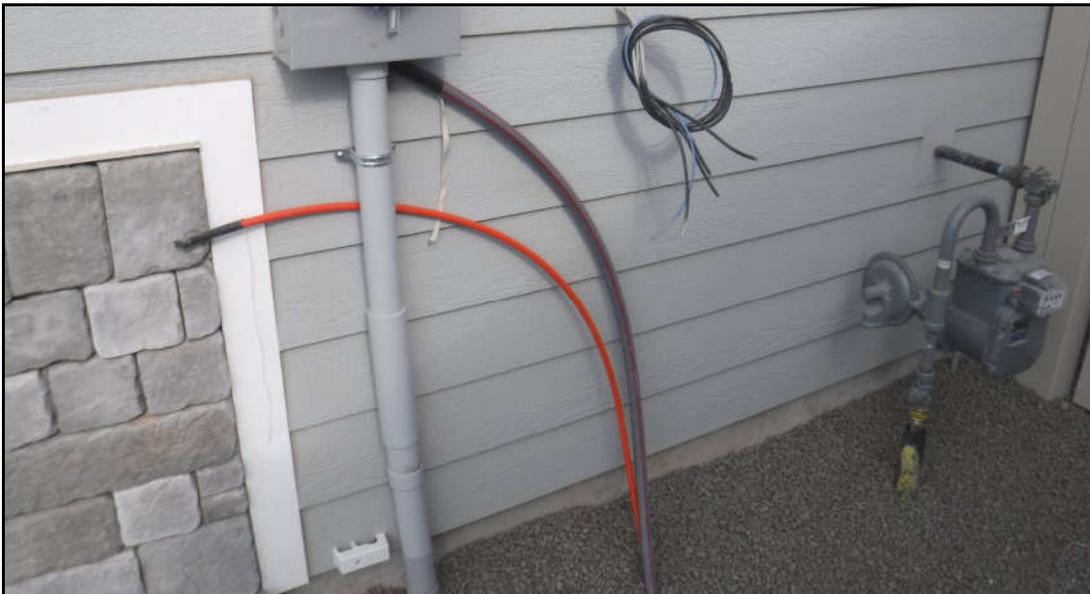
- The home includes conduit and low-voltage wiring for telephone, cable, and the Internet at the right front corner of the garage, as shown in the following photo. If these services are activated with any providers, their respective control boxes will be added at this location. (The white plastic cover provided over a “courtesy ground” terminal strip for the possible future utility providers can be seen near the bottom of the photo to the left of the gray plastic power conduit that leads upward to the electric meter.)

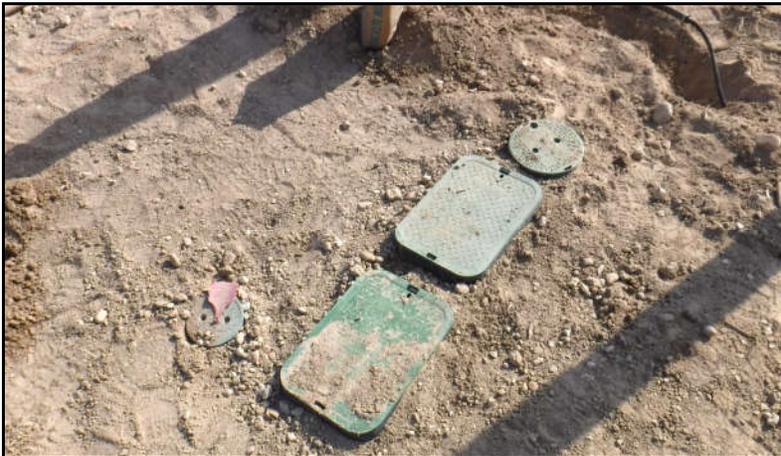
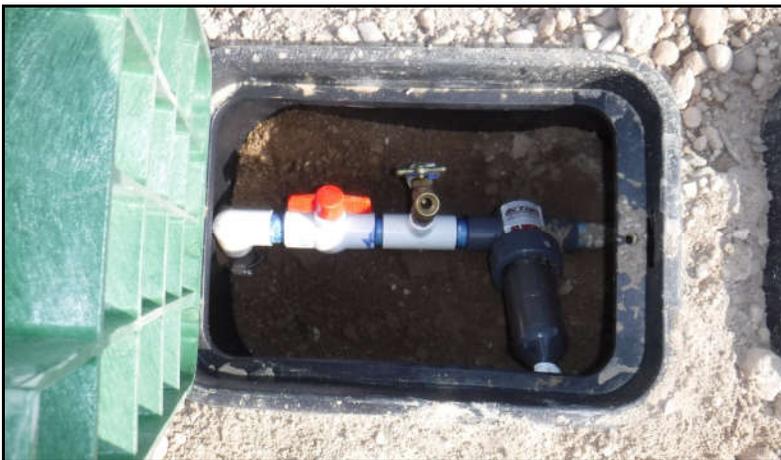
- The pressurized irrigation shutoff valves for the sprinklers are located at the right rear corner of the property, as shown in the following two photos. I suggest regularly cleaning the filter, to reduce weeds in the lawn and the clogging of sprinkler heads.

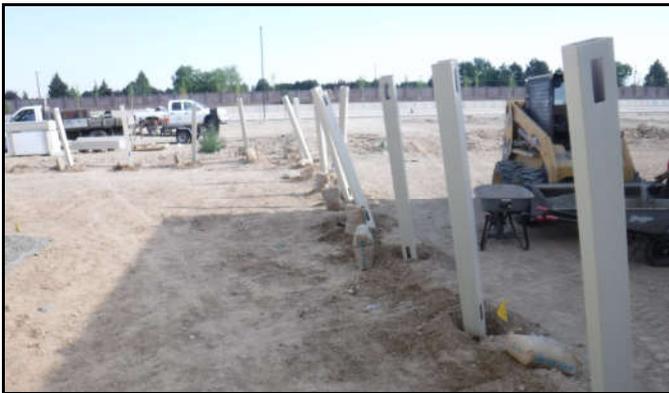
- Piping has been provided at the rear interior of the garage for a possible future water softener. However, no appliance is currently in place. NOTE: I strongly suggest that any further piping modifications for these purposes be made only by a licensed plumber.
- The fence around the back yard was in process of being installed during the inspection, as exemplified in the following photo. Similarly, some of the landscaping rock was being placed around the perimeter of the foundation. It is my understanding that the backyard landscaping is included with the purchase of the home, and will likely be completed prior to closing.

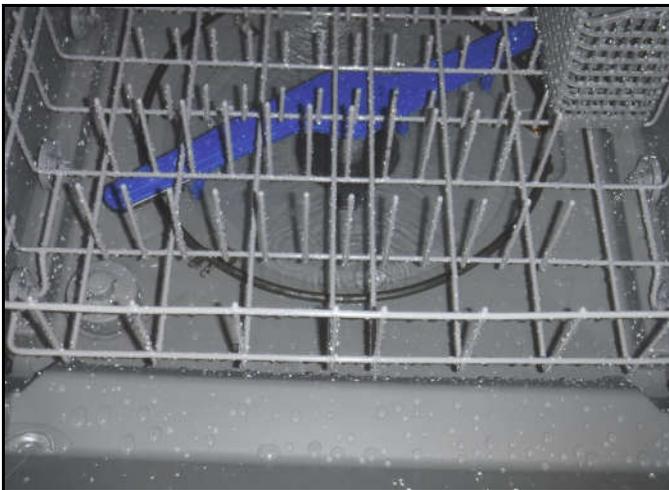
- The overhead garage door keypad could not be tested, as the code was not made available to the inspector at the time of this inspection.
- The dishwasher was operational, as shown in the following photo.

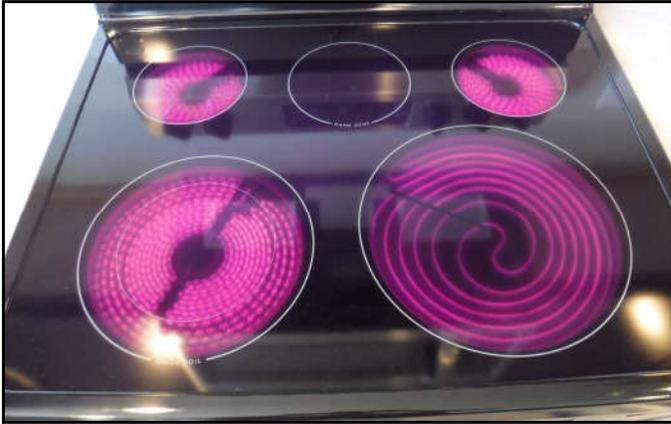
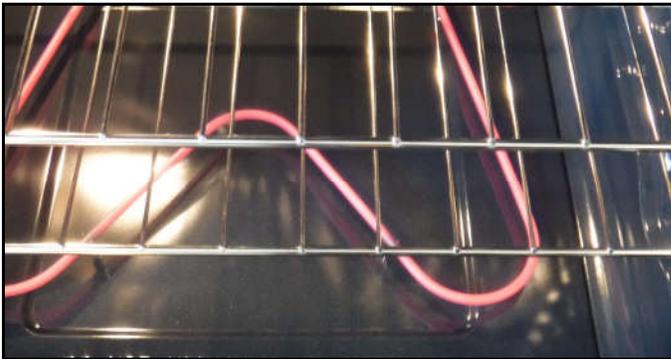
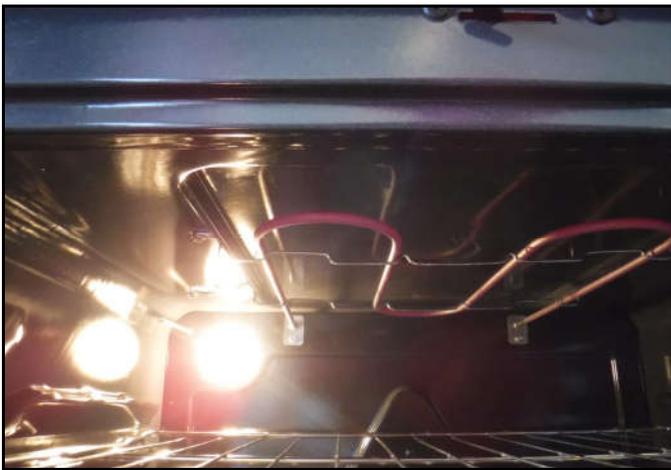
- The exterior-mounted light fixtures at the front of the garage are controlled by a photocell and were not tested at this time. (I suggest verifying proper operation of this circuit after dusk.)
- The heating functions of the free-standing electric range were all operational during this inspection, as shown in the following three photos.
